# District Report

## Ramechhap

6 - 19 July 2018

## Field Visit /Joint Field Monitoring Visit Reports

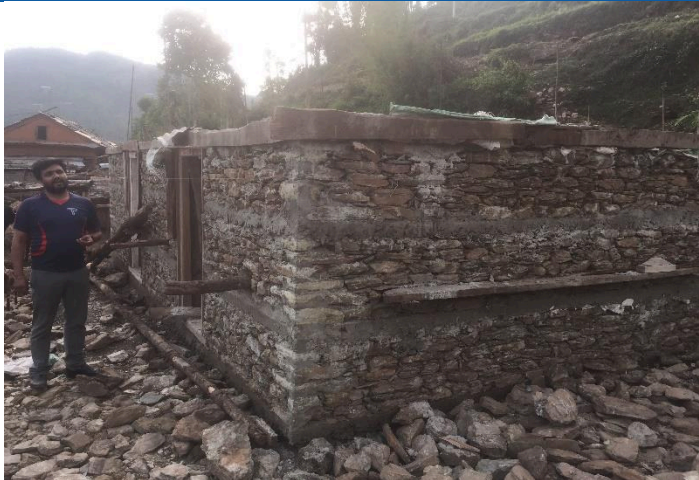
| | <ul style="list-style-type: none"> <li>The construction rate as found very satisfactory. The support of government technical personnel was helpful and the presence and working modality of NGO/INGOs in the area was also constructive.</li> </ul> | | |
|---|---|---|---|
| HRRP Technical Coordinator interaction with the house owner regarding the reconstruction at Dhobi Ramechhap. The house has been constructed using stone in mud mortar and file has been forwarded for the 2 <sup>nd</sup> tranche. | | The house constructed in Likhu Tamakhosi rural municipality Ramechhap. The house has been constructed using brick in cement mortar and RCC Bands have been provided and file has been forwarded for the 3 <sup>rd</sup> government tranche. | |

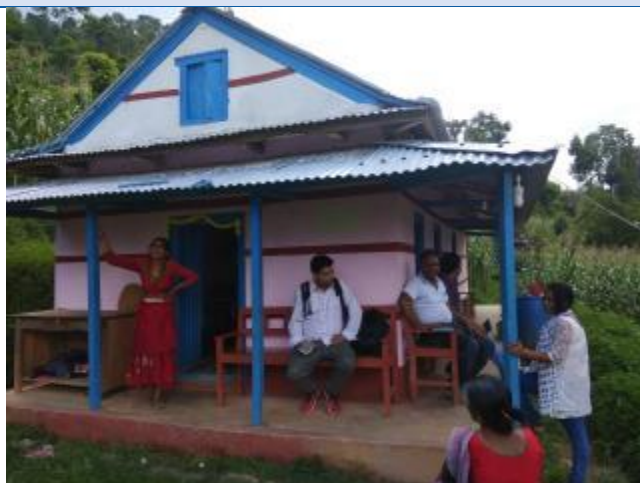
*The house of Ros Bahadur Nepali constructed in Gothgaun, Ramechhap-1. The house has been constructed using stone in mud mortar and RCC Bands have been provided. The gable wall has been constructed using heavy materials without gable band. The house owner has received second tranche of reconstruction grant*

| Visit 2 | | | |
|---|---|---|---|
| 10-12 houses are in non-compliances | NRA engineer should interaction with beneficiaries and motivated them to make correction. | NRA Engineer and beneficiaries | As soon as possible. |

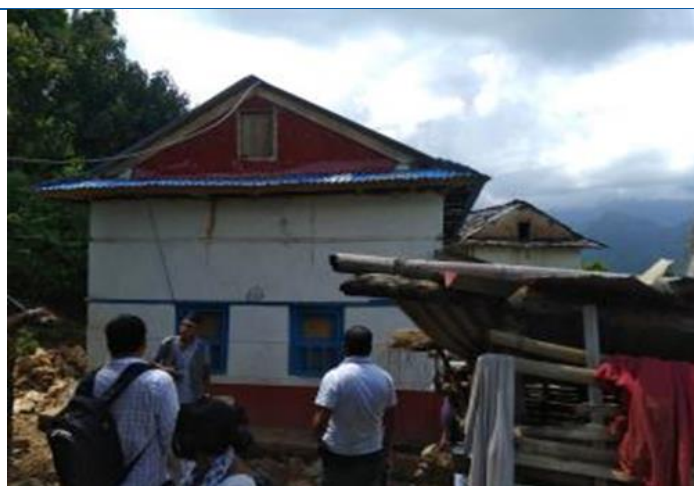
*Interaction with the beneficiaries at Gothgaun, Ramechhap-1. After the consultation of the NRA Engineer, the heavy gable wall has been removed and has been replaced by light structures. The house of Kalu Sarki constructed in Gothgaun, Ramechhap-1. The house has been constructed using stone in mud mortar and RCC Bands have been provided. The house owner has received second tranche of reconstruction grant and has been forwarded for the third tranche.*

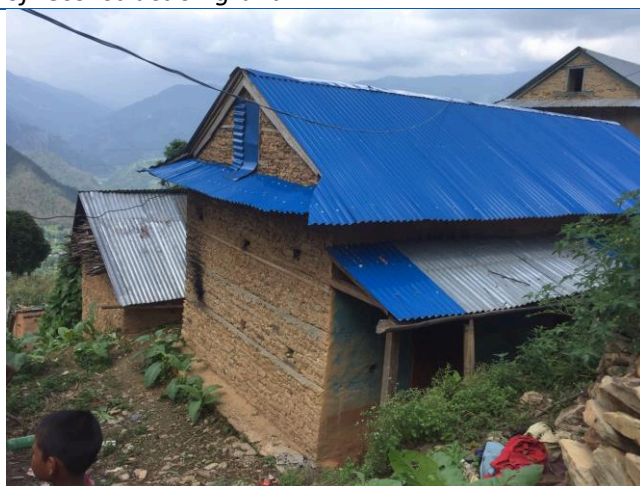
*The house has been constructed using stone in mud mortar and RC banda have been provided. The gable wall has been constructed using heavy materials without gable band. The house owner has received second tranche of reconstruction grant.*

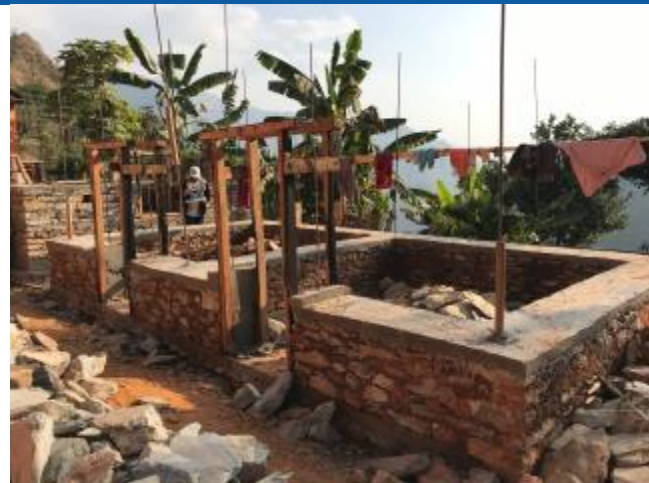
The house of Bel Kumar Basnet being constructed in Saipu, Likhu Tamakoshi RM-2. The house has been constructed by using stone with mud mortar. RC bands have been provided to the house. The house has been constructed up to sill level. The house owner has received second tranche of reconstruction grant. The house has been constructed under TA of KFS Nepal

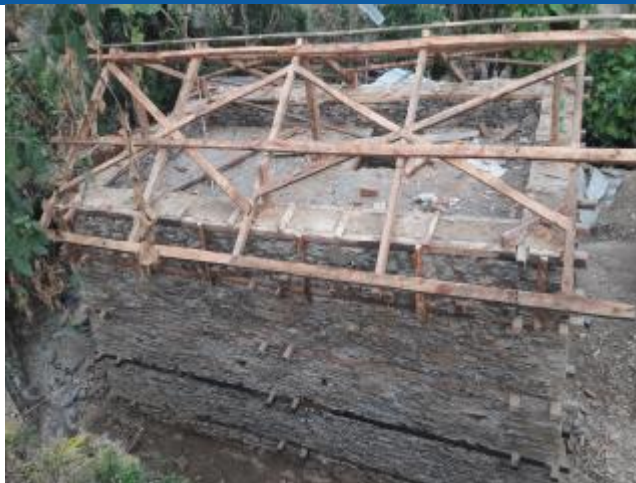
The house of Bharat Kumar Karki being constructed in Saipu, Likhu Tamakoshi RM-2. The house has been constructed by using stone with mud mortar. Timber bands have been provided to the house. The house owner has received third tranche of reconstruction grant. Bracing has been provided in truss. The house has been constructed under TA of KFS Nepal

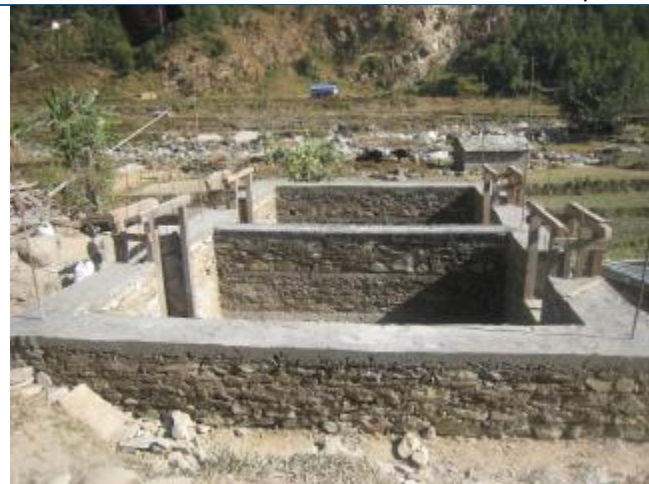
The house of Bikram Bhujel being constructed in Saipu, Likhu Tamakoshi RM-2. The house has been constructed by using stone with mud mortar. RC bands have been provided to the house. The house has been constructed up to intermediate band level. Double framed windows and doors have been used. The house owner has received second tranche of reconstruction grant. The house has been constructed under TA of KFS Nepal.

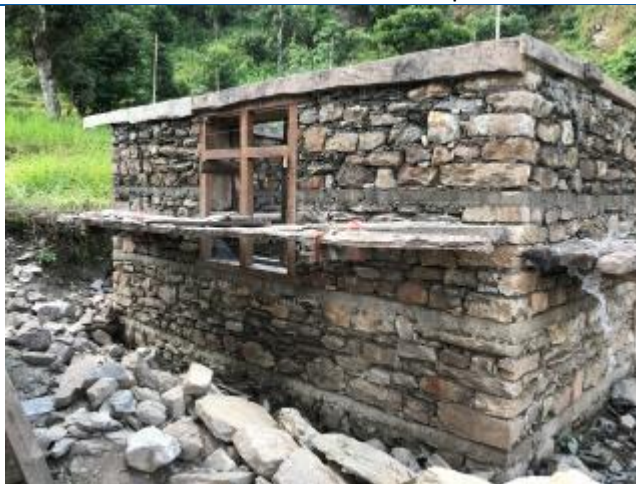
The house of Bel Kumar Basnet being constructed in Saipu, Likhu Tamakoshi RM-2. The house has been constructed by using stone with mud mortar. RC bands have been provided to the house. The house has been constructed up to lintel level. The house owner has received second tranche of reconstruction grant. The house has been constructed under TA of KFS Nepal. Chandra Bahadur Tamang

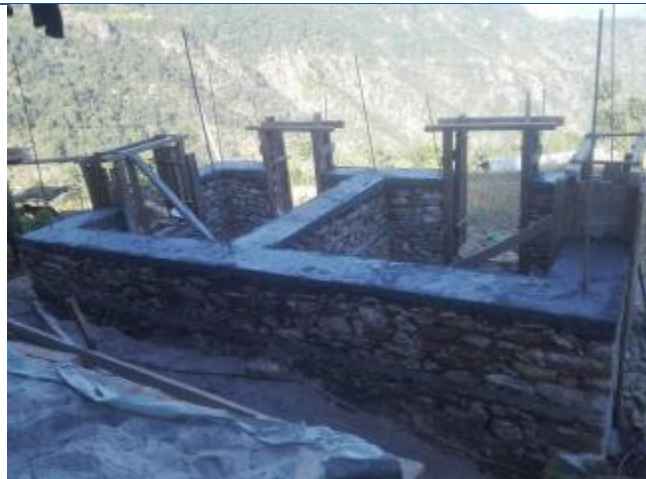
The house of Chaturman Darji being constructed in Saipu, Likhu Tamakoshi RM-2. The house has been constructed by using stone with mud mortar. RC bands have been provided to the house. The house has been constructed up to intermediate band level. Double framed windows and doors have been used. The house owner has received second tranche of reconstruction grant. The house has been constructed under TA of KFS Nepal.

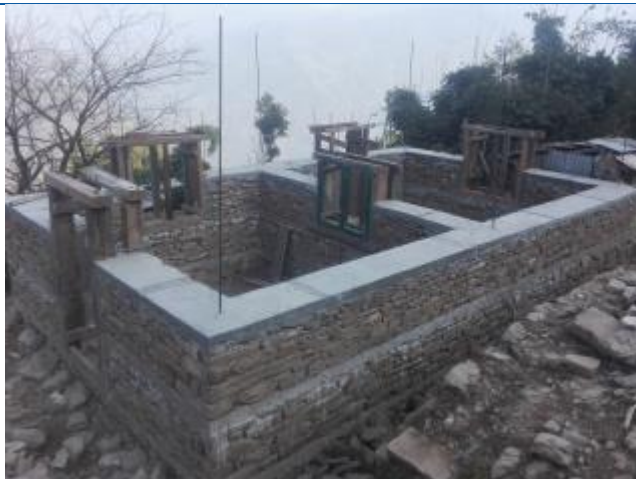
The house of Dhal Bahadur Magranti being constructed in Saipu, Likhu Tamakoshi RM-2. The house has been constructed by using stone with mud mortar. RC bands have been provided to the house. The house has been constructed up to intermediate band level. Double framed windows and doors have been used. The house owner has received second tranche of reconstruction grant. The house has been constructed under TA of KFS Nepal.
