## Monthly District Report

### Lalitpur, Bhaktapur

22 October – 21 November 2019

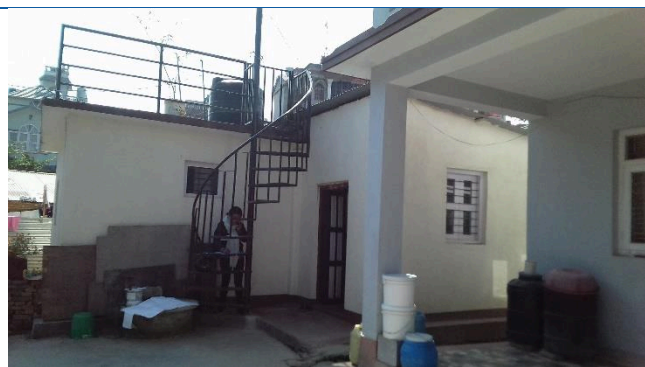
Beneficiary name: Indira Thapa, Ward no. 15, Khumaltar, Lalitpur Metropolitan City, single storey 3 room wall system BMC house have party rigid roof and flexible roof too. The owner is a single women, accessed 1<sup>st</sup> tranche and was reconstructed soon after earthquake and before deployment of engineers.

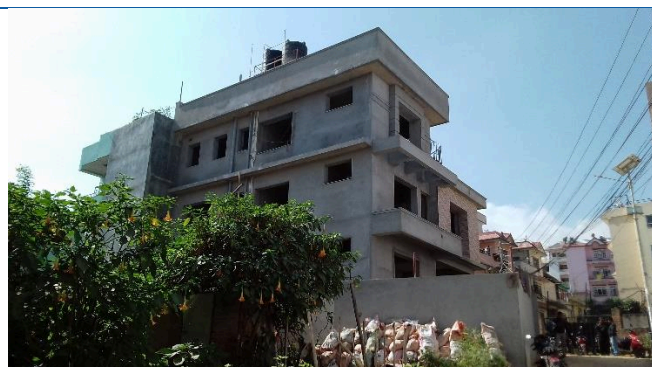
Beneficiary name: Babu Ram Bogati, Ward no. 15, Khumaltar, Lalitpur Metropolitan City, 2.5 storey RCC house has 7 rooms in total. The house is compliant and have received 1<sup>st</sup> tranche too. The owner had earthquake damaged house at Mahankal Rural Municipality and received building drawing approval for plot at Ward no. 15, Khumaltar, Lalitpur Metropolitan City. The owner still resides in rented place at Balkhu, Kathmandu.
