# NRA GEO-HAZARD ASSESSMENT

## Survey Data

Steve Revill (UNOPS) – 09 August 2017

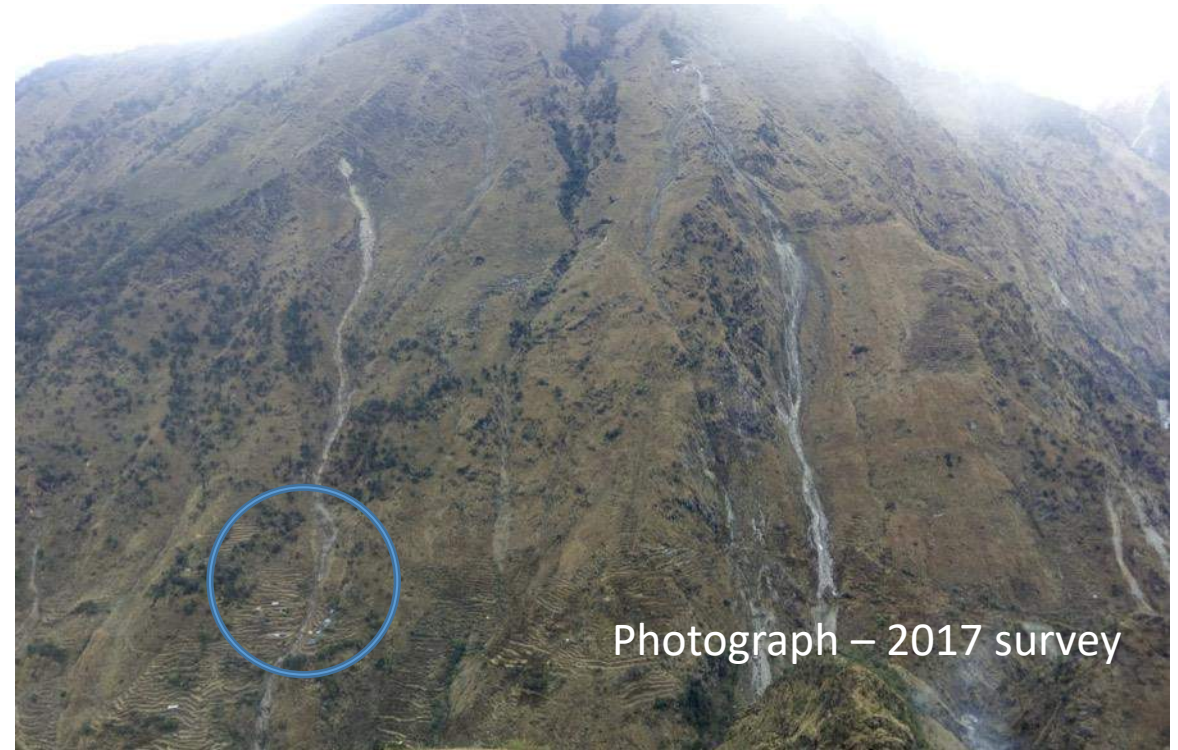
## Dhading: Tipling VDC – Simpale

NRA ASSESSMENT – Category 3: All 18 households require relocation

LANDSLIDE DID NOT EXIST BEFORE THE EARTHQUAKE

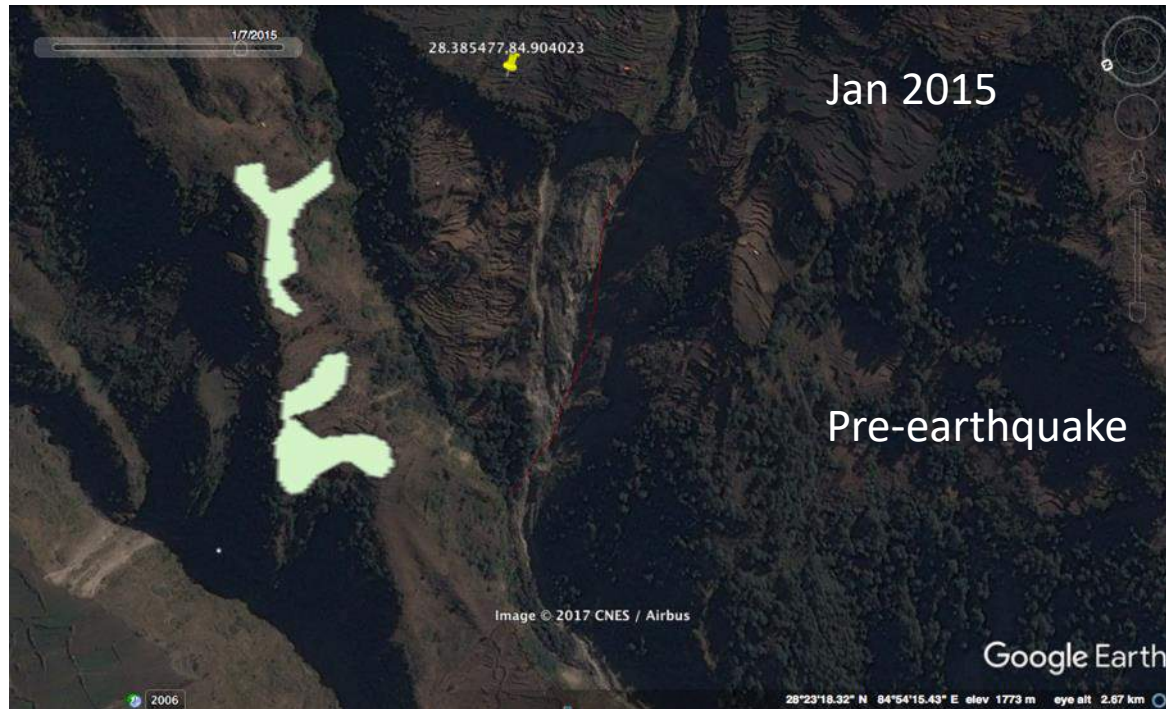
# Gorkha: Sirdibas VDC – Dewal Gaun

NRA ASSESSMENT – Category 2: Drainage, bioengineering, slope trimming & retaining walls recommended

LANDSLIDE EXISTED BEFORE THE EARTHQUAKE – LOOKS TO HAVE DETERIORATED AS A RESULT & MAY BE GETTING WORSE

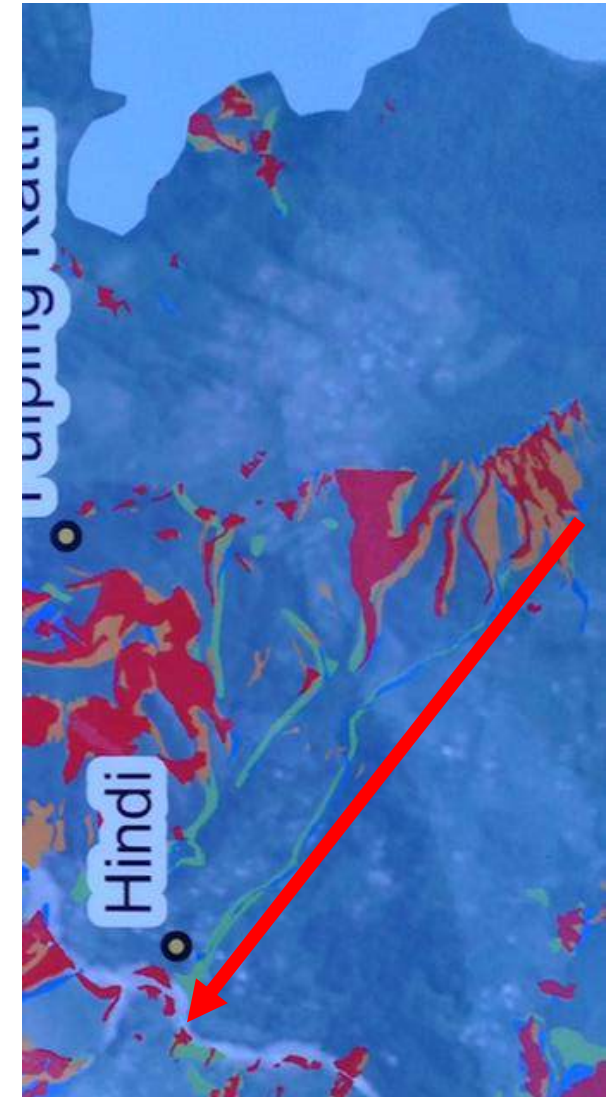
# Sindhupalchowk: Fulpingkatti VDC – Hindi Luksing (visited 5 March 2017)

NRA ASSESSMENT – Category 2 – Drainage, cascade construction, river training

Durham University data – mapped expansion of debris flow matched on ground

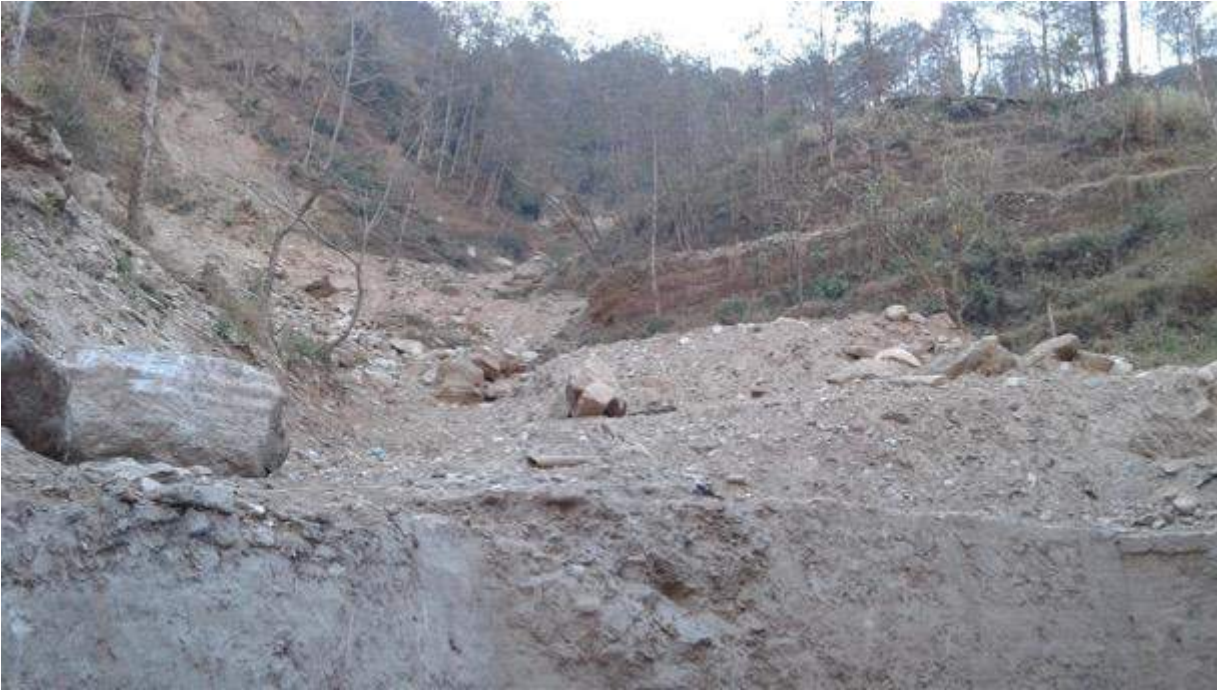
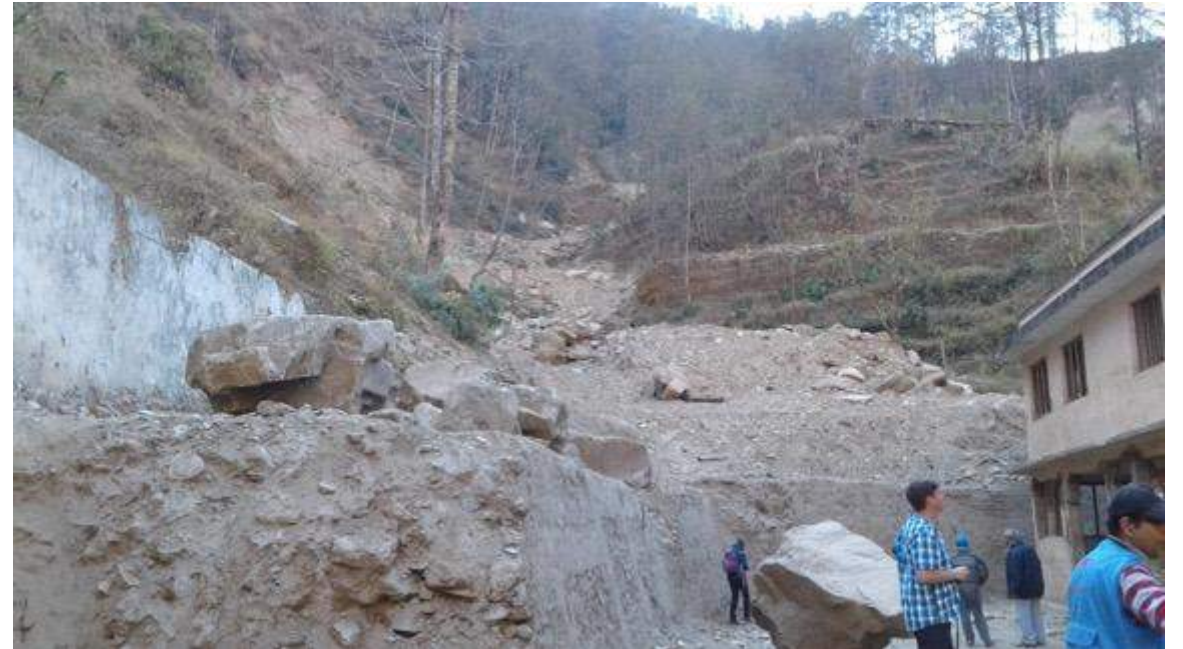
# Sindhupalchowk: Fulpinkatti VDC – Hindi Luksing (visited 5 March 2017)

Debris flow behind school

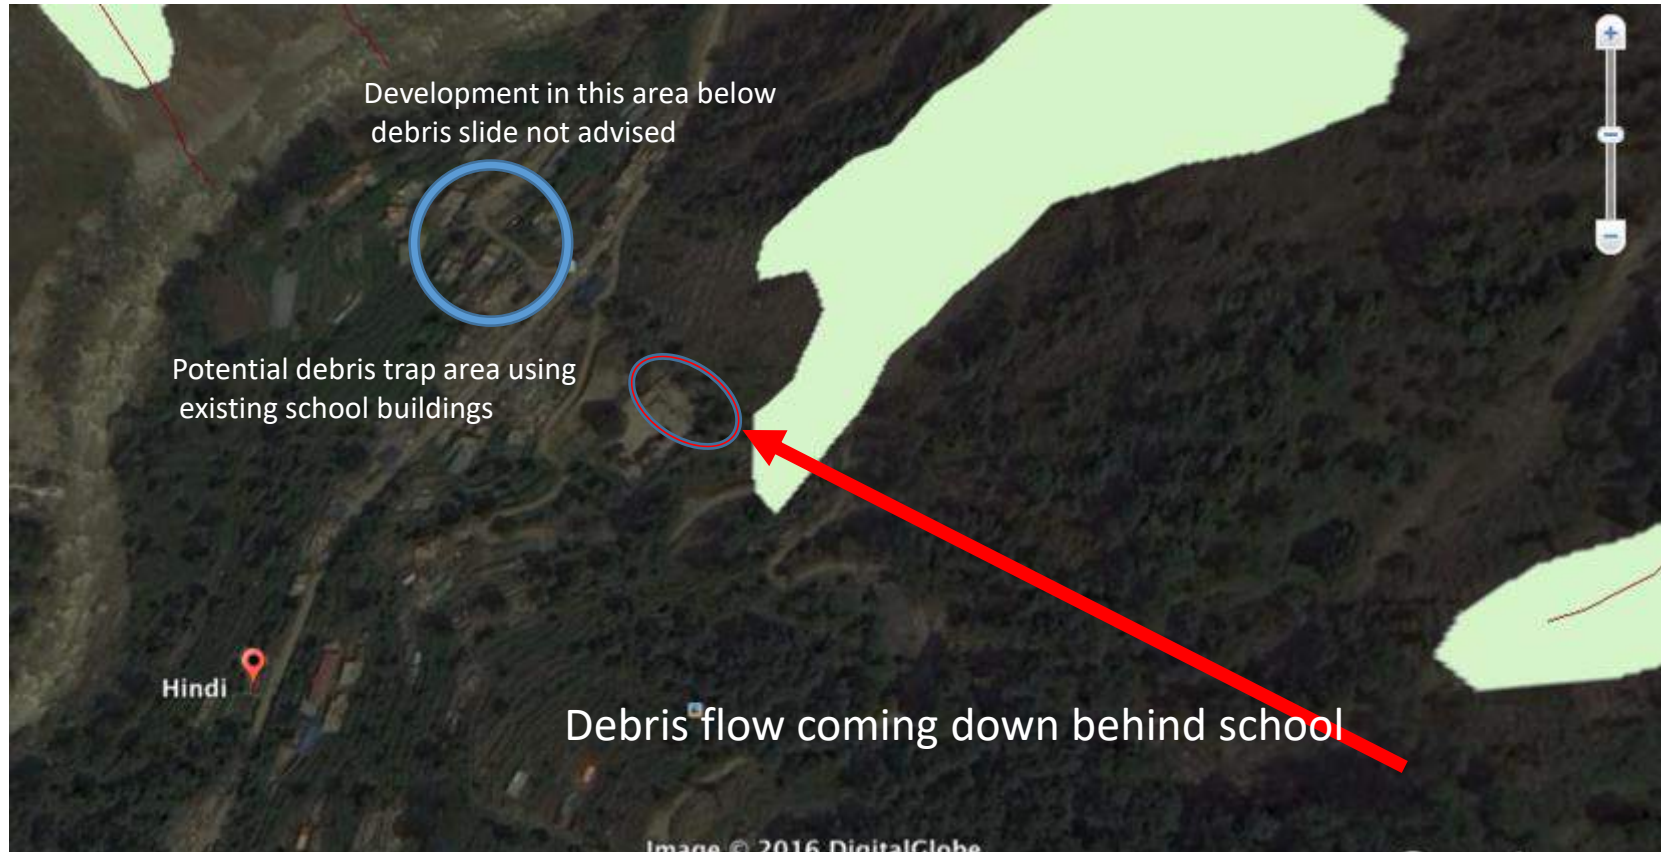
# Sindhupalchowk: Fulpinkatti VDC – Hindi Luksing (visited 5 March 2017)

NRA ASSESSMENT – Category 2 – Drainage, cascade construction, river training

- Is it feasible to utilize damaged school as debris trap – will require maintenance
- Should houses directly below debris flow be relocated reclassifying it as Category 3?

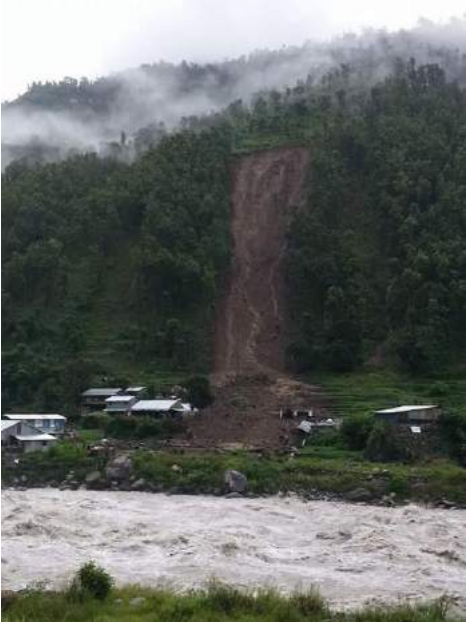
Translational failure in Rasuwa– soil and weathered rock (shallow circa 2 m)

Lower strength along failure surface than before failure – needs to be considered in the design
