## Fortnightly District Report

### Okhaldhunga

1 - 14 February 2019

## Housing Typology Report

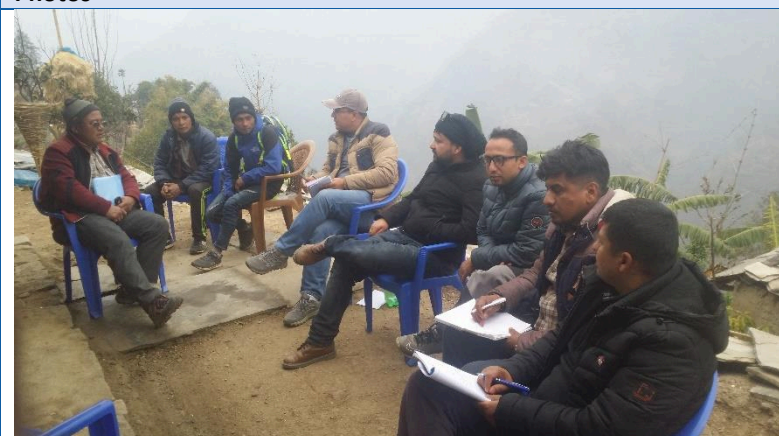
Figure 1 Meeting with ward leader at Khijidemba Rural Municipality ward no 1 Salpu

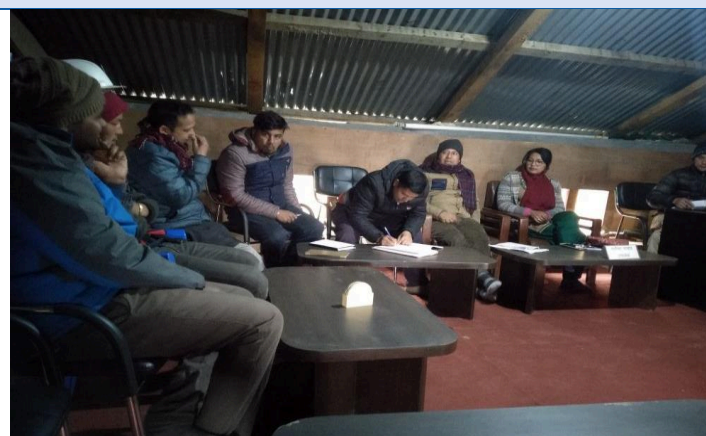
Figure 3 Meeting With Vice Chair Person at Khijidemba Rural Municipality 5 Khijifalate

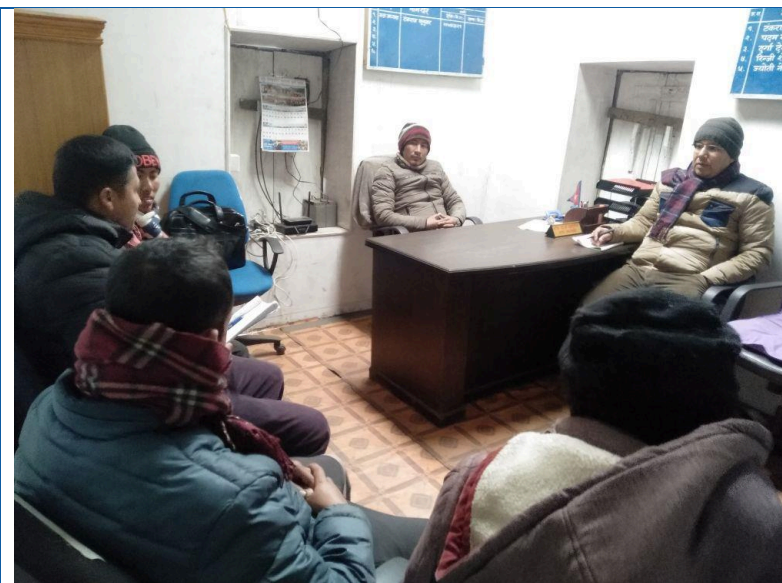
*Figure 2 Meeting with Ward Leader at Khijidemba Rural Municipality 3 Chandeswori*

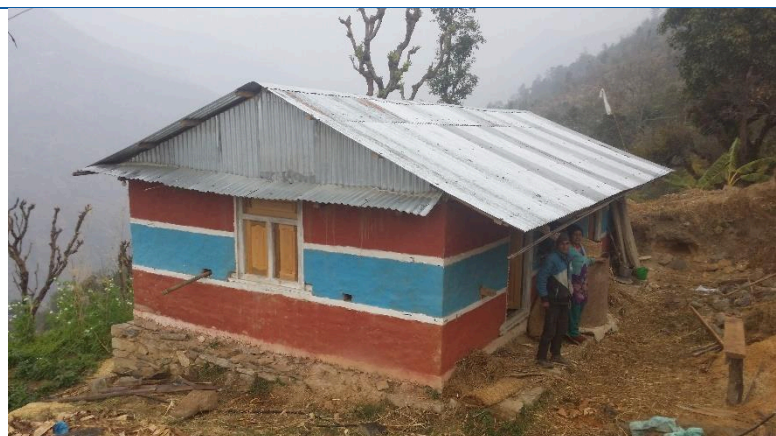
**Figure 3** House Owner Tej Narayan Shrestha Khijidemba Rural Municipality ward no 1 Chapleti

This house Compliance made up of Stone in Mud Mortar and wooden Bands provided at the appropriate location and the Beneficiary has received all three tranches provided by the Nepal Government.

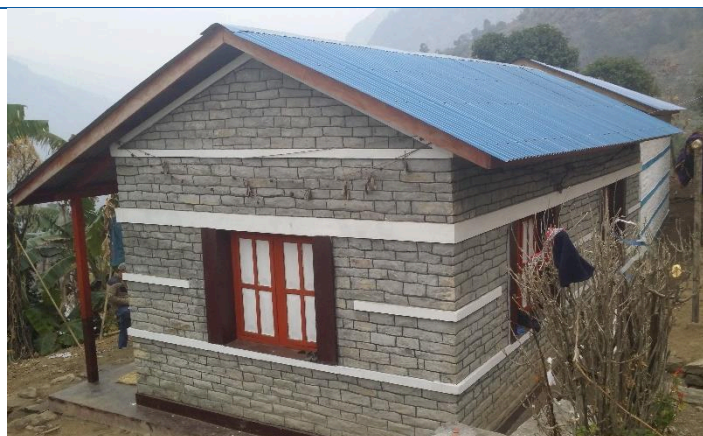
**Figure 4** House of Chandra Bahadur Sunuwar Khijidemba Rural Municipality Ward no 1 dadagaun.

The beneficiary has built this house under the Support of (GWS) Gorkha Welfare Society. The house is made up of in mud mortar with RCC bands provided The Beneficiary has also received all three tranches from the Nepal Government.

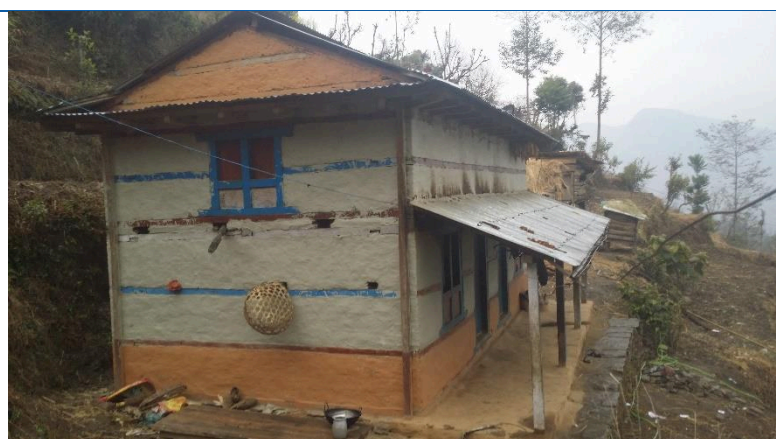
**Figure 5** Dilli Bahadur Nepali khijidemba Rural Municipality ward no 3 Patule Khijichandeswori

This house is noncompliance since the attic height is more than 3 feet and has not received third tranche The house is made up of stone in mud mortar with wooden band .DSE has suggested correction by applying vertical support on both side above the floor for the house for third tranches.

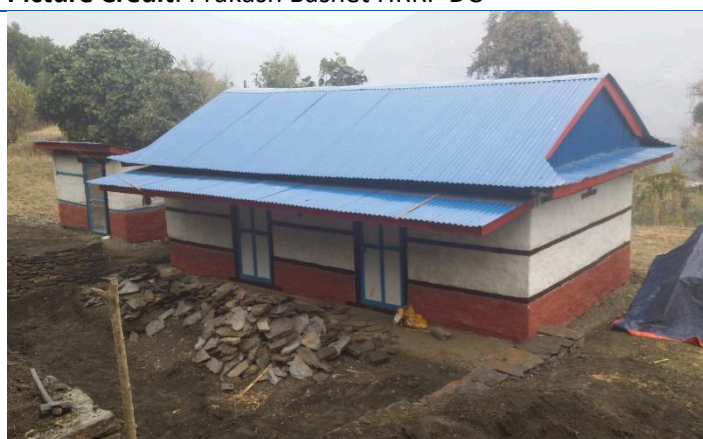
**Figure 6** House of Bhakta Bahadur Sunuwar Khijidemba Rural Municipality ward no 3 Chandeswori

House made with stone in mud mortar with wooden bands Provided at appropriate place. The beneficiary has received first and second tranches from the government and third tranche is

has been recommended by the field engineer five months ago but the beneficiary has not received yet

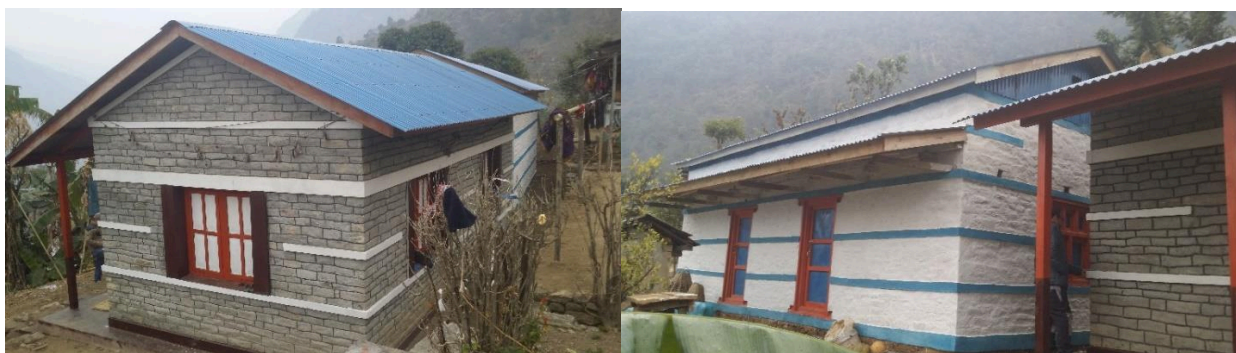
*Figure 1 House of Chandra Bahadur Sunuwar Made with the support of Gorkha Welfare Society (GWS) and Nepal Gov. Gran*
