# District Report

## Rasuwa

25 May - 7 June 2018

## Field Visit Reports

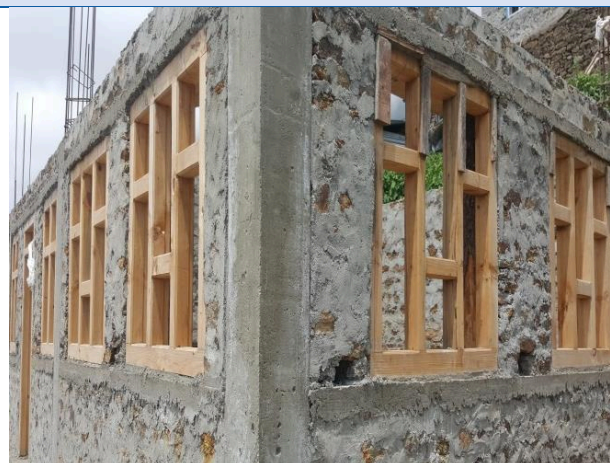
- House owner: Dawa mingmar lama. As he was not present at the site we talked with his wife Pemba Ghosum Ghale
- The constructed structure was stone masonry in cement mortar constructed up to the lintel level. She has received the 2<sup>nd</sup> tranche and was not sure what to put above the lintel level as cover and was planning to cover with GI sheets.
- Suggestion by us: As the structure contained column of 12" x 12" so we suggested her to construct beam connecting all pillars which could help her to receive the 3<sup>rd</sup> tranche and the made her understand the importance of slab, beam and column system in a structure and load transfer system.

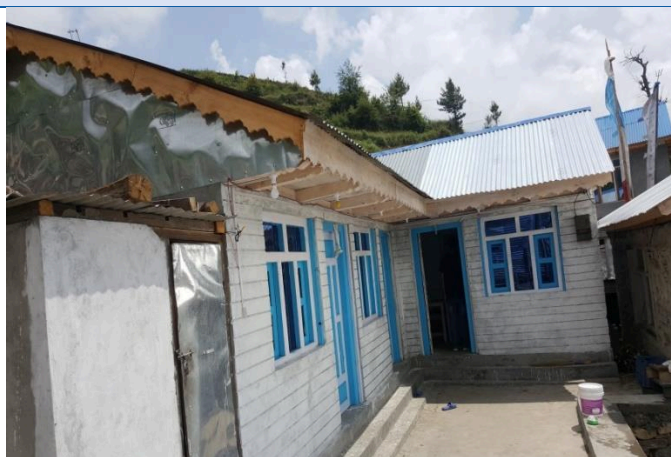
Chiring wanghook tamang and Pasang wanghook tamang – Relation is father and son, both are beneficiaries took the 3<sup>rd</sup> tranches as well but constructed the houses attached in L shaped. No seismic gaps were left to reduce the effect of torsion during earthquake. Lack of technical supervision seen but the tranches were taken.

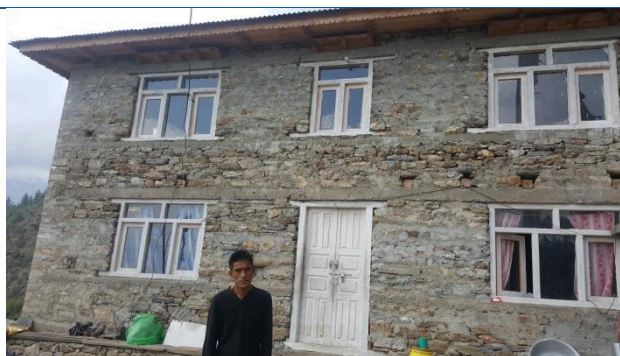
- House Owner: Sanga Tenjing Tamang.
- Gosaikunda gaupalika ward no-3

| <ul style="list-style-type: none"><li>• The house was under construction but was not constructed according to the NBC. He had taken 2nd tranche. It was a single room structure wall thickness 18" but the size of the room was L=29'4" and B=33'4". The cement was just sprayed outside but not inside. No vertical reinforcement.<ul style="list-style-type: none"><li>▪ Suggestion given by us: The dpc was made for construction of two rooms so we suggested for the partition of room with cross wall as the dpc was already present as a partition. Moving the door from the present location to 2' away the partition wall and provide vertical reinforcement. Lack of technical supervision was seen.</li></ul></li></ul> | <ul style="list-style-type: none"><li>• Taken all 3 tranches but the area of the house was large resulting in non-compliance. Lack of supervision by technical was seen during construction phase.</li></ul> | |

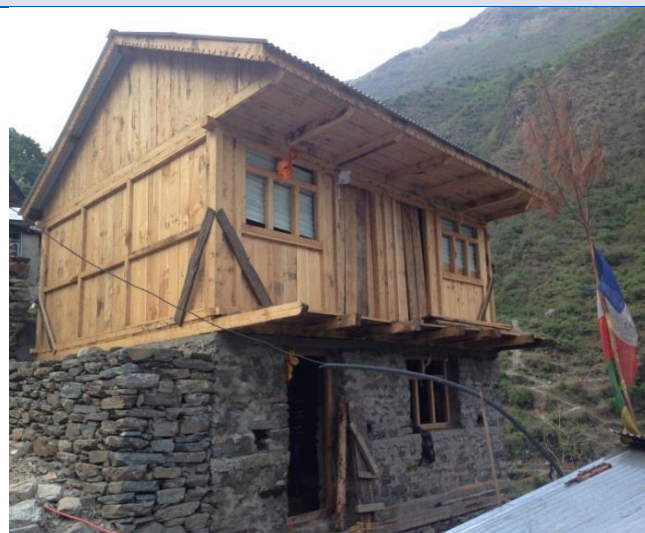
Bahadur Tamang, Ama chhodingmo R.M.-5, Rasuwa. Received 2<sup>nd</sup> tranche. Not proper connection between lower and upper floors.

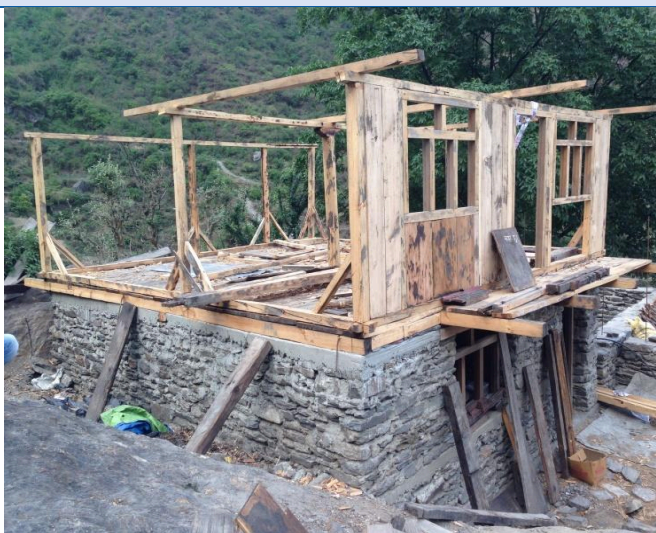
Nima Gombo Tamang, Ama chhodingmo R.M.-5, Rasuwa. Received 2<sup>nd</sup> tranche. No proper connection of woods.

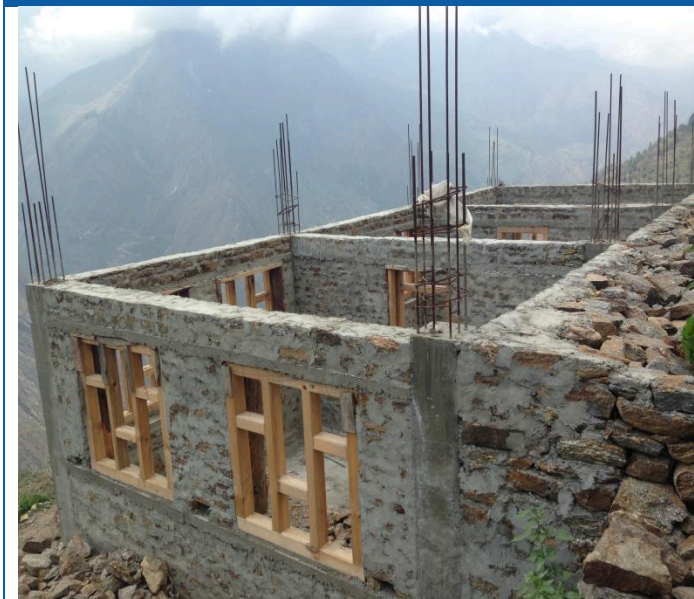
Dawa Mingmar Tamang, Gosainkunda R.M.-3, Rasuwa. Received 2<sup>nd</sup> tranche.

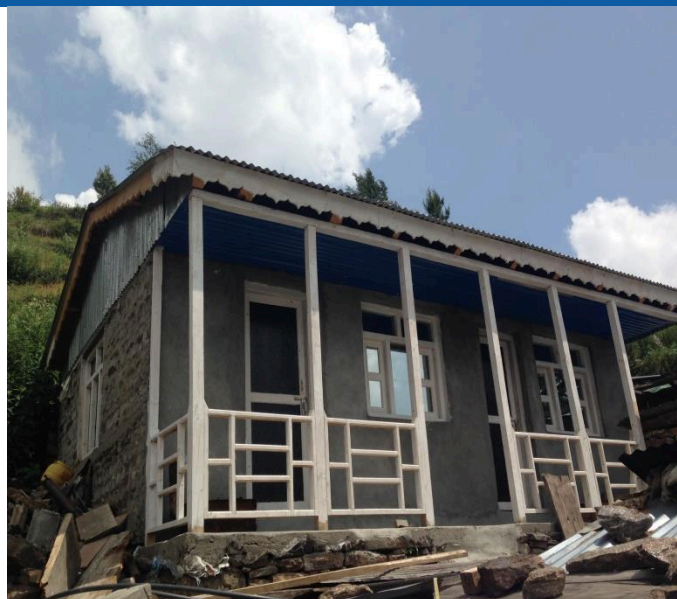
Mingmar Gyalbo Tamang, Gosainkunda R.M.-3, Rasuwa. Received 3<sup>rd</sup> tranche.

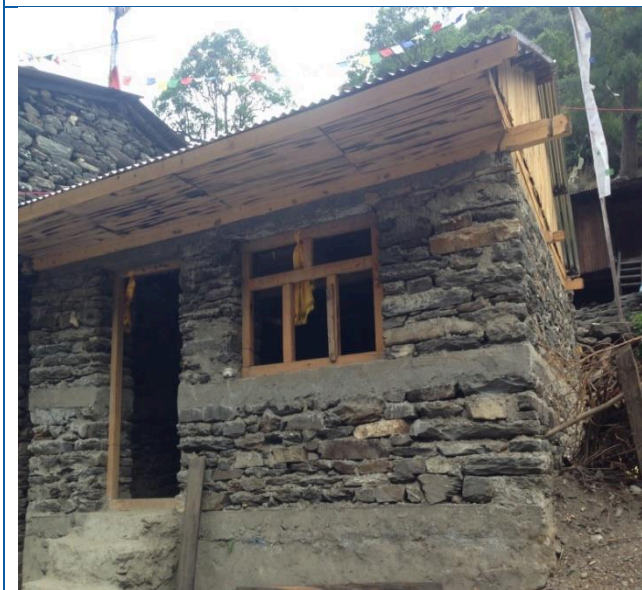
Phurbu sangbo Lama, Ama chhodingmo R.M.-5, Rasuwa. Received 2<sup>nd</sup> tranche. Recommended 3<sup>rd</sup> tranche.

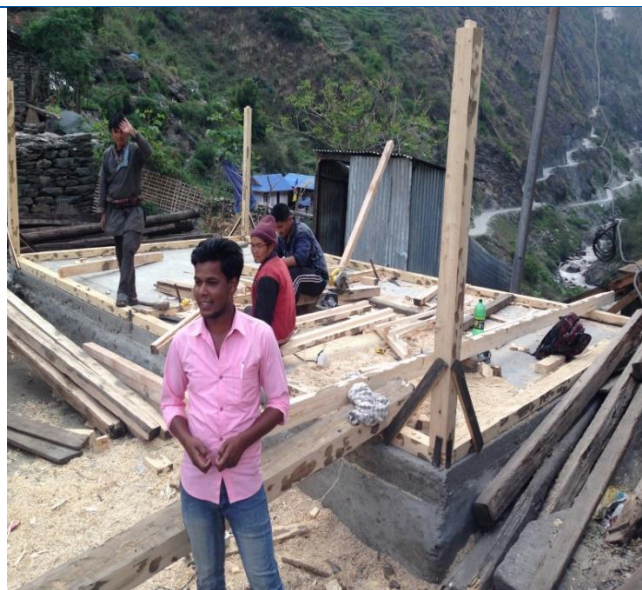
Gopal Tamang, Ama chhodingmo R.M.-5, Rasuwa. Received 2<sup>nd</sup> tranche.

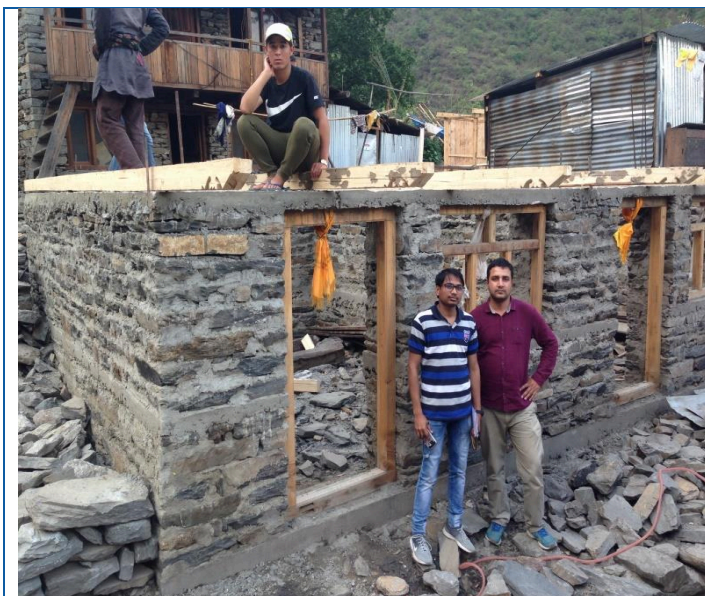
Kancha Tamang, Ama chhodingmo R.M.-5, Rasuwa. Received 2<sup>nd</sup> tranche.

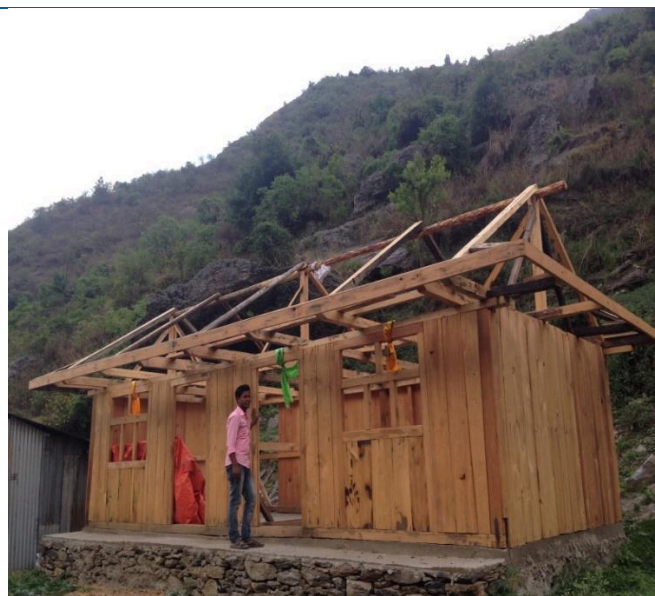
Timber structure. Sonam Ghale, Ama chhodingmo R.M.-5, Rasuwa. Recommended 2<sup>nd</sup> tranche.

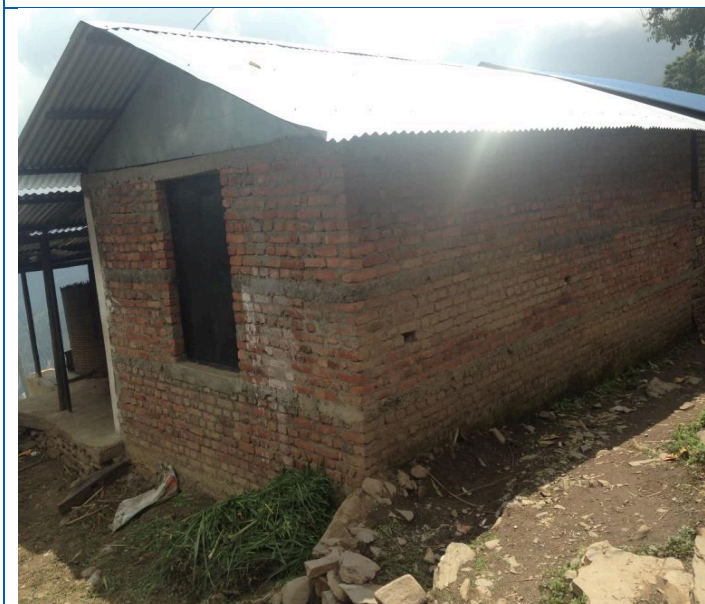
Prem Bishwokarama, NauKunda R.M.-1, Rasuwa, Received 3<sup>rd</sup> tranche.

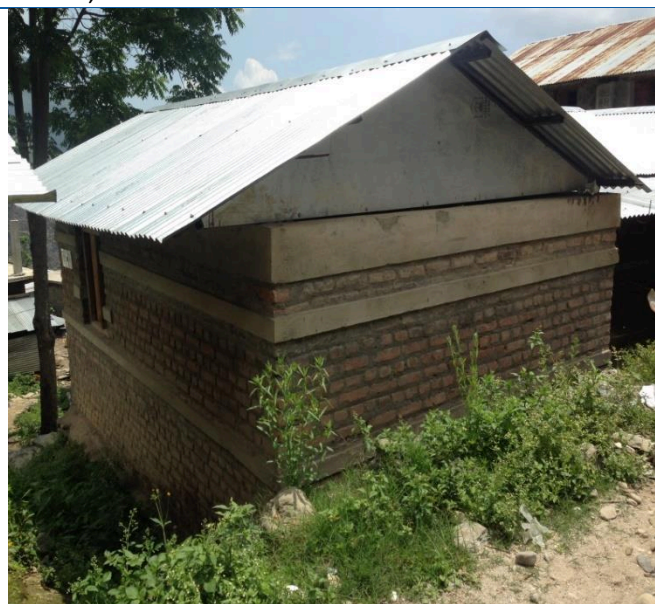
Dawa Ghale, NauKunda R.M.-1, Rasuwa. Received 3<sup>rd</sup> tranche.
