# District Report

## Kathmandu Valley

21 Dec 2018– 3 Jan 2019

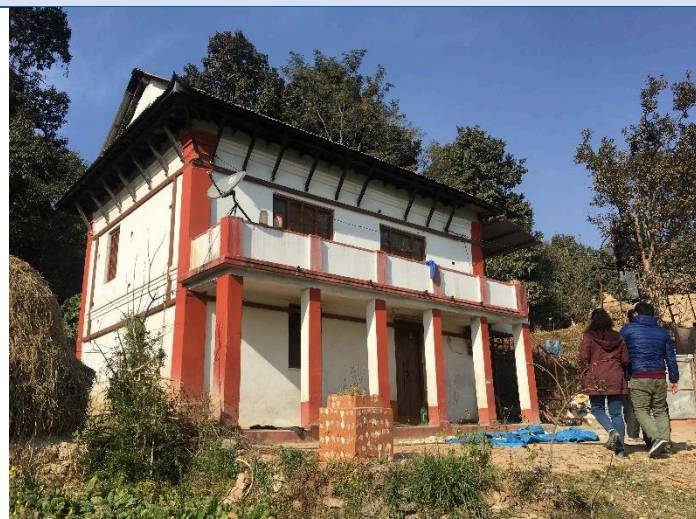
Beneficiary Name: Ananda Prasad Sharma Bhandari, ward no 3, Gokarneshwor Municipality. The beneficiary has requested to change from full damage to retrofitting name list. The beneficiary has claimed to have retrofitting two storey BMM structure. Steel post of been used to form a frame structure in the second storey of the house. The beneficiary was suggested to reconstruct another house as the structure is not considered to be retrofitted.

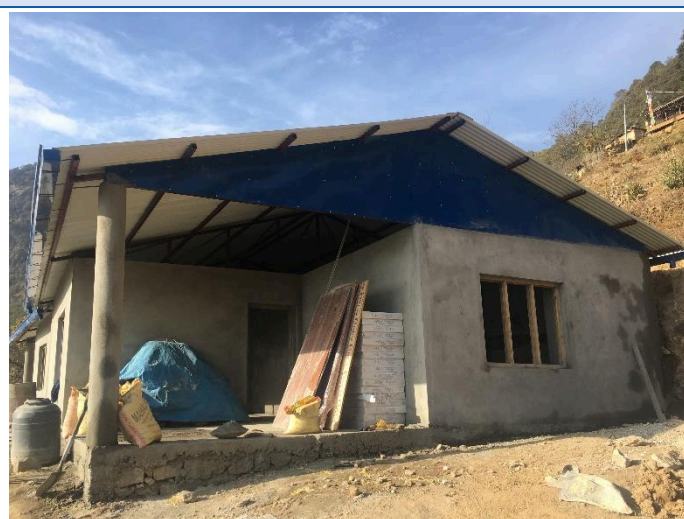
Beneficiary Name: Subash Tamang, ward no 3, Tarebhir, Gokarneshwor Municipality. One storey 3 room SMC structure with flexible roof. The beneficiary has construed the house as per the design catalogue SMM 1.1 modified to SMC. During the inspection process the structure was found to be compliant and the inspection of 2<sup>nd</sup>, 3<sup>rd</sup> and completion was conducted at once.

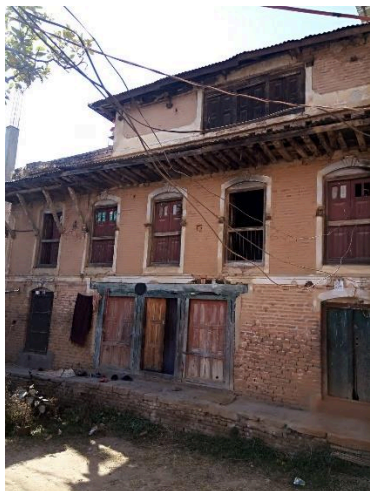
Photo: Front view of Mr. Mahendra Raj Rajopadhaya's earthquake damaged house. Mr. Rajopadhaya has recently returned 1<sup>st</sup> tranche as he unintended to rebuild his house.

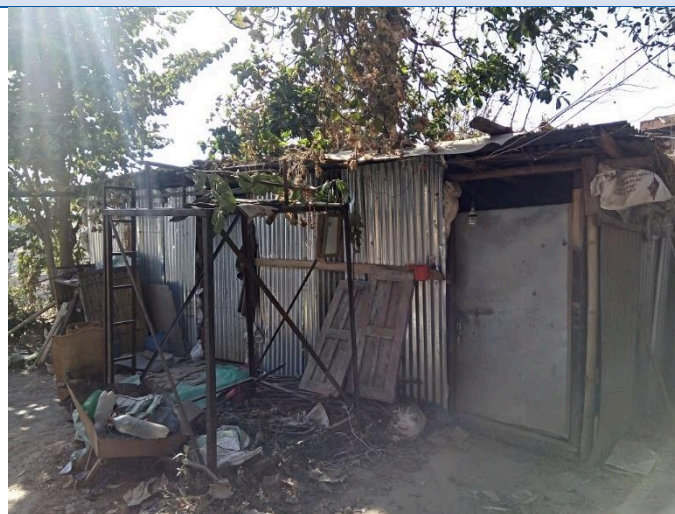
Photo: Temporary shelter owned by Mr. Mahendra Raj Rajopadhaya. This T-shelter is still in use by Mr. Rajopadhaya's family.

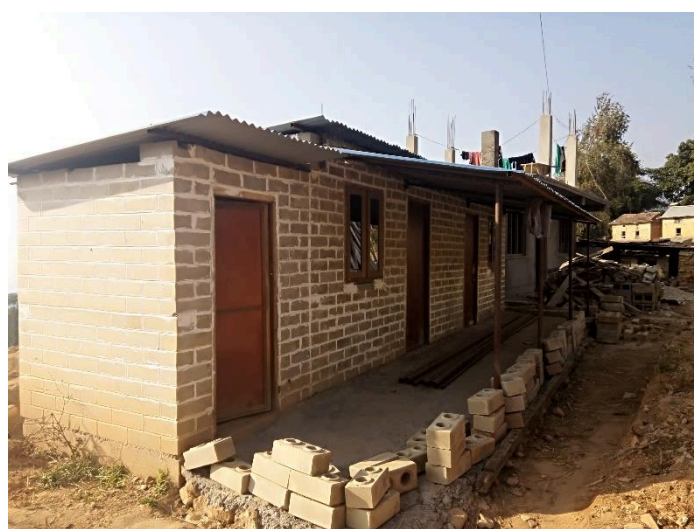
Beneficiary name: Ms. Putali Tamang, Ward no. 6, Bakhri Gaun, Nagarkot, Changunarayan Municipality, is single storey and made from interlocking bricks with flexible roof. DPC works has been properly done. The owner has approved building drawing and applied for 2<sup>nd</sup> and 3<sup>rd</sup> together.

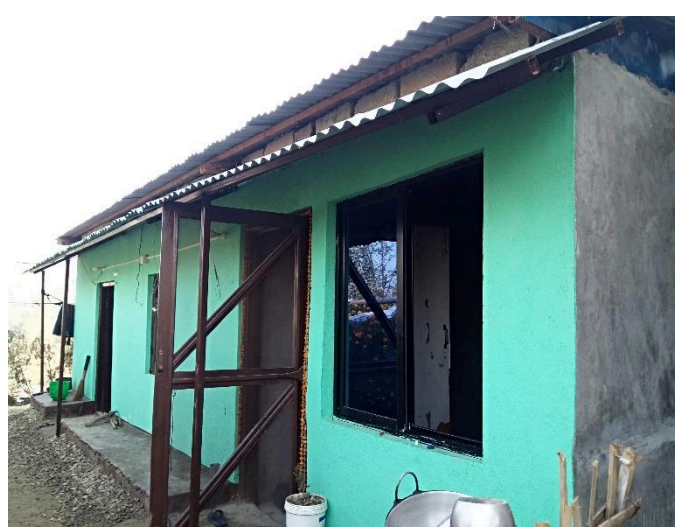
Beneficiary name: Mr. Niran Nepali, Ward no. 6, Pipalbot, Nagarkot, Changunarayan Municipality, reconstructed his house with hollow concrete blocks, single storey and wall system with flexible roof. The beneficiary revealed that tie beam and bands has been properly kept. The owner has approved building drawing and applied for 2<sup>nd</sup> and 3<sup>rd</sup> together.

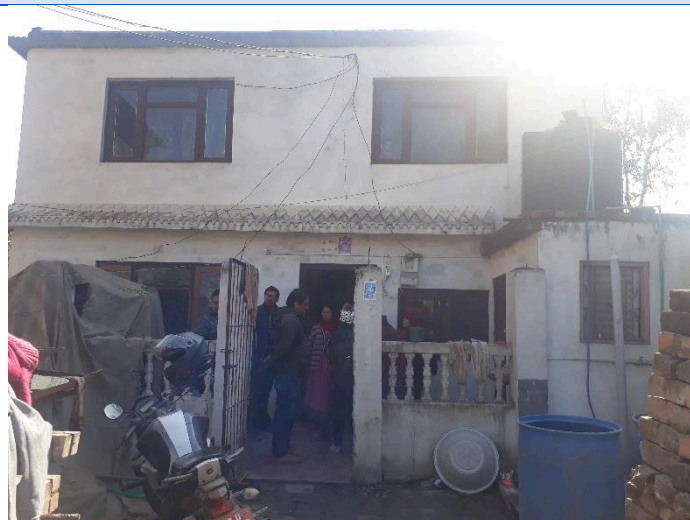
- The 2 storey house of Sulochana Karki, Ward no. 8, is BMC load bearing with flexible roof. It house constructed immediately after earthquake was registered as non-compliance as it had 9" wall, missing lintel beam, no vertical reinforcement and incomplete sill bands. The monitoring team suggested beneficiary to wait until the decision from NRA to address such cases comes out.

Beneficiary name: Sulochana Karki, Ward no. 8, BMC load bearing with flexible roof. The house is constructed immediately after earthquake, was registered as non-compliance as it has 9" wall, missed lintel beam, no vertical reinforcement and incomplete sill bands. The monitoring team suggested beneficiary to wait until the decision from NRA to address such cases comes out.

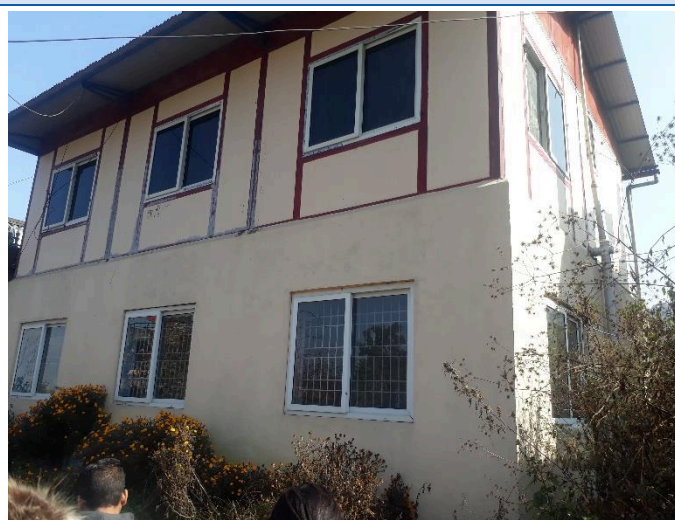
- Govinda Hari Chalise, a beneficiary located in ward no. 8, reconstructed 2 storey hybrid structure, BMC in ground floor and prefab for the 2<sup>nd</sup> storey with flexible roof. The M&E and DSE recommended to forward the house for 2<sup>nd</sup> and 3<sup>rd</sup> tranche after the structural analysis.

Beneficiary name: Govinda Hari Chalise, a beneficiary located in ward no. 8, reconstructed 2 storey hybrid structure, BMC in ground floor and prefab for the 2<sup>nd</sup> storey with flexible roof. The M&E and DSE recommended to forward the house for 2<sup>nd</sup> and 3<sup>rd</sup> tranche after the structural analysis.
