Housing Recovery and  
Reconstruction Platform

# Temporary Shelter Research Report

June 2018

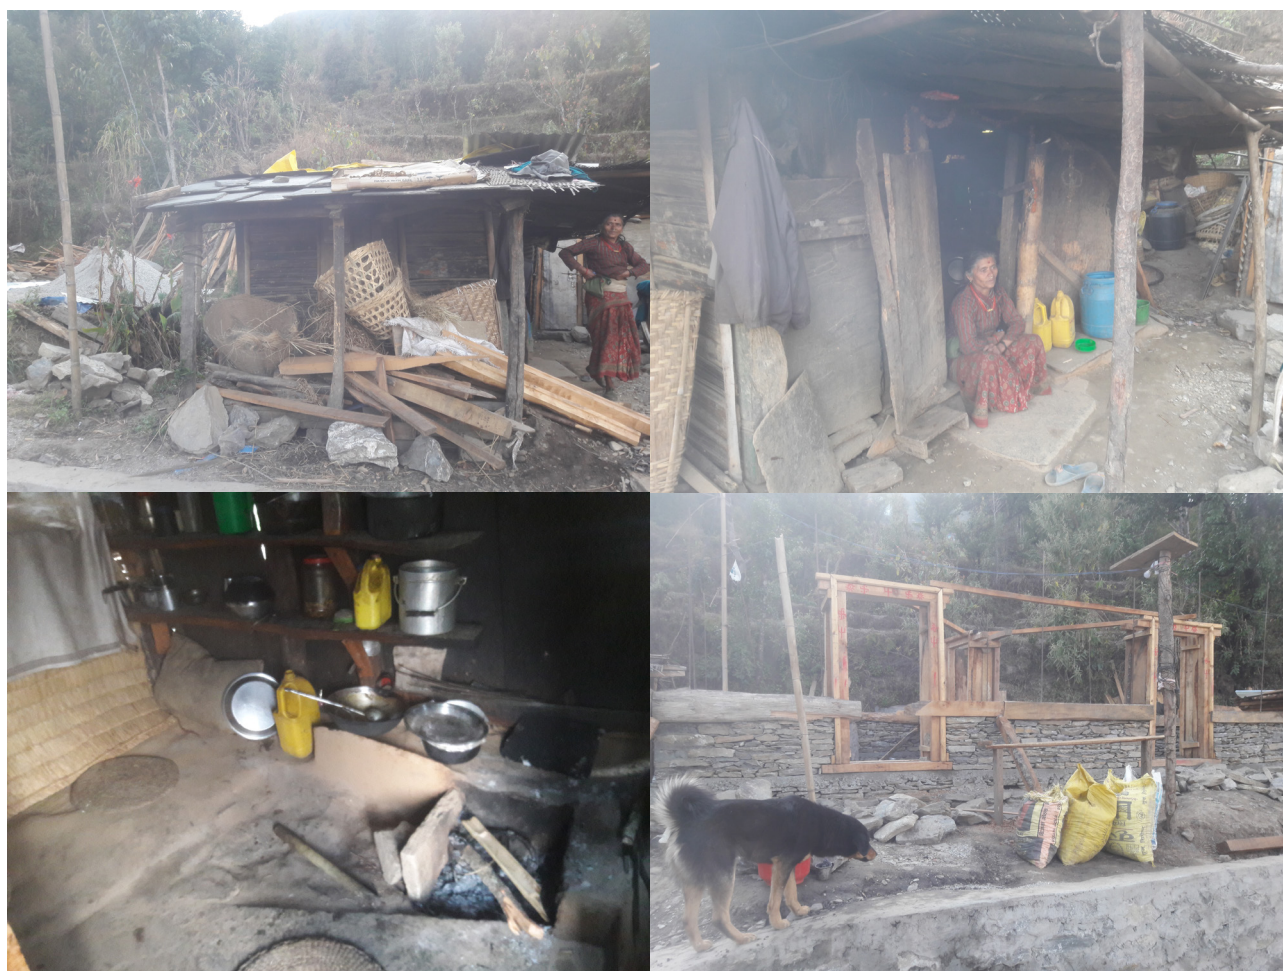
Top left and top right: Amrit outside her temporary shelter. Bottom left: inside Amrit's temporary shelter. Bottom right: Amrit's house under construction. Amrit Maya Budhathoki, and her husband Dan Bahadur Budhathoki, are over 60 years old and live in this shelter which is just 2.2m<sup>2</sup> in ward no. 3, Kalinchowk Rural municipality, Dolakha. Their income source is agriculture and livestock and they report that there has been no impact on their income / economic status because of the earthquake and living in a shelter. Neither Amrit or Dan have ever been to school. Their shelter is on the land that their home was on pre-earthquake. They are eligible for the GoN housing reconstruction grant and have received the first tranche and reported that their house is under construction. They reported that they did not receive temporary shelter support and have received no socio-technical assistance. They are aware of the GoN deadlines for disbursement of the second and third tranche.

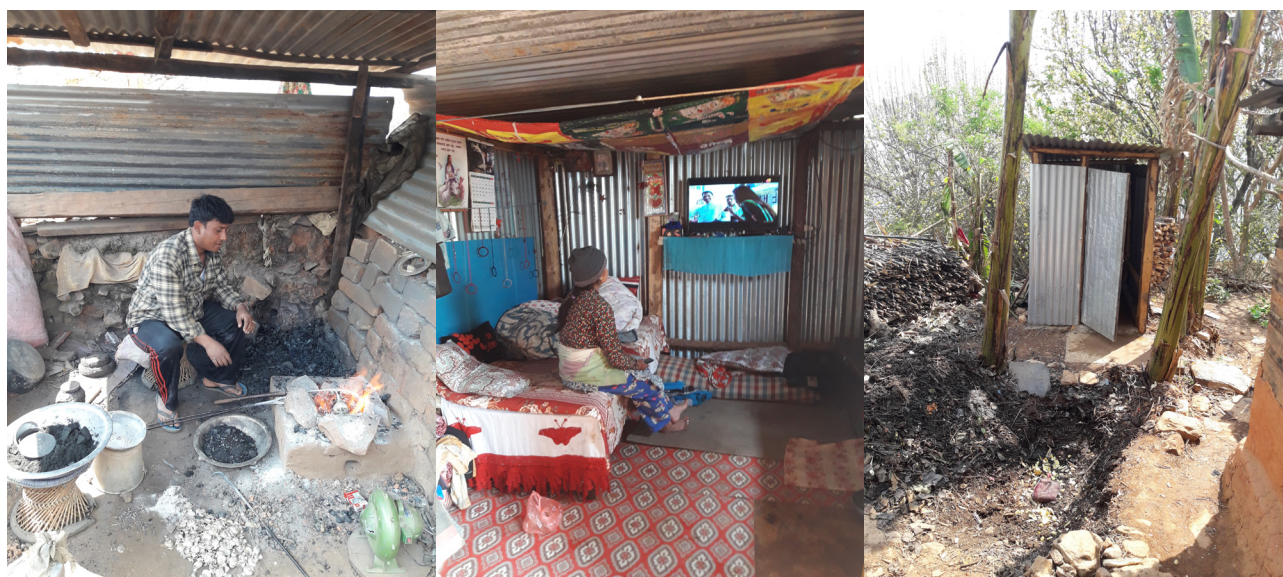
Buddha Lal Sunar's shelter in ward no. 8, Dakshinkali Municipality, Kathmandu; the kitchen (L), inside the shelter (centre), and the toilet (R). Buddha lives in the shelter with his three children and his wife. Their shelter around the average size of 20.5m<sup>2</sup> and is built on land that they own where their house used to be. They are eligible to receive the GoN housing reconstruction grant, and have already received the first tranche of 50,000 NPRs, but they have yet to start rebuilding their home as they are still saving to cover the cost of reconstructing and they have not had access to any technical assistance.

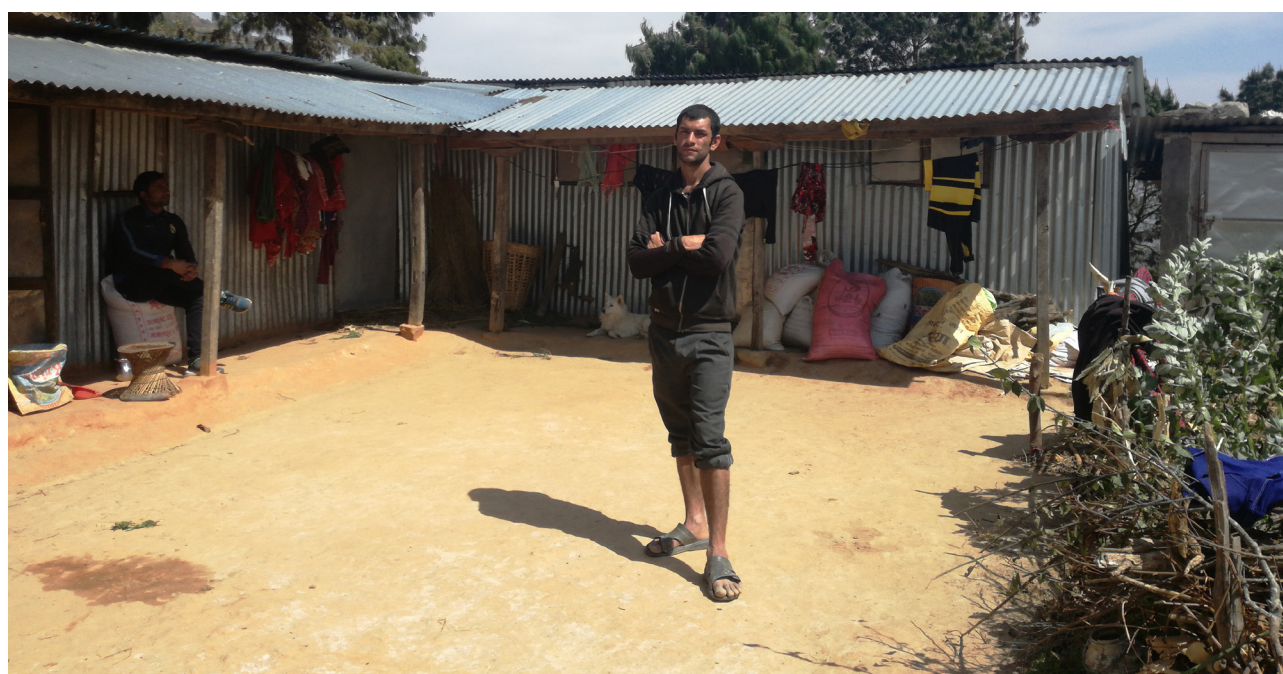
Uddab and Santa Bagjai live in this shelter, which is one of the largest at over 145m<sup>2</sup>, in ward no. 3, Banepa Municipality, Kavre. They reported that their income was reduced after the earthquake when they moved into the temporary shelter and they have been displaced from their land and are now on public land. They have not been listed as eligible to receive the GoN housing reconstruction grant but have lodged a grievance and as a result they have yet to start their reconstruction.

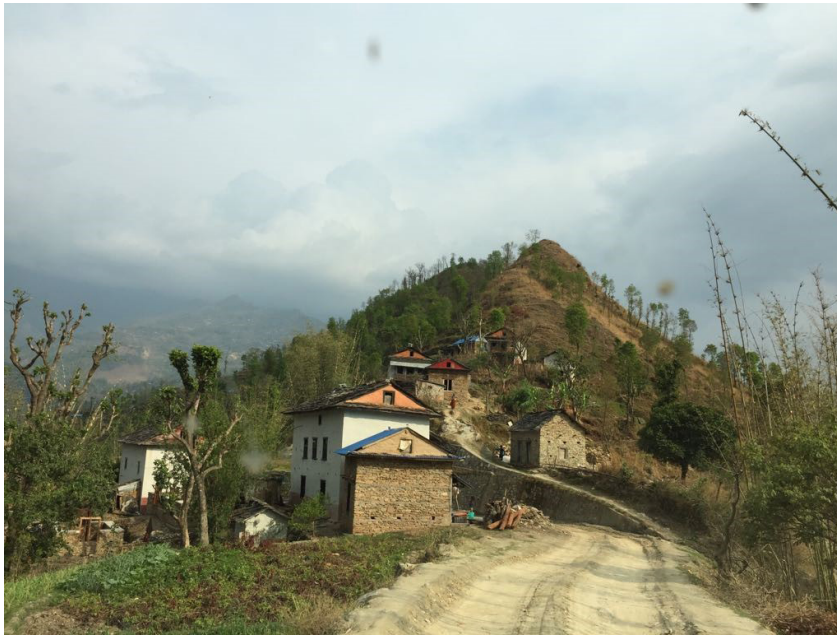
*Poku, Ramechhap: the home owner has built a one room, one storey 'earthquake-safe' building next to their old, damaged house to access the GoN housing reconstruction grant. They continue to live in the old house because the new one is too small for the family. Photo Credit: Subash Karki/BBC Media Action<sup>12</sup>*

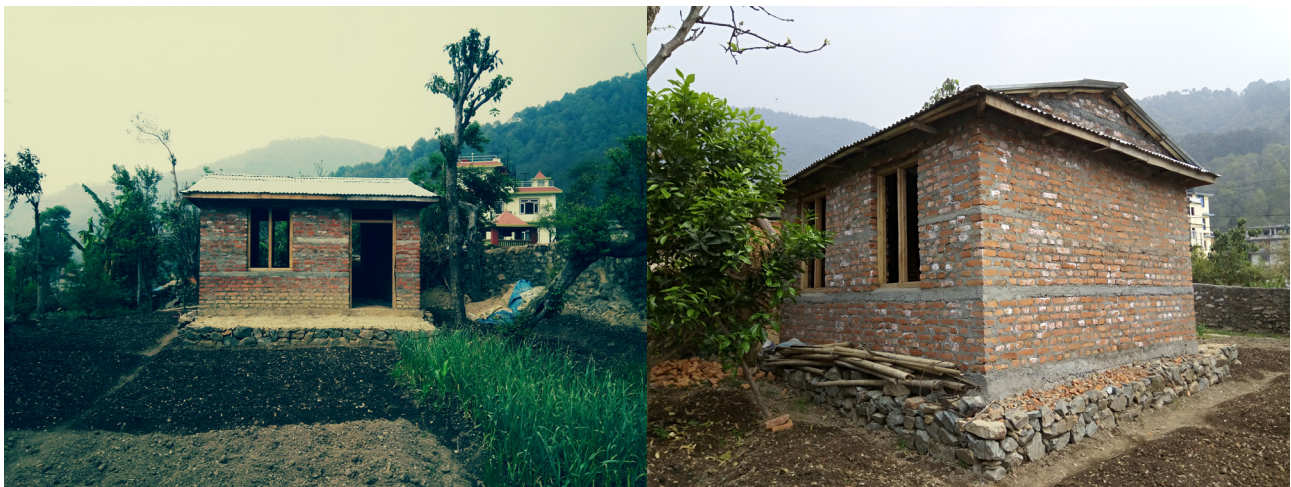
*Sisneri, Ward No. 9, Lamatar Area, Mahalaxmi Municipality, Lalitpur: a one room, one storey, brick and cement mortar masonry house with CGI roof which is part of an ever-increasing trend of building tiny houses to access the GoN housing reconstruction grant but the houses do not meet families living requirements. The house owner did get the drawings for the house approved by the municipality and they have received the second tranche. During a recent joint monitoring visit by HRRP and MoUD CLPIU, the monitoring team identified difficulties getting into the house due to its small size<sup>13</sup>.*

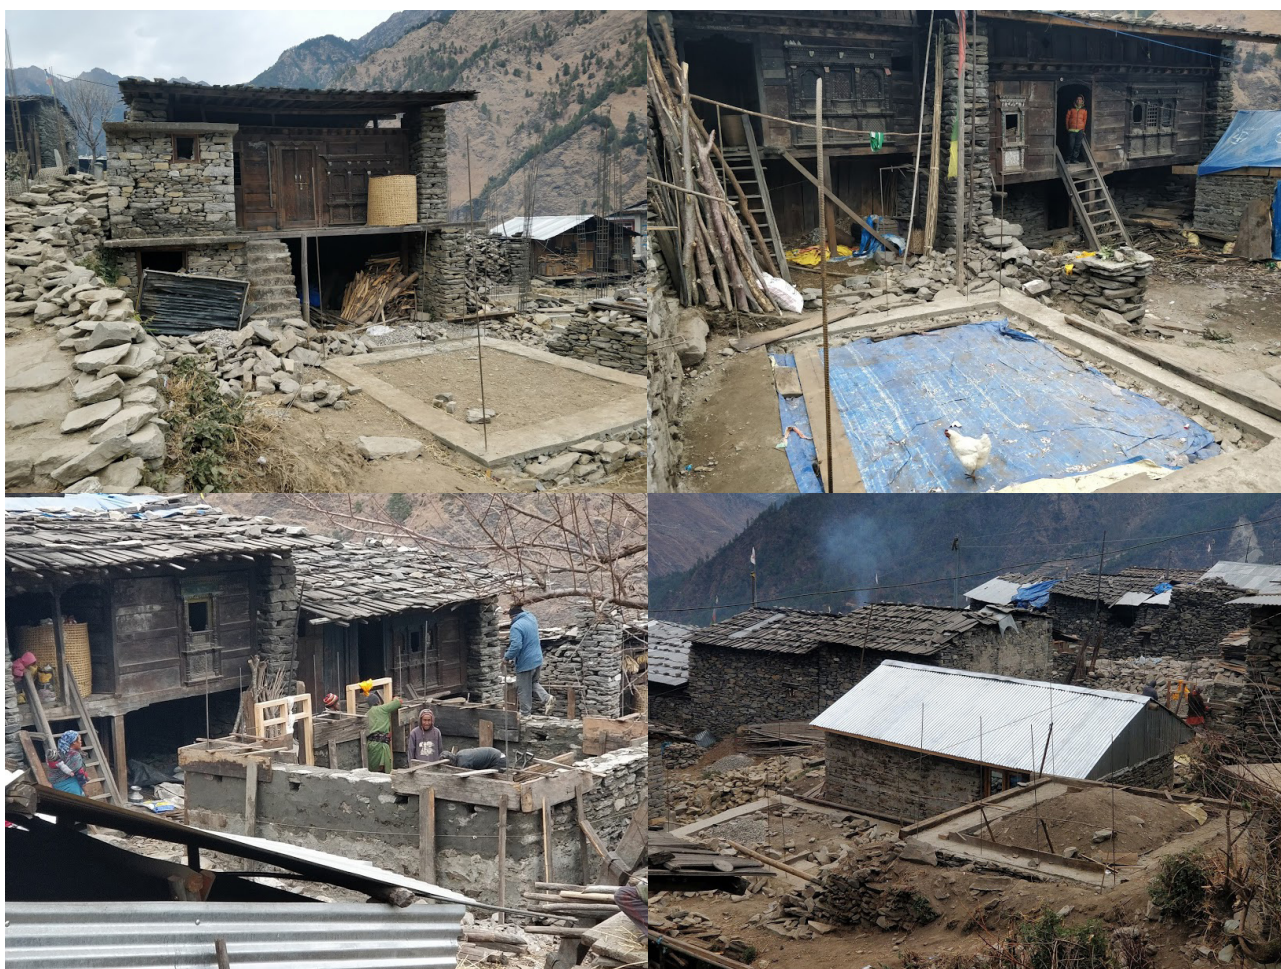
*In Gatlang, Rasuwa new one room buildings are being constructed to access the GoN housing reconstruction grant but their traditional houses, mostly reconstructed in 2015, do not currently meet compliance requirements. Investment is required in research and testing to develop relevant corrections / retrofitting measures so that the traditional houses can be compliant – and most importantly strengthened to reduce risk from future earthquakes. Photo Credit: Magnus Wolfe-Murray/DFID Nepal<sup>14</sup>.*

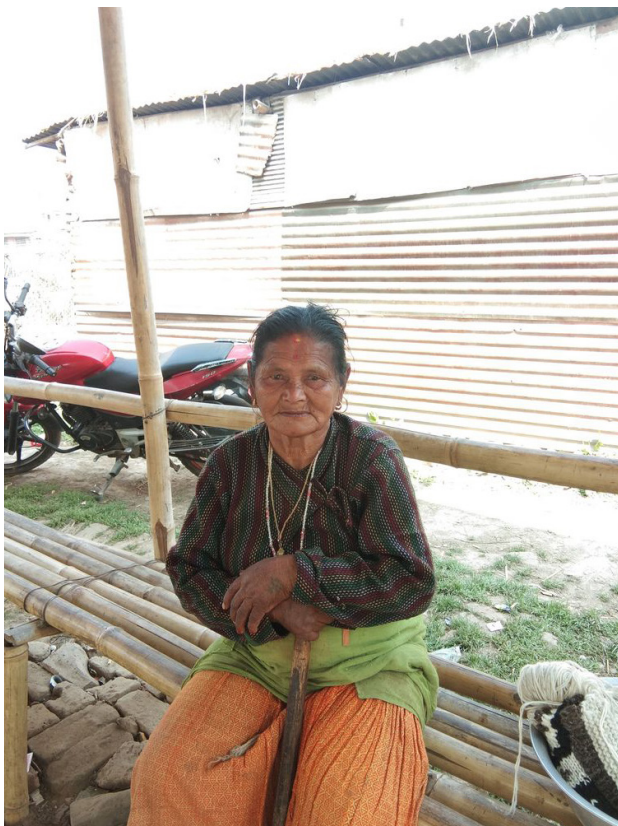
### 5.1 Maiya Sahi, Bhaktapur Municipality, Ward No. 2, Bhaktapur

Maiya is 74 and a widow and she, along with her 19 family members, have been living in temporary shelters since the 2015 earthquake damaged their home and made it unsafe to live in. Initially the whole family were staying in one shelter but this was extremely cramped and eventually she and her four sons decided to construct their own shelters for their families.

Maiya has signed the partnership agreement with the GoN for the housing reconstruction grant and received the first tranche of 50,000 NPRs which they have already spent. They have not managed to start reconstructing their home because their plot of land is smaller than the allowed standard and they have not been able to get a house design approved by the municipality. In addition to this, the area is within Bhaktapur Durbar Square so the family must follow the guidelines of the National Archeological Department.

Maiya and her family now feel that they will be unable to rebuild within the GoN reconstruction programme as they cannot see how they will manage their reconstruction before the NRA deadlines for receiving the second and third tranches.

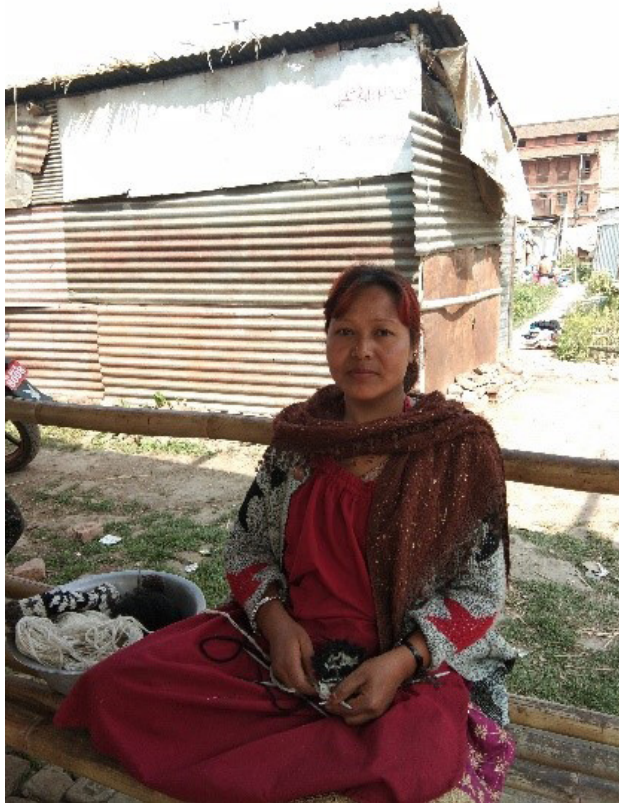
## 5.2 Sumitra Byanju, Bhaktapur Municipality, Bhaktapur

Sumitra is 35 and lived with her husband, mother in law, and two children in their home in the Bhaktapur Durbar square. Their home was completely destroyed by the 2015 Gorkha earthquake. Immediately after the earthquake, Sumitra and her family spent several nights staying in the open part of the Durbar Square. After this initial period, her family received a tent but it was difficult to live in as the weather conditions were not good. When the family received material support from IOM, the Red Cross, and other humanitarian organisations her husband built a temporary shelter in the open space of a school nearby their old house.

The family is eligible for the Government of Nepal (GoN) housing reconstruction grant and they have already received the first tranche (50,000 NPRs). However, they have not been able to start reconstruction due to land issues. When they started planning their reconstruction they found out that the land they were residing on was not separated among the brothers of her father in law and they weren't the sole owner of that property. Their cousin is claiming half of the property which does not leave them with sufficient land on which to construct. A court case on the separation of the land is pending in the courts. As a result of these issues, they have decided not to reconstruct their home. They have rented 2 small rooms in Bhaktapur bazaar where her children and mother in law are staying. She and her husband also stay in the rented house during the day, and only use the temporary shelter for sleeping.
