## Fortnightly District Report

### Kathmandu Valley

18 - 31 January 2019

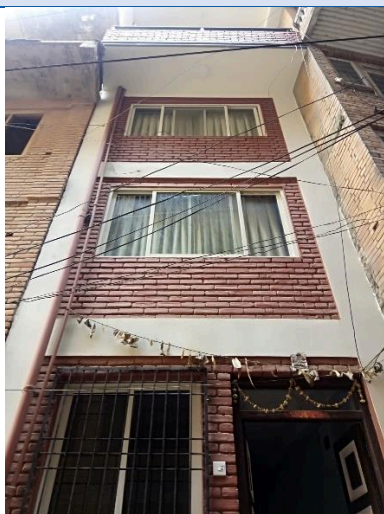
Beneficiary name: Chandra Maharjan, Ward no. 1, Hwakacha Tole, Kirtipur Municipality. Single bay, 5 storey house of RCC – C category house has received building permit upto 3<sup>rd</sup> storey only but have added extra 2 storey which has posed threat to the house. The house has received up to 2<sup>nd</sup> tranche and 3<sup>rd</sup> tranche is pending till now.

| Challenges / Issues Identified | Action Required | Responsible | Timeframe |
|---|---|---|---|
| Addition of extra storey than mentioned in approved building drawing increases threat to the resiliency of houses and of neighbors too. | There should be a strong mechanism to cross check the houses that have added extras storey. Already constructed houses can either demolish the added storey or apply retrofitting measures. Houses under current reconstruction phases should be strictly monitored and should sign commitment paper about not adding storey. | Municipality, ward office, DLPIU engineers | As soon as possible |

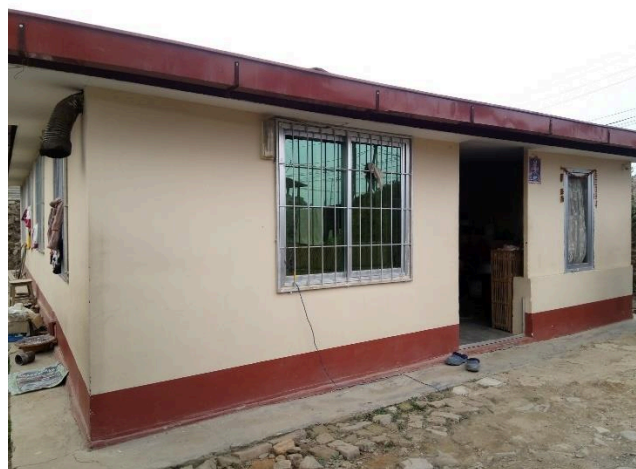
Beneficiary name: Radhakrishna Bista, Ward no. 5, Bista Gaun, Kirtipur Municipality. Single storey house is made of gypsum board (a light weight material) with steel windows and 5 rooms in total. The house has area exceeded and received up to 2<sup>nd</sup> tranche whereas the 3<sup>rd</sup> tranche is on hold.

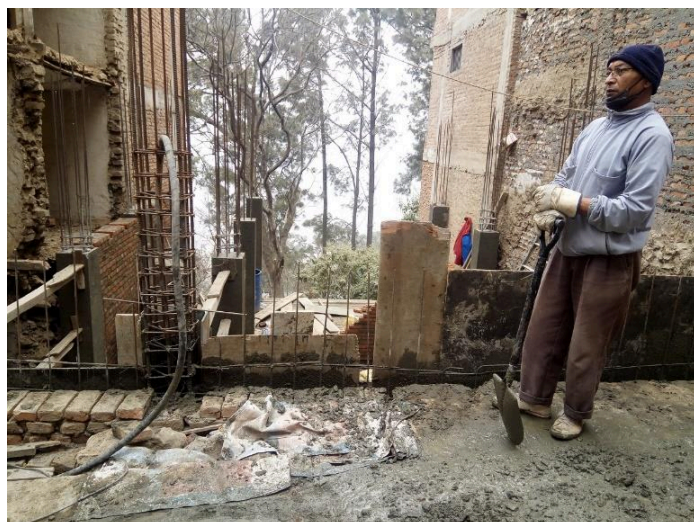
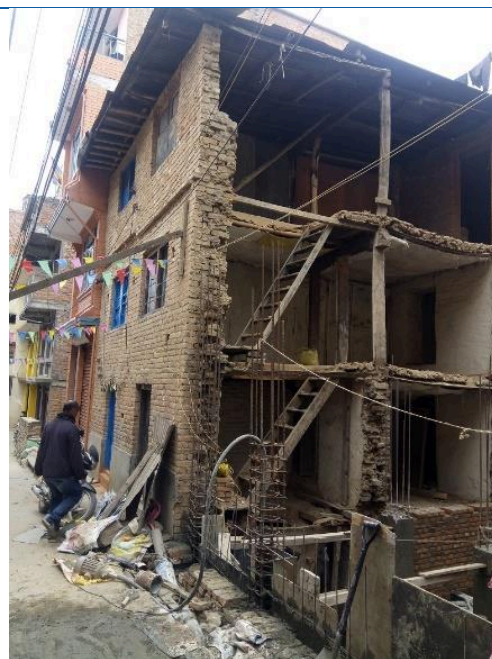
Beneficiary name: Kiran Singh, Ward no. 2, Devdhoka, Kirtipur Municipality. The proposed 4 storey RCC house including basement, is in reconstruction phase. The owner has received 1<sup>st</sup> tranche and got temporary building permit to reconstruct the house.

The damaged 4 storey BMM house of Ward no. 2, Devdhoka, Kirtipur Municipality belongs to two people, among which one house owner was listed as beneficiary and has received 1<sup>st</sup> tranche whereas another was addressed by the grievance and is now listed as beneficiary. The beneficiaries had land ownership paper from land revenue office but it's under their name. Each house has 4 rooms.

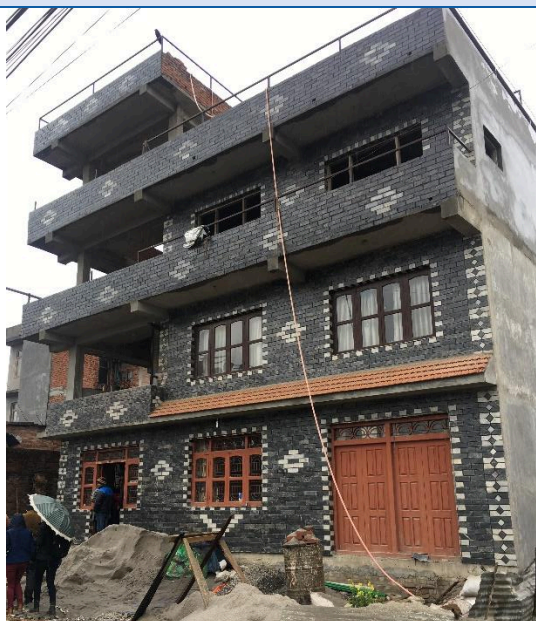
Beneficiary Name: Laxman Aaganja, ward no 3, Changunarayan Municipality, Bhaktapur. The beneficiary has requested for 2<sup>nd</sup> and 3<sup>rd</sup> tranche but the structure was found to be non-compliance. 3 and half storey RC frame structure with 9"X12" column. The structure was found to be unsafe by the structural analysis conducted by the DSE. At present the file cannot be forward for the tranche.

| Challenges / Issues Identified | Action Required | Responsible | Timeframe |
|---|---|---|---|
| Municipality has been approving the design and giving building permit to RC structure with 9"X12" pillar size for 3 storey and more which is found to be unsafe during the structural analysis. | As per MRT the 12"X12" column so Technical staffs of Municipality should not promote such construction practice and disapprove such houses. | Municipality, DLPIU-Building, CLPIU-Building | As soon as possible |

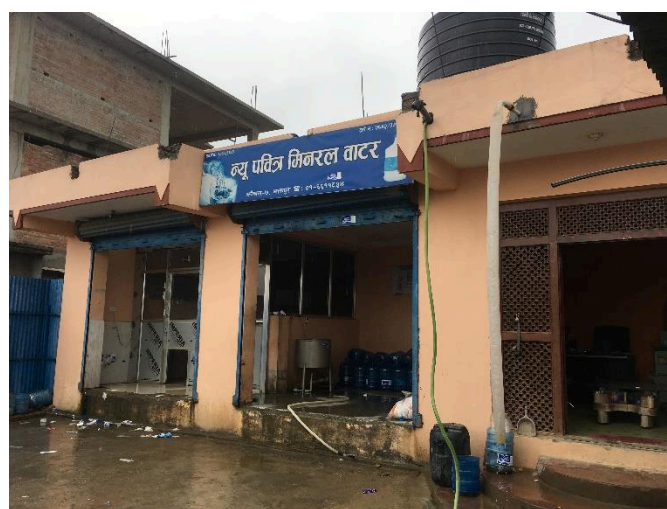
Beneficiary Name: Tulsi Das Sulu, ward no 3, Changunarayan Municipality, Bhaktapur. The beneficiary has requested for 2<sup>nd</sup> and 3<sup>rd</sup> tranche but the structure was found to be non-compliance. One storey load bearing brick in cement mortar masonry structure with 2 rolling shutter and larger opening area. The beneficiary was suggested to remove the shutters and construct wall to be eligible for the remaining tranche.

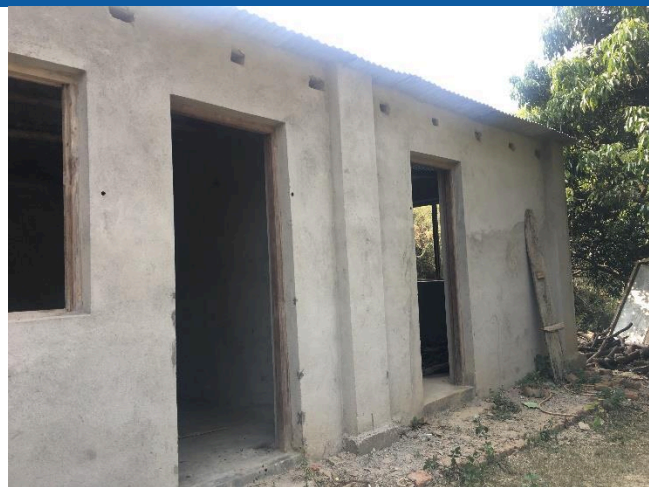
Beneficiary name: Bhimsen Shrestha, Ward no. 8, Pakhure, Nagarjun Municipality, single storey load bearing BMC structure with CGI roof. The beneficiary has requested for 2nd and 3rd tranche together.

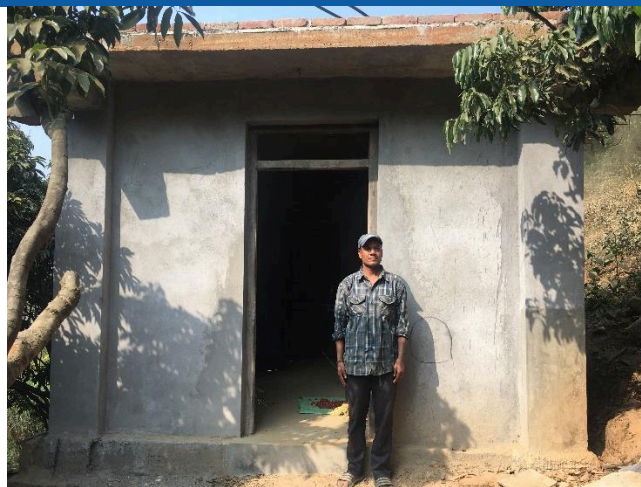
Beneficiary name: Gangaram Baskota, ward no 8, Pakhure, Nagarjun Municipality, single storey load bearing BMC structure with rigid roof. Beneficiary has requested 2nd and 3rd tranche together

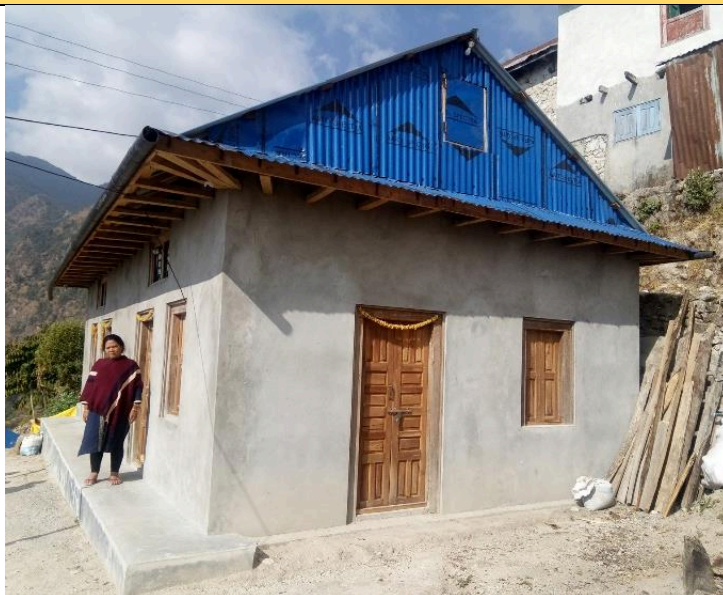
### Case story 1

Gyanu Gole, 45 years old married women lives with her 7 family members in Ward no. 5, Chandanpur, Mahankal Rural Municipality. Her husband works as driver in Kathmandu and visits Chandanpur sometimes. Due to 2015 Gorkha Earthquake, her old load bearing SMM house was severely damaged. She along with her other extended family members and relatives were forced to live on temporary shelters for long. After she signed PA agreement with NRA/GON with 1st tranche in hand, she along with her husband started reconstructing the house nearly one year back. She also received approved building permit to rebuild her house. She found a well-trained local mason to rebuild her SMM, single storey, 2 roomed structure with attic. She revealed that she has clearly watched the reconstruction phase of her house and has maintained well equipped toilet too. The trained mason has properly kept all the earthquake resistant elements such as lintel, sill and roof band along with vertical reinforcements in corners and openings. When she applied for 2nd tranche and 3rd tranche, the engineers came to inspect her house time to time. As a result, she was successful in receiving all the tranches from GON/NRA. She revealed that a total of NPR 14 lakh was spend in reconstructing this house.

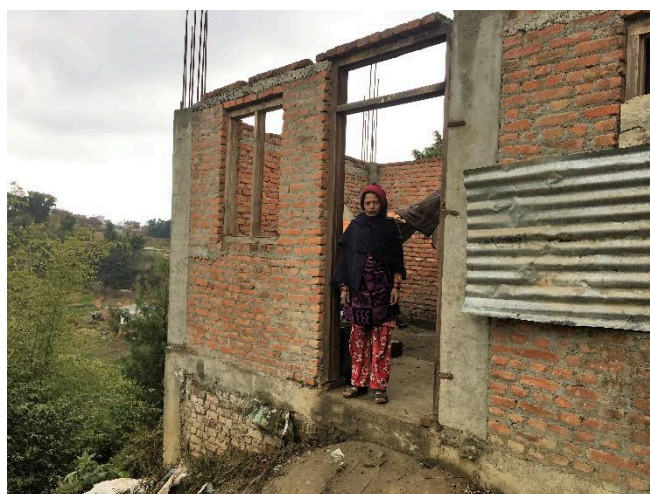
*Ms. Bhawani Damai in front of her newly constructed one storey RC structure which is at risk of landslide.*

Ms. Damai has family of 6 members including her disabled father-in-law. She earns her living from sewing cloths along with her son. For the reconstruction of the house she has taken loan from people in her community and claims that she has spent around 11 lakhs in the construction. The reconstructed house was in slightly slope area. During the rainy season of 2018 the continuous rainfall loosened the soil in the slope which consequently resulted in the landslide on the morning of July 12, 2018. The landslide swept away the part of the hills nearby exposing the house to edge of the hill.

| Challenges / Issues Identified | Action Required | Responsible | Timeframe |
|---|---|---|---|
| Houses in Pokhrel Gaun, ward no. 4 are directly under risk of landslides. | Municipality, DLPIU-GMaLI and NRA should look on the issue and find a way forward to prevent the landslide risk. | Municipality, DLPIU-GMaLI and NRA | |

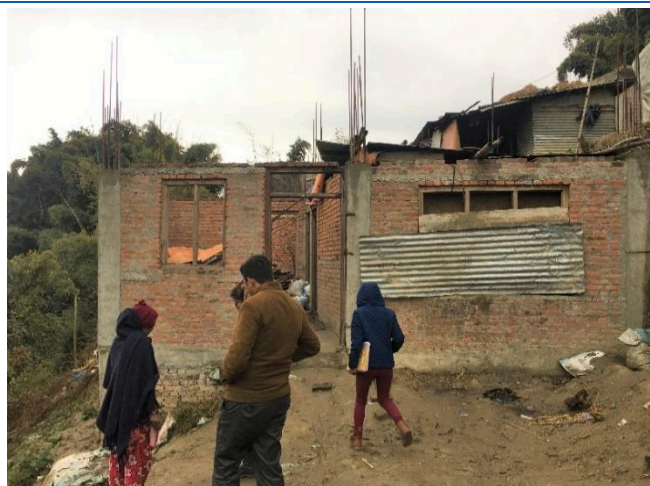
At present she is living in a temporary shelter constructed in a public land near by her house. Not only Ms. Damai house but the other 5 houses in the vicinity are at potential threat of landslide.

*The newly constructed house of Ms. Bhawani Damai which has been brought on the edge of the hill after the landslide of July 2018.*
