# District Report

## Kathmandu Valley

17 -30 August 2018

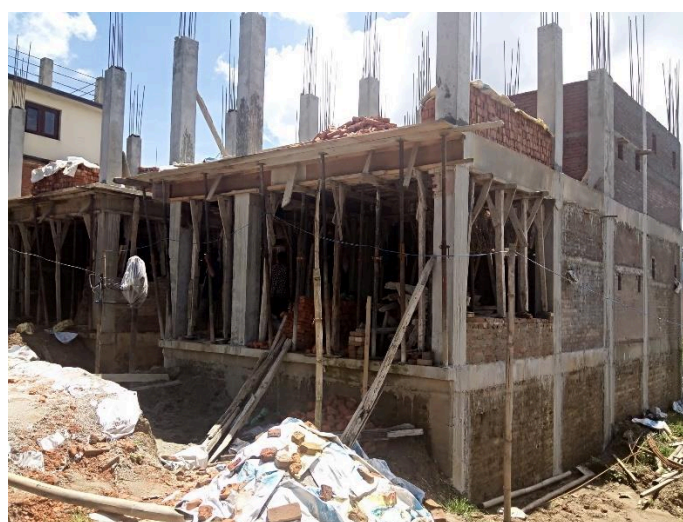
Beneficiary name: Joint house of five brothers namely- Narendra Awal, Ashesh Awal, Purna Bahadur Awal Asta Awal and Shailendra Awal at Ward no 1, Saraswatikhel, Duwakot, Changunarayan Municipality, Bhaktapur. Each five houses has 12x12 inch pillars with 24 inch beam and targets for 2 storey in overall five houses. The five beneficiaries have individual PA agreement & approved building drawing for each houses, with separate entrance door and separate staircase. The 5 houses has applied for 2<sup>nd</sup> & 3<sup>rd</sup> tranche together. Technically, the house is seen as a single house and suggested to conduct structural analysis. If the analysis report declares the house as safe, then the house is eligible for 2<sup>nd</sup> - 3<sup>rd</sup> tranche.

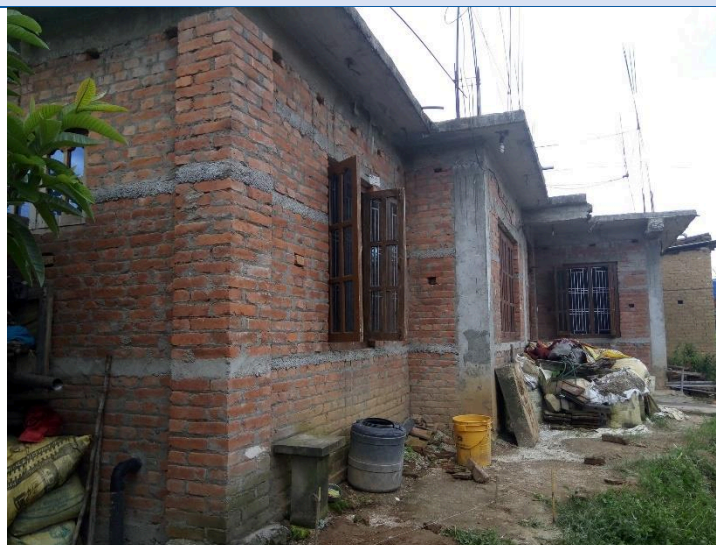
Beneficiary name: Min Bahadur Shrestha, has applied two types of structures while reconstructing the single storey house at Ward no. 3, Jhaukhel, Changunarayan Municipality. Half part of the house has BMC structure while half were dominated by RCC structures. Lintel band and sil band were kept properly. The beneficiary was suggested to conduct structural analysis. If the analysis report declares the house as safe, then the house is eligible for 2<sup>nd</sup> - 3<sup>rd</sup> tranche.

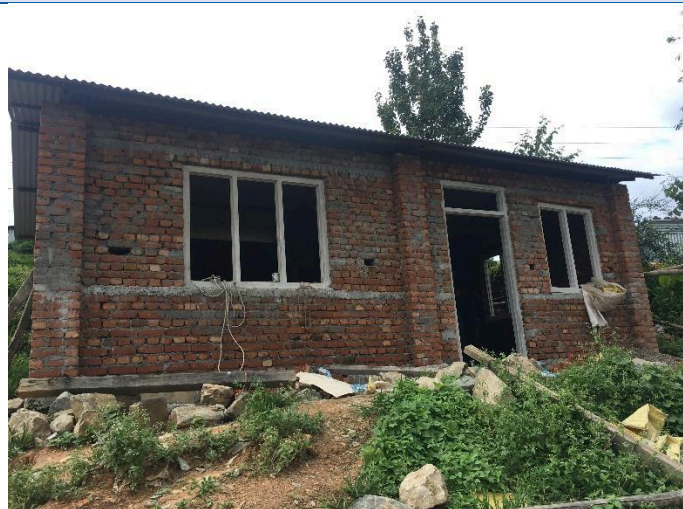
Beneficiary name: Shankhar Bhomjom, Ward no 8, Dakshinkali Municipality, Kathmandu. One story load bearing structure. The beneficiary has received second tranche and have requested for the inspection for the 3<sup>rd</sup> tranche. The house is non-compliance as the roof band is missing. The beneficiary agreed to add the roof band to be eligible for the grant.

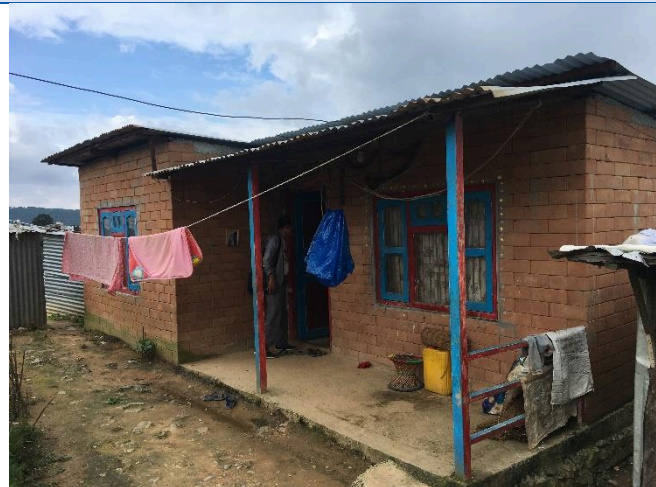
Beneficiary name: Panchalal Ghising, Ward no 8, Dakshinkali Municipality, Kathmandu. One story load bearing structure using interlocking bricks. The beneficiary has received second tranche and have requested for the inspection for the 3<sup>rd</sup> tranche. The house is non-compliance due to the larger room size. The file will be send to the DSE for further analysis
