# District Report

## Makwanpur

2 – 8 February 2018

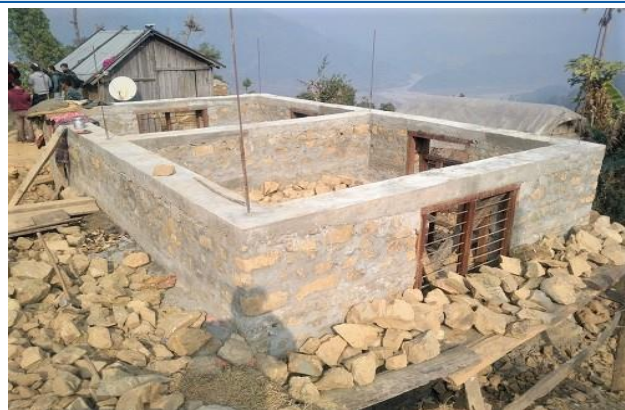
Figure 2: Manhari Rural Municipality, Makwanpur. House owner Shant Bahadur Thokar is made up stone in cement mortar. Under construction building, house owner has received 2<sup>nd</sup> tranche and processing for third tranche. Also he has constructed the toilet.

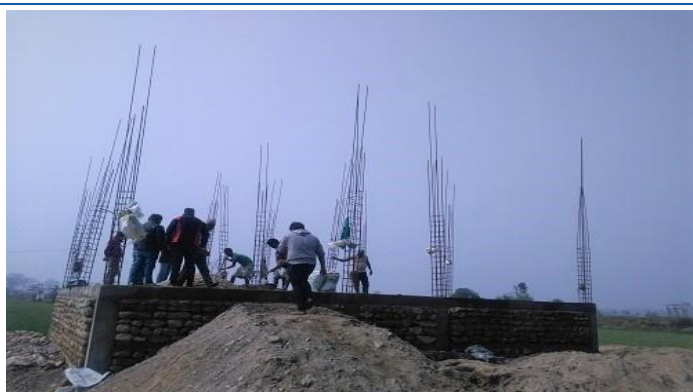
Figure 3: RCC frame structure, house owner is Khadak Man Shrestha. This building is in under construction and recommended for 2<sup>nd</sup> tranche by DLPIU field base engineer. location of this building is Manhari Rural Municipality-05.

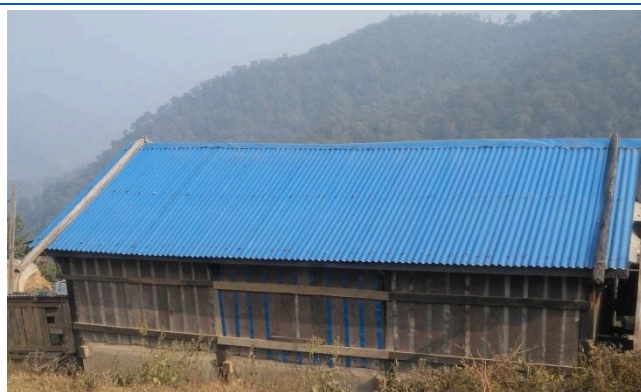
Figure 4: Hybrid structure, ground floor constructed with stone in mud mortar and first floor constructed with timber structure with flexible roof but this building was constructed without supervision of technicians and before 1 years. it is non-compliance issues so DSE suggested for correction like as provide vertical post, to provide chicken mesh wire in band with required area. Also we regular flow up this noncompliance issues.
