# Fortnightly District Report

## Sindhuli

1 - 14 February 2019

## Housing Typology Report

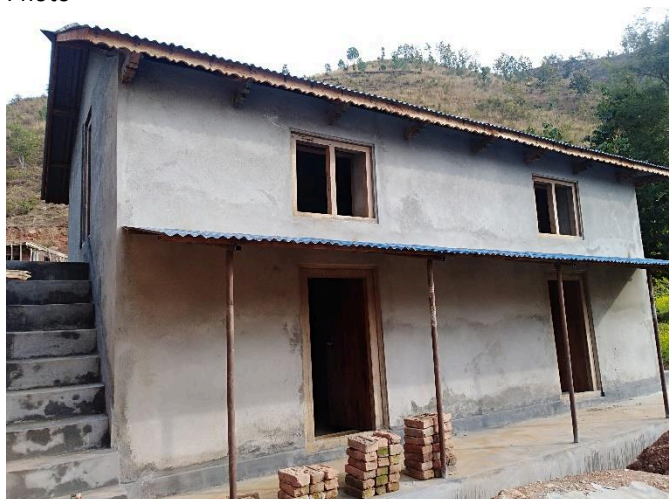
Photo

The house belongs to Mrs. Ambika Acharya, permanent residence of Ramtar ward no. 05, Sunkoshi Rural Municipality, Sindhuli. She has received 2<sup>nd</sup> tranche of GON housing grant. Construction of the house is completed using Stone in Cement Mortar (SMC) with flexible roofing. The house is non-compliant due to inadequate floor height. However, technical support was provided by Mercy Corps, beneficiary herself constructed against the technical staff's advice/suggestion.

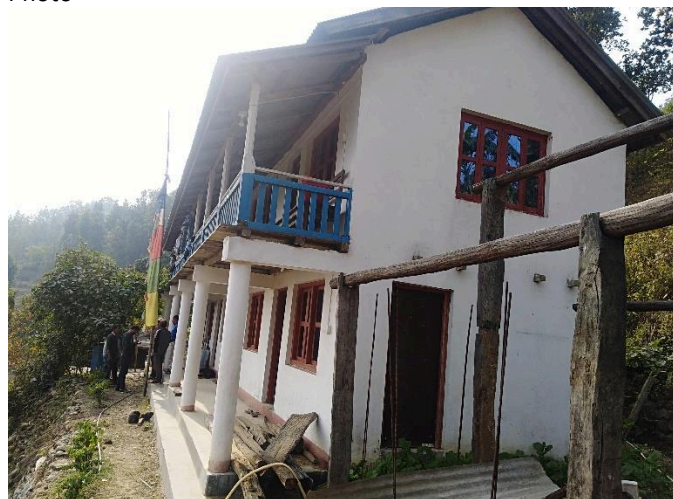
Photo

The house owner is from ward no. 06, Marin Rural Municipality, Sindhuli. He has received 2<sup>nd</sup> tranche of GON housing grant. Construction of the house is completed using Brick in Cement Mortar (BMC) with flexible roofing. The house is non-compliance due to inadequate Length: Breadth (L: B) ratio. Length of house is 45 feet and width is 13 feet, which seems length is greater than 3 times width.
