# District Report

## Makwanpur

3 – 16 August, 2018

## Field Visit /Joint Field Monitoring Visit Reports

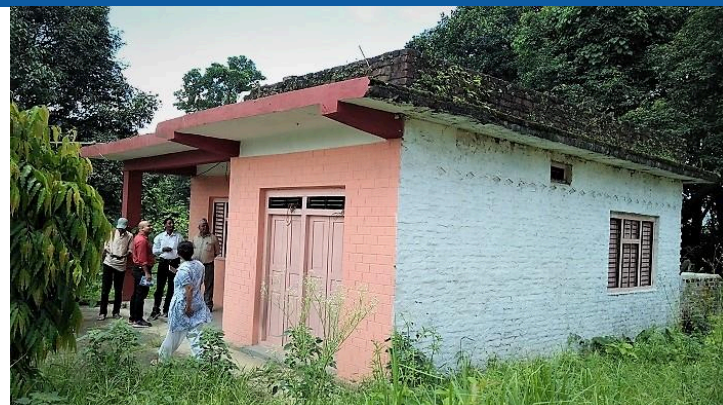
**Figure 3: Hetauda- 16, house owner Shyam Krishna Tiwari, his house one of the example of retrofitting. They are unknown how to put seismic elements, they don't trust about retrofitting. They know simply crack repairing is retrofitting. It is a problem in field about retrofitting construction. Brick in cement mortar with rigid roof, one story. He received first tranche of retrofitting. But he couldn't start yet. He has not provided any elements for seismic resistant so DSE suggested for correction.**

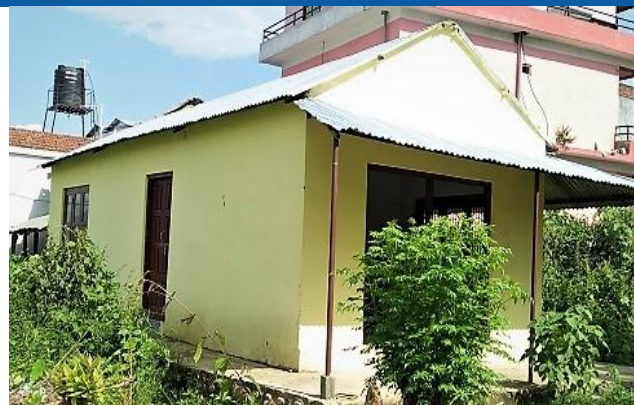
**Figure 4: Hetauda- 17, house owner Anita Bhandari, Block Masonry construction, two rooms with flexible roof. She has received first tranche & verified for third tranche her house. Total construction cost is around 5.5lakh.**

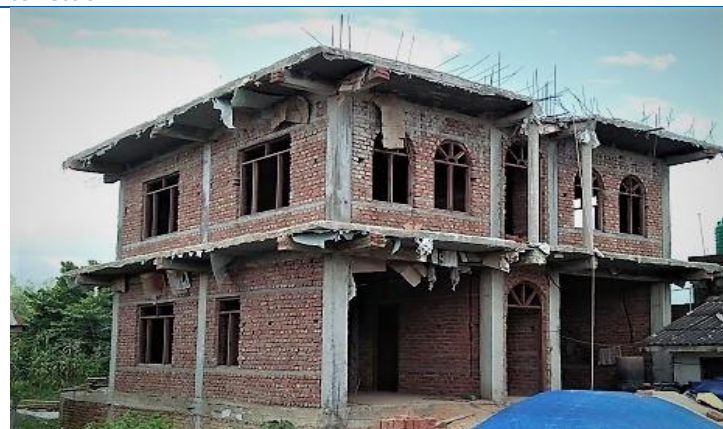
**Figure 5: House owner Ridhi Prasad Rijal, RCC frame structure with two stories with rigid roof Hetauda-16, he received all tranches of government grant.**

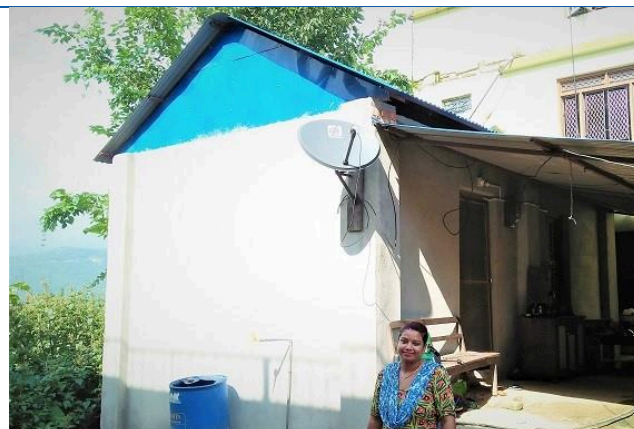
**Figure 6: Hetauda-18, house owner Gauri Bhandari, brick in cement mortar with two rooms, flexible roof. The technical assistance provided by TCN Nepal during OJT training. She received the all tranches of government grant. Total construction cost is 7lakh exclude labor cost.**
