# District Report

## Dolakha

15 February - 14 March 2019

## Housing Typology Report

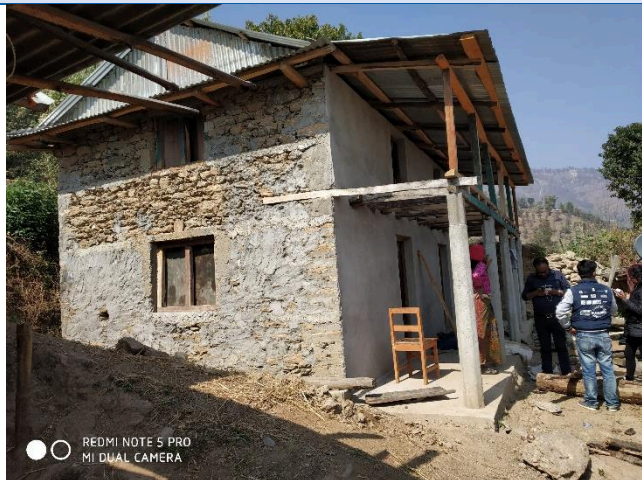
This meeting was short in which non-compliance in the ward were discussed. In Bhedpu mostly attic height more than the standard is the main issue. Er. Suresh Sah told that people have made attic height more to make use of attic for storing of food stuff and other utility purpose since 3 ft is not enough. In Bhedpu tentatively 15 buildings have such cases and have not received their final tranche. Most of the people are living inside the house and they are not willing to do corrections since it needs money and mason. After this we did field level inspection of few cases where we found that some of the beneficiaries have constructed 6ft attic which is like another story and they are using it for living purpose. We noted such cases even the DSE did so to forward such cases in the CLPIU for further support. After that few typologies were collected for the report.

Caption: Field level monitoring of non-compliance buildings Pic: Binod Kalauni

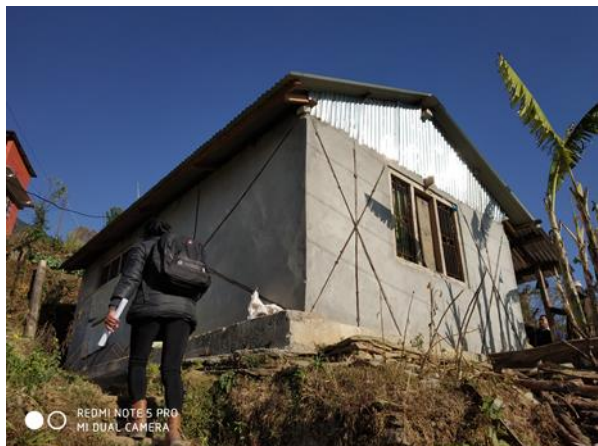
One Storey non-compliance building in which 12" \* 12" columns are provided but upper tie beam is missing, and wall thickness is 4". After study from DSE, panel strengthening with the help of reinforcement is the correction measure suggested to house owner but not done properly as many panels are not strengthened. This house belongs to Krishna Prasad Mainali of Sundrawati, 09-ward of Kalinchowk Rural Municipality. During the joint monitoring strengthen of individual panel is recommended by DSE. This house has received second tranche. Pc = Binod Kalauni

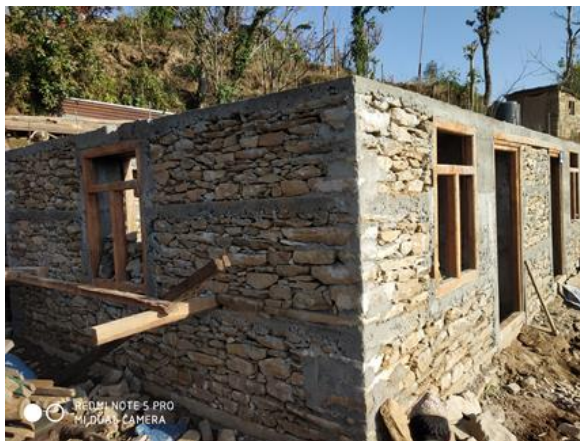
Load bearing and stone in mud mortar building has been constructed in 09-Sundrawati, Kalinchowk RM. Mr. Megh Nath Mainali is the house owner and he has received second tranche till date. Pc = Binod Kalauni

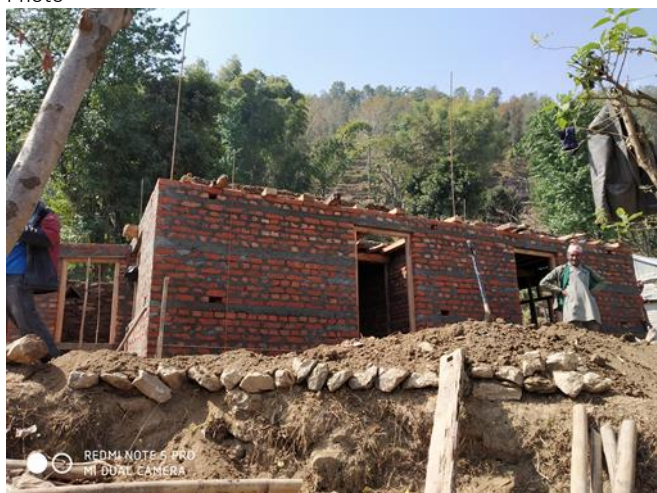
Caption: Load Bearing and Brick in cement mortar building has been constructed in Bhedpu, 04-ward of Melung RM. Shayam Br. Adhikari is the house owner and he has received first tranche till date. This house lies in the road alignment so ward has requested not to forward tranche to the ward engineer. Pic: Binod Kalauni

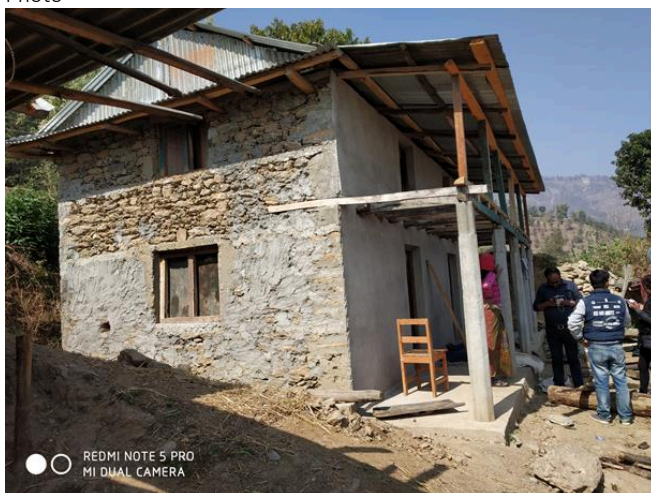
Caption: Load bearing and stone in mud mortar non-compliance building in Bhedpu, 04-ward of Melung RM. The non-compliance issue is attic height (4' 3") more than recommend. Mr. Kalu Man Adhikari is the house owner and he has received second tranche. Pic: Binod Kalauni

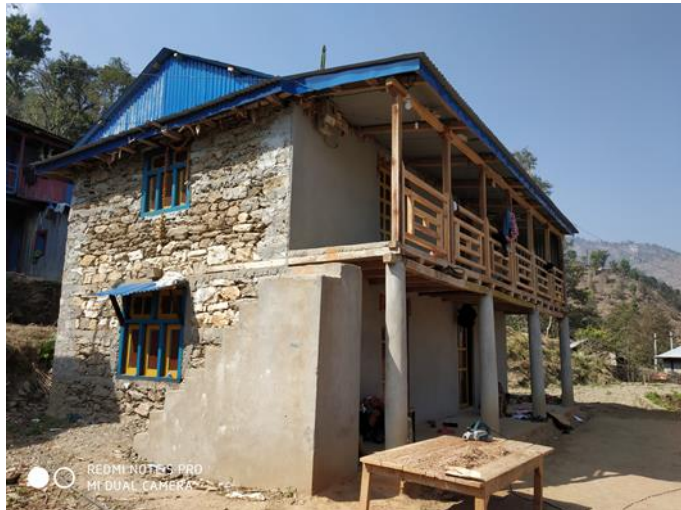
Caption: Load bearing and stone in mud mortar non-compliance building in Bhedpu, 04-Melung RM. The non-compliance is attic height (6') more than recommended. Mr. Narayan Budhathoki is the house owner and he has received second tranche. Photo: Binod Kalauni

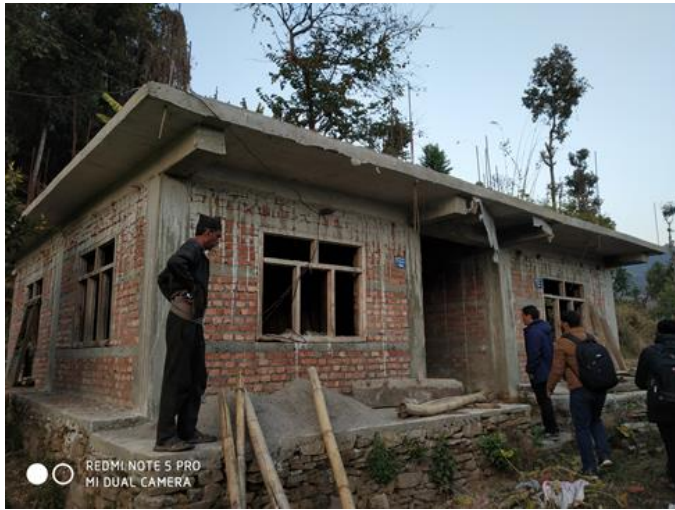
Caption: RCC building which belongs to two brothers both are separate beneficiaries and they have constructed building with same DPC and Slab. From outside it looks like single building, but it belongs to two beneficiaries called Mr. Indra Sedai and Mr. Dil Prasad Sedai. They have received second tranche. It lies in Sundrawati, 09-ward of Kalinchowk RM. Photo: Binod Kalauni
