# District Report

## Sindhupalchok

22 June - 5 July 2018

### Field Visit /Joint Field Monitoring Visit Reports

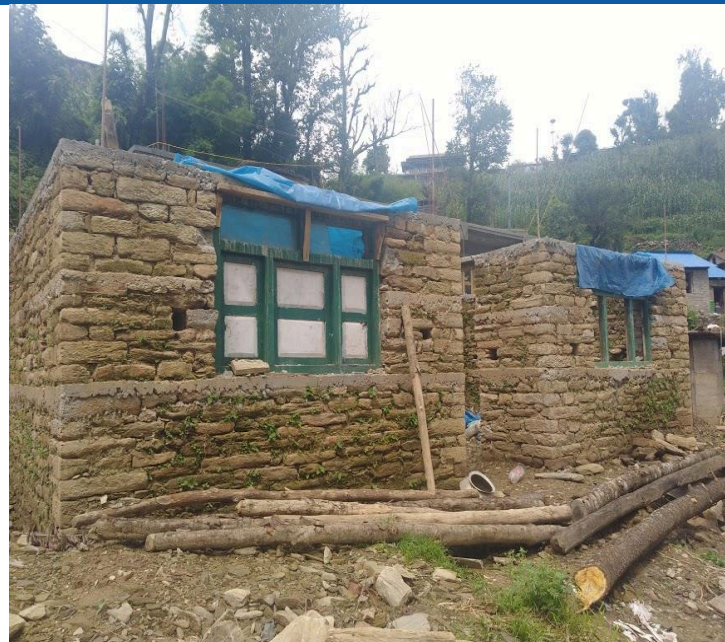
Pema Tamang and Dhanjit Tamang  
No corner stitch, cementing in stone on outer sides to fake RC band. <117 sq ft, same toilet for both households, 2 houses of 1 room each, Stone in Mud Mortar  
Lisankhupakhar RM, ward no-7, Thulo Pakhar, photo taken by Aarju Basnet.

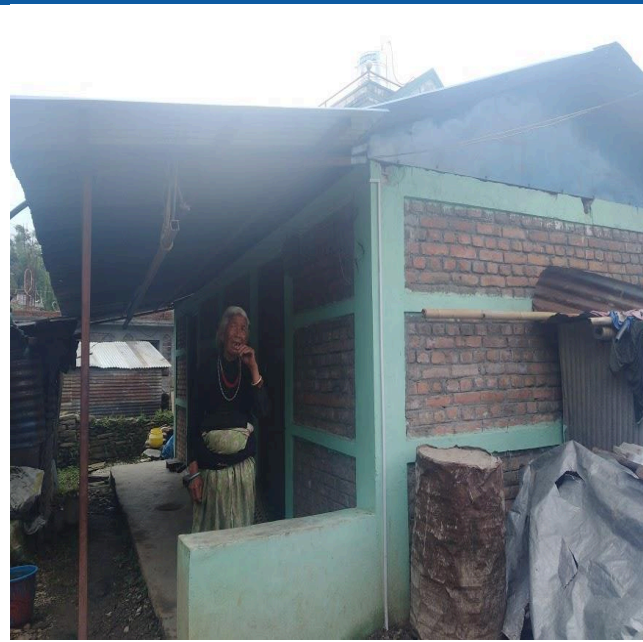
Maiti Devi Tamangni, Brick in Cement Mortar, received all tranche. 2 room houses, Brick in Cement Mortar, the old toilet hadn't collapsed so needn't have to construct a new one,  
Lisankhupakhar RM, ward no-7, Thulo Pakhar, photo taken by Aarju Basnet

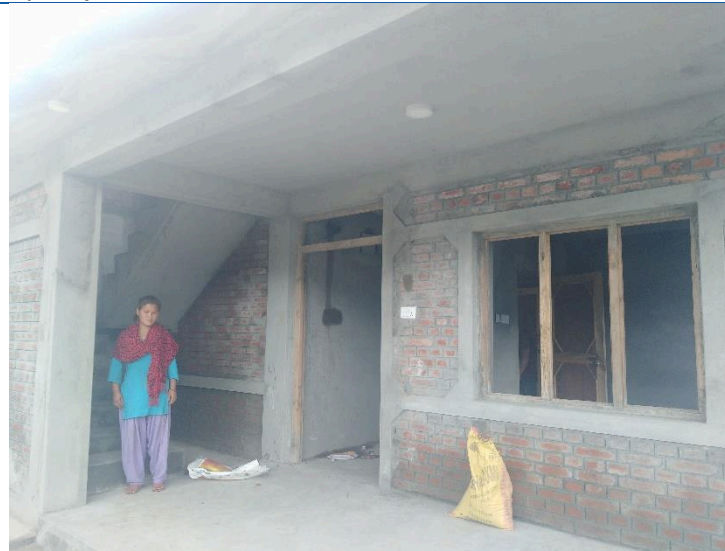
Chinlal Tamang , RCC, Total cost:20 lakhs, Received all three tranche, Lisankhupakhar RM, ward no. 7, Thulo Pakhar, Photo taken by Aarju Basnet

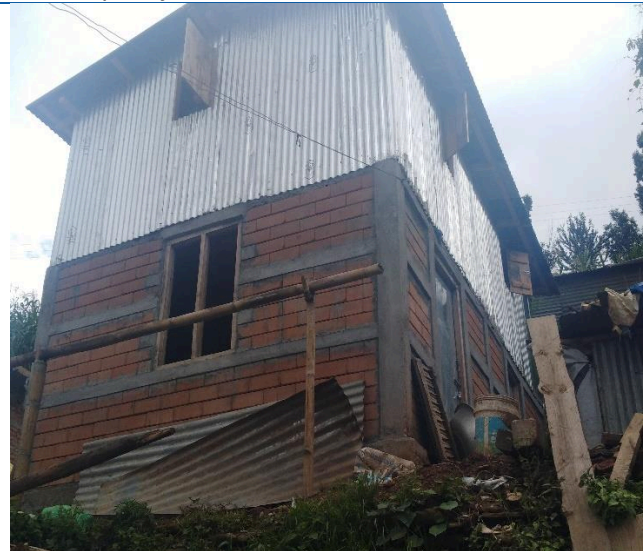
Bimala Tamang has received all tranches, Hybrid structure and wooden bracing , Interlocking Brick with cement mortar and light weight roofing material Sindhupalchok, ward no.7, Thulo Pakhar, photo taken by Aarju Basnet.

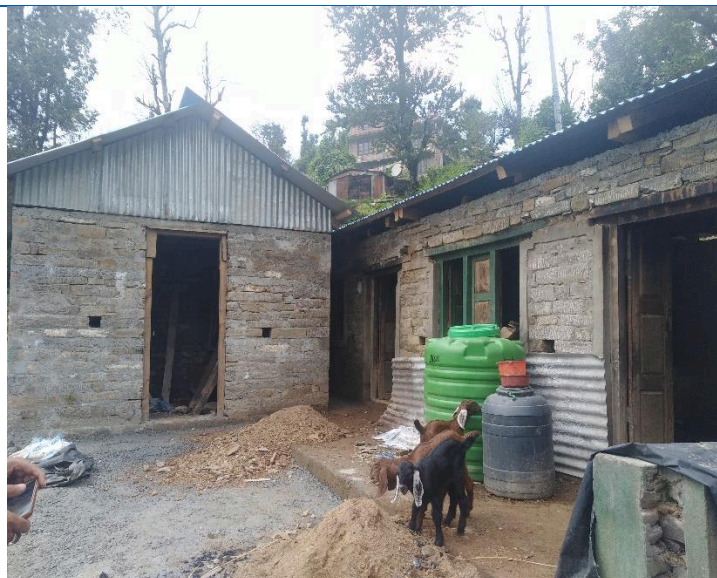
Kanchi Maya Tamang, SMC  
1 room house constructed to receive tranche. The old house on the side was 3 story but upper 2 story collapsed in earthquake. The family is staying in the ground floor now and has constructed a one room house to receive tranche.  
Photo taken by: Aarju Basnet

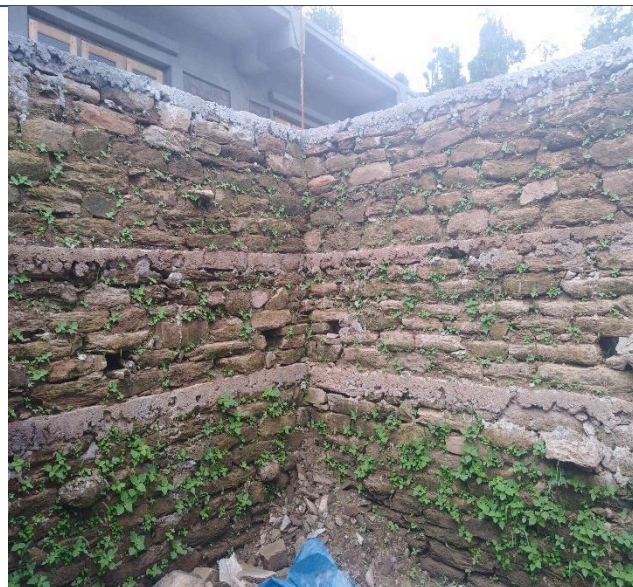
Pema Tamang and Dhanjit Tamang, SMM,  
No corner stitch, cementing in stone on outer sides to fake RC band. <117 sq ft, same toilet for both households, 2 houses of 1 room each, Stone in Mud Mortar Lisankhupakhar RM, ward no-7, Thulo Pakhar, photo taken by Aarju Basnet.

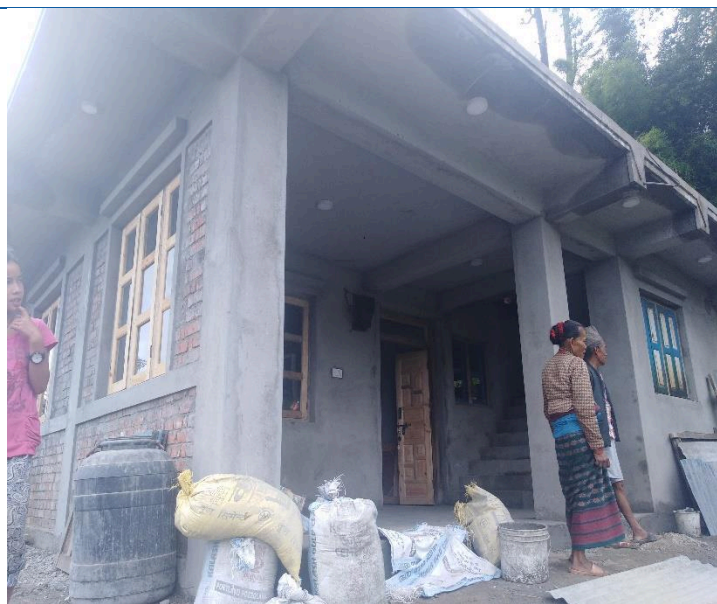
House owner: Pasang Dorjt, RCC,  
Received all three tranches, cost almost 20 lakhs,  
Sindhupalchok, Lisankhupakhar RM, Thulo Phakhar, ward no.7, photo taken by Aarju Basnet

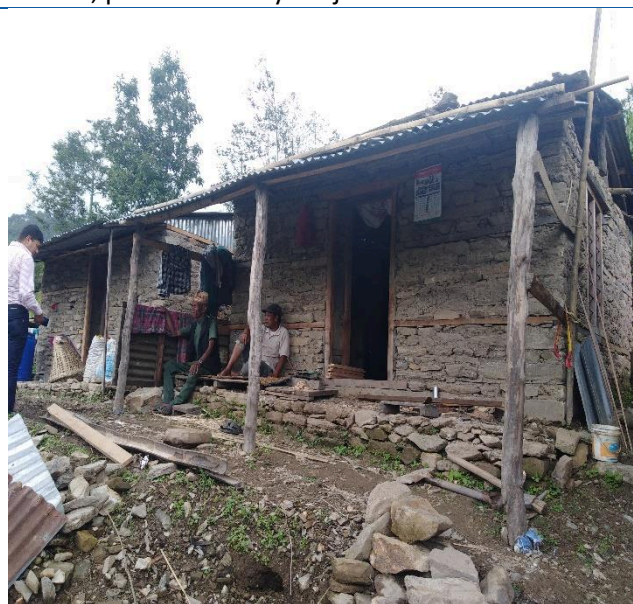
There are four houses sequentially in a same plot each for: Son, Father and grandfather, Stone in Mud/Flexible roof/rigid roof. The fourth one is a temporary shelter of 3 room constructed by an NGO after earthquake. The toilet is not ready so hasn't received 3rd tranche yet, Sindhupalchok, Lisankhupakhar RM, wrd no.6, Petku , photo taken by Aarju Basnet.

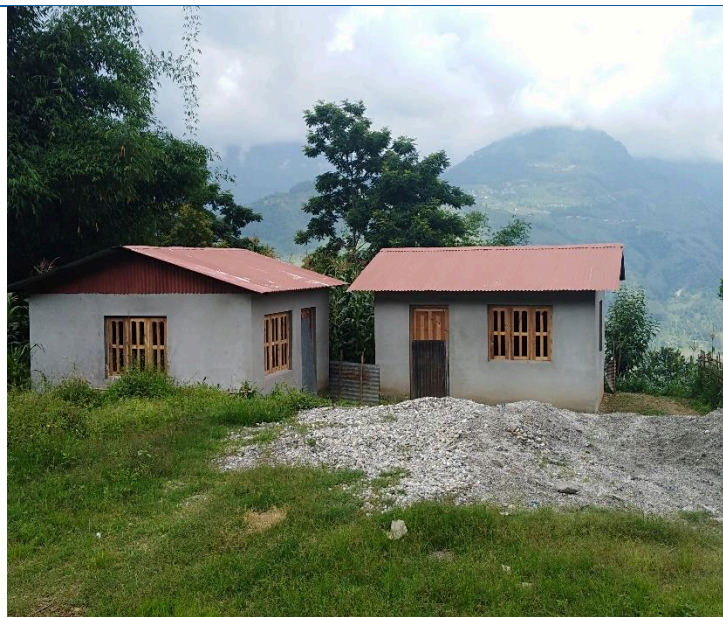
2 houses of 1 room , Stone in Cement/Flexible roof/rigid roof, Lisankhupakhar RM, ward no. 6, Petku, Photo taken by Aarju Basnet

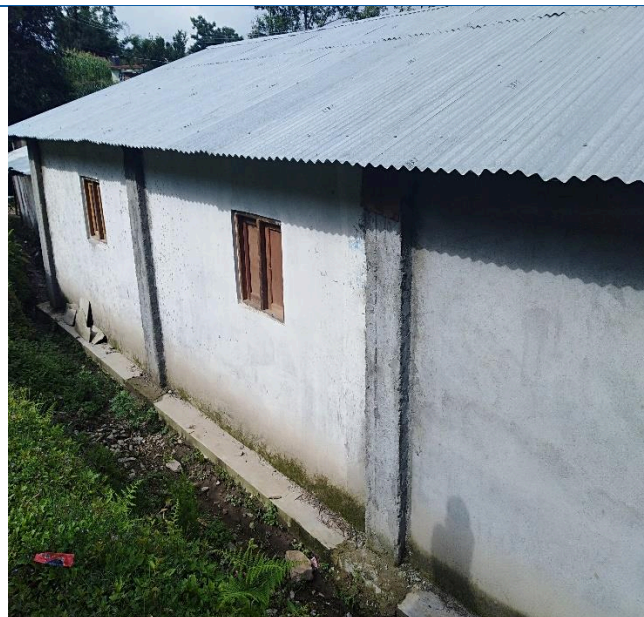
House owner: Bir B Tamang  
Absence of vertical members previously so correction for vertical members has been done, Stone in Cement/Flexible roof/rigid roof, Lisankhupakhar RM, ward no.6, Petku, Photo taken By Aarju Basnet.

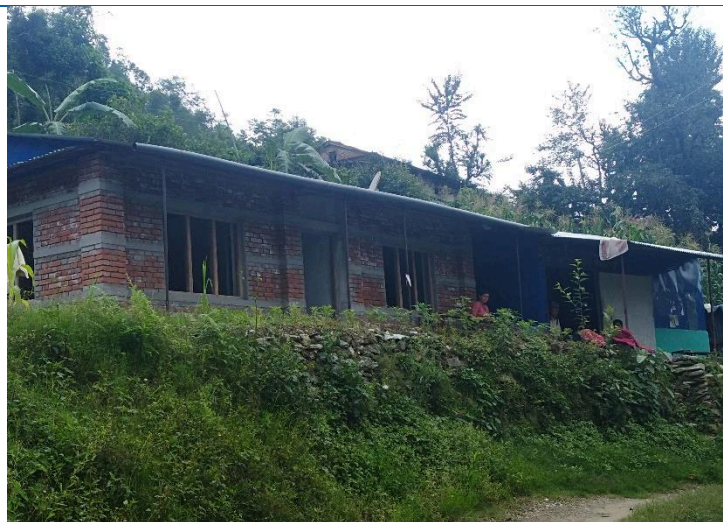
Ramesh Khadka  
Recommended for 3rd tranche  
Constructed by masons from Bardiya, Brick/Block in cement/Flexible roof/rigid roof, Sindhupalchok, Lisankhupakhar RM, ward no.6, Petku, Photo taken By Aarju Basnet.

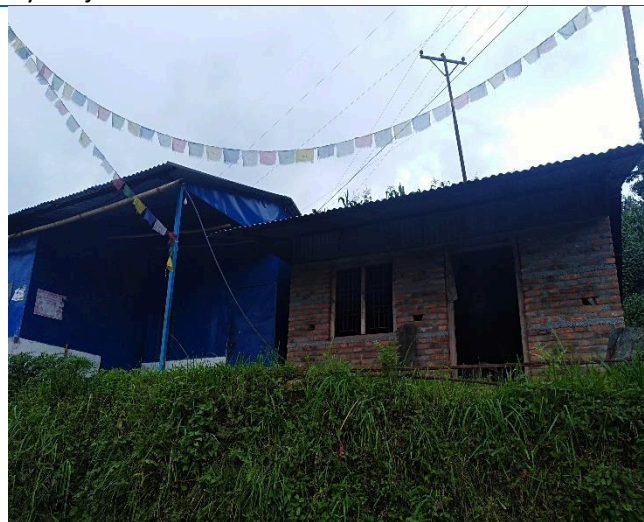
Juli Maya Tamang  
Recommended for 3rd tranche, Brick/Block in cement/Flexible roof/rigid roof, Sindhupalchok, Lisankhupakhar RM, ward no.6, Petku, Photo taken by Aarju Basnet.
