# District Report

## Kavrepalanchok

28 September-5 October 2017

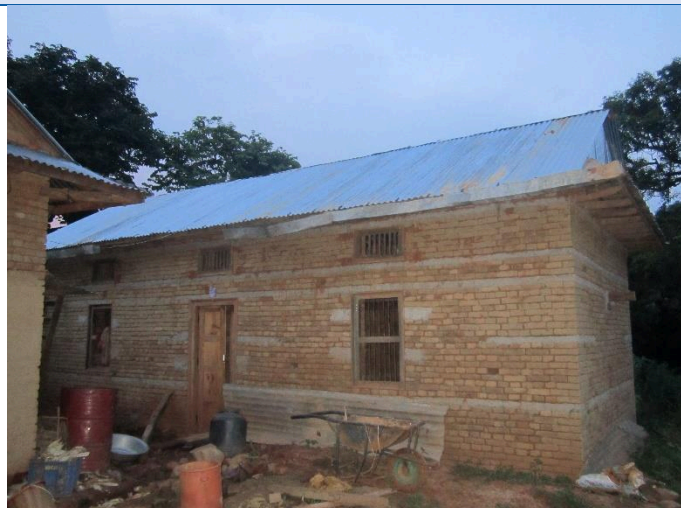
| <p>This house sees all the earthquake resistant elements but the construction is on adobe. The house owner Pushpa Maya Danuwar has received the municipal permit for this design as well. (Ojheta, Panchkhal Municipality)</p> | |
