# District Report

## Dhading

6-19 July 2018

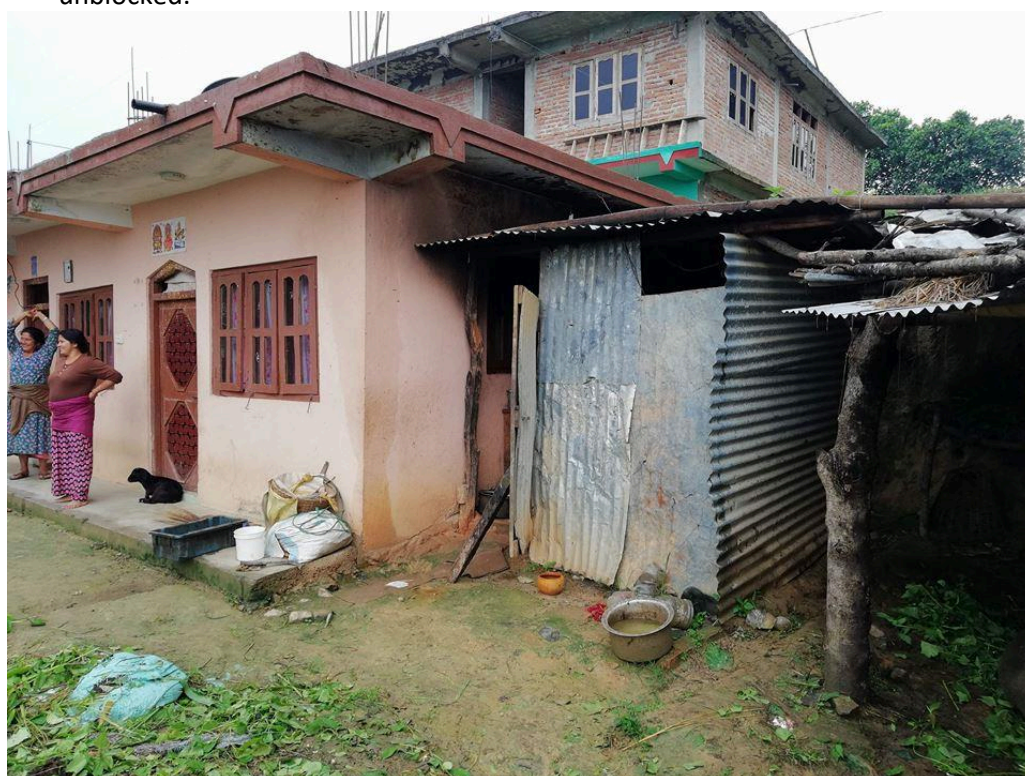
The accounts of 20 beneficiaries were blocked since technical person has forwarded non-compliance buildings for second tranche. These houses are analysed by DSE team and only 3 houses were found to be unsafe and accounts of 17 beneficiaries are unblocked.

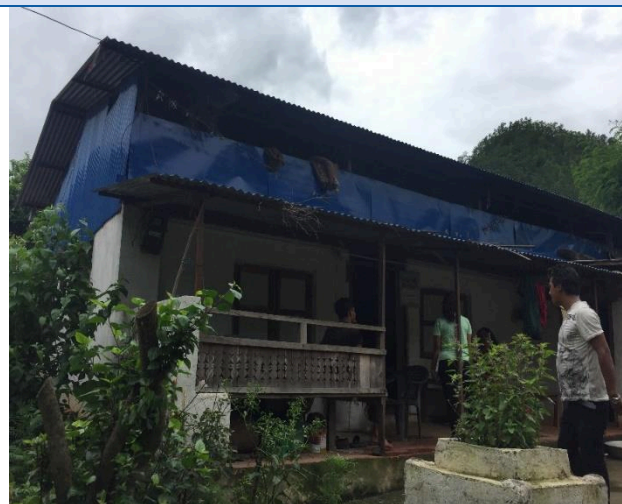
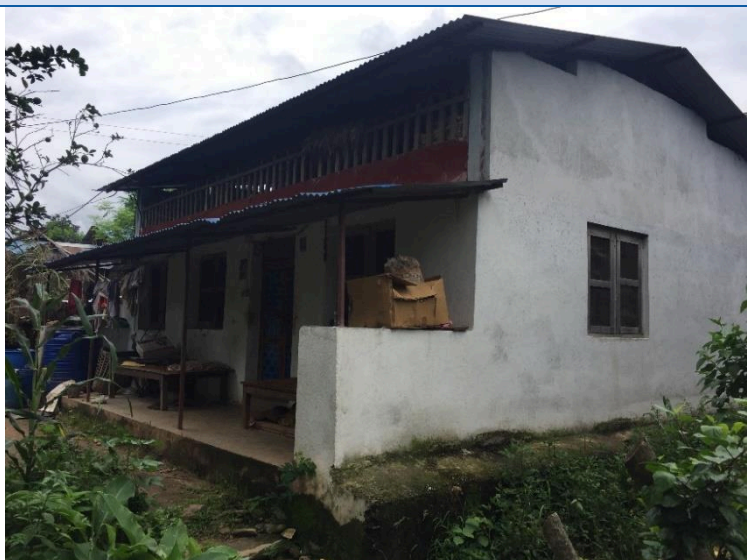
| <p>The house located at Galchhi VDC - 07, Dhading Antari Tamang, the house owner, had received first Tranche but not approve for Second Tranche. It is a two storey Load Bearing Building before earthquake but now it's just a one storey with CGI sheet roofing.</p> <p>Key Points: -</p> <p>Stone Masonry in mud mortar<br/>Highly damaged<br/>No Tie beam, bands etc<br/>Flexible roofing</p> | <p>Similar, Manoj Tamang, residence of Kalleri VDC-07, Dhading had received first Tranche and get approved for second tranche too.</p> <p>Key Points: -</p> <p>Load Bearing Structure<br/>Tie Beam provided<br/>Sill Band<br/>Lintel Band<br/>Roof Band<br/>CGI roofing<br/>Proper bonding in junction</p> |

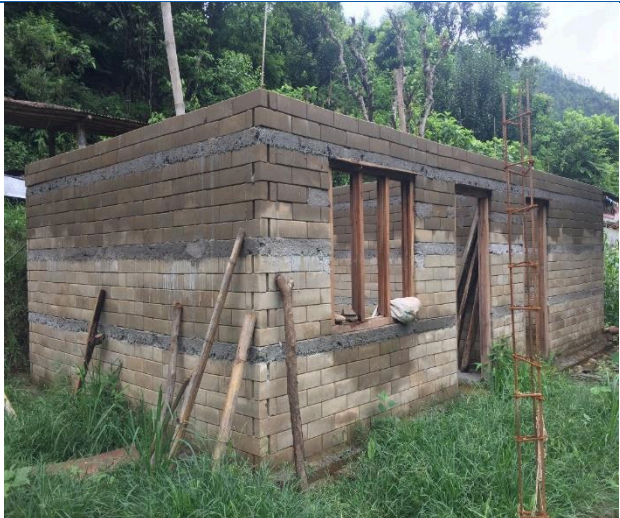
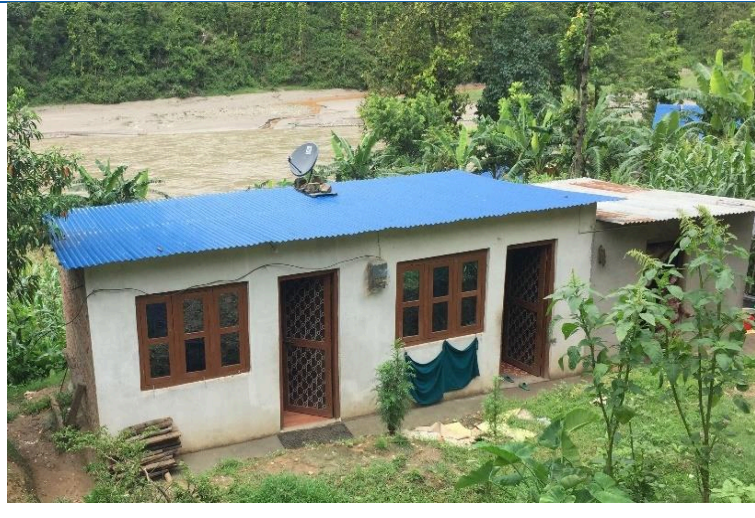
| <p>Ram Badhaur Tamang, residence of Thakre VDC - 07, had constructed a Load Bearing Structure (Block masonry in Cement Mortar).</p> <p>1 storey building<br/>Get 1st tranche<br/>Unable to get 2nd tranche</p> | <p>Thulikanchhi Tmang, residence of Galchhi VDC, is complete a Load Bearing Structure (Stone masonry in Cement Mortar. She received first Tranche and gets approved for second tranche too.</p> |

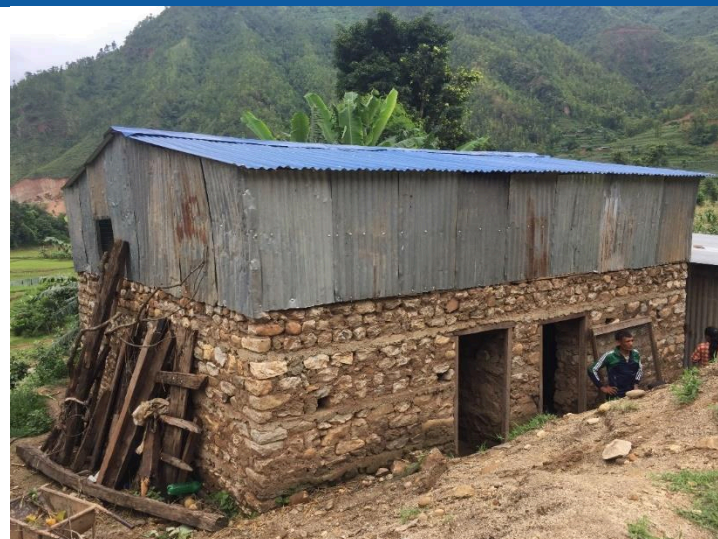
**Mixed Structure**  
Stone masonry with mud mortar in Ground floor and CGI Sheet framing in first floor

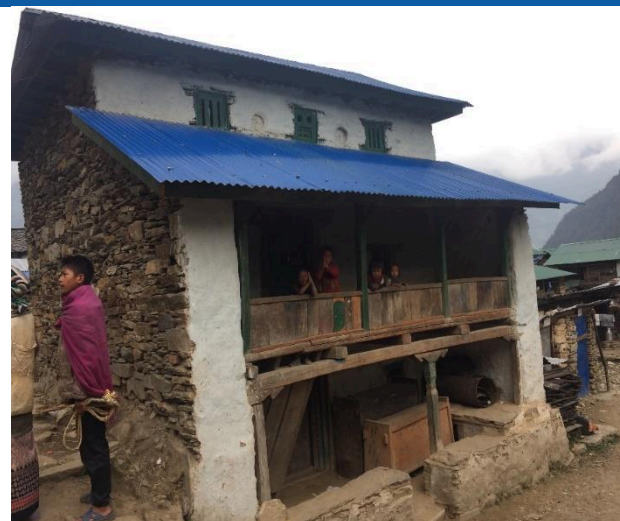
The picture shows a building constructed before earthquake. Building has no horizontal bands and vertical rebars constructed with stone masonry. The building is still on use since no damage is seen.

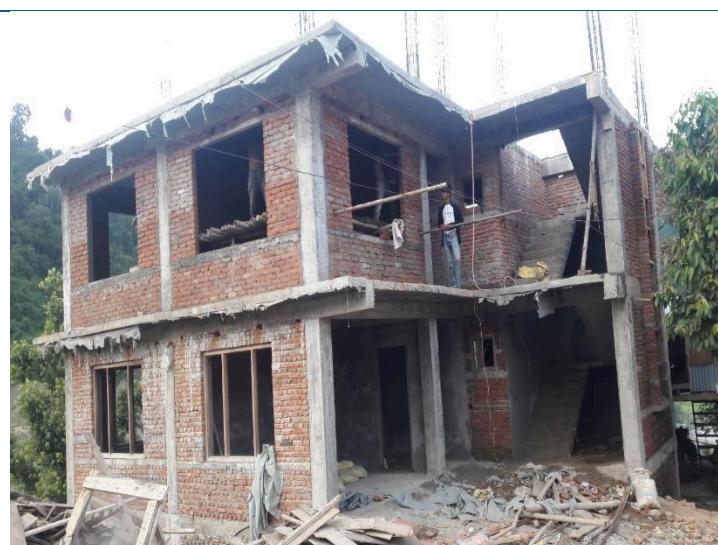
**RCC Framed Structure(L-shaped) building at Thakre.**

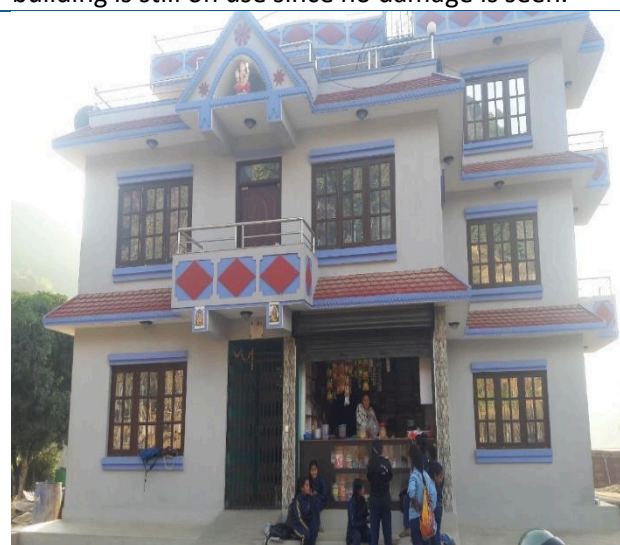
**RCC Framed Structure building (Column size 9"X12") at Benighat.**
