# District Report

## Kathmandu Valley

5-19 April 2018

## Field Visit Report

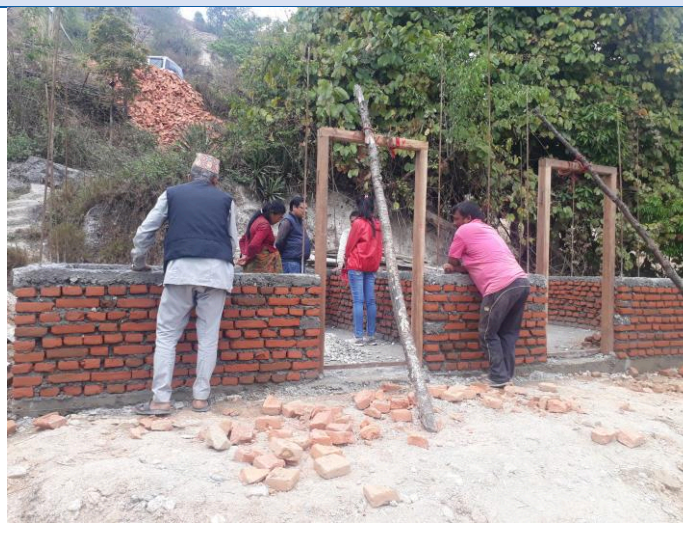
Gagalfedi, Ward No. 1, Kageshwari Manahara N.P. Under construction house of a single woman with brick in cement mortar house, CGI roof. For the last 2 months she is living alone since her husband died. She has not applied for II tranche, has not site plan/location map prepared and is on the process of land ownership transfer from husband.

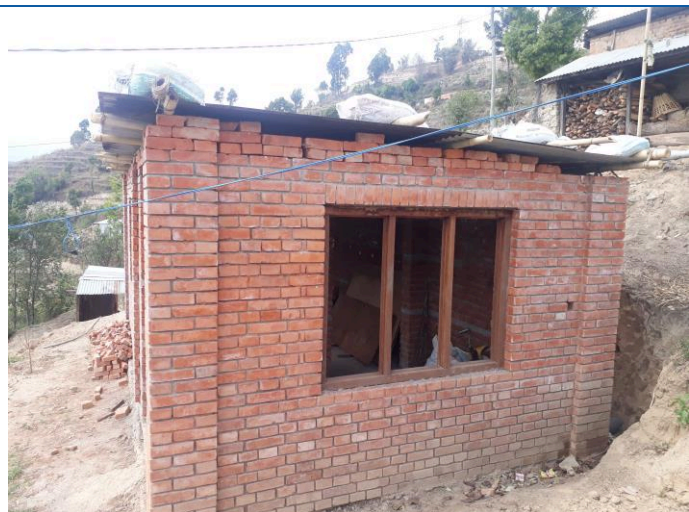
Gagalfedi, Ward No. 1, Kageshwari Manahara N.P. Brick in cement mortar house, 2 rooms, CGI roof. Beneficiary does not have building permit, site plan/location map. The owner has applied for 2<sup>nd</sup> tranche and has planned to add up roof band with the 2<sup>nd</sup> tranche.

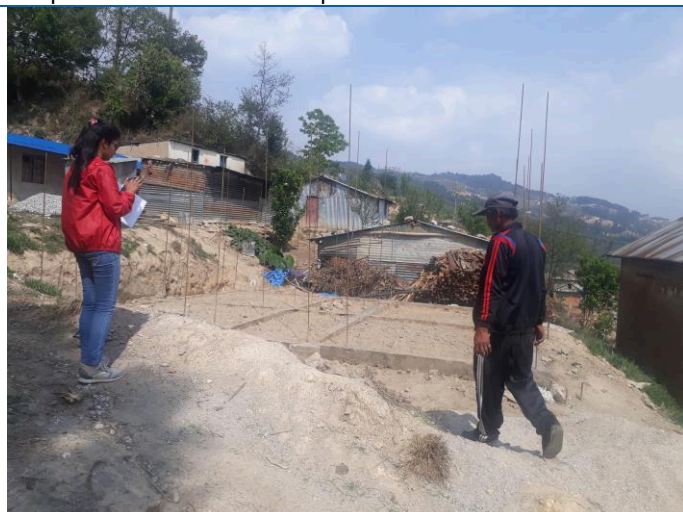
Ekka tole, Gagalfedi, Ward No. 1, Kageshwari Manahara N.P. BMC, 4 rooms, 1 story. DLPIU engineer inspecting his house up to DPC in the same day of application registered. Beneficiary himself is mason, trained by NSET.

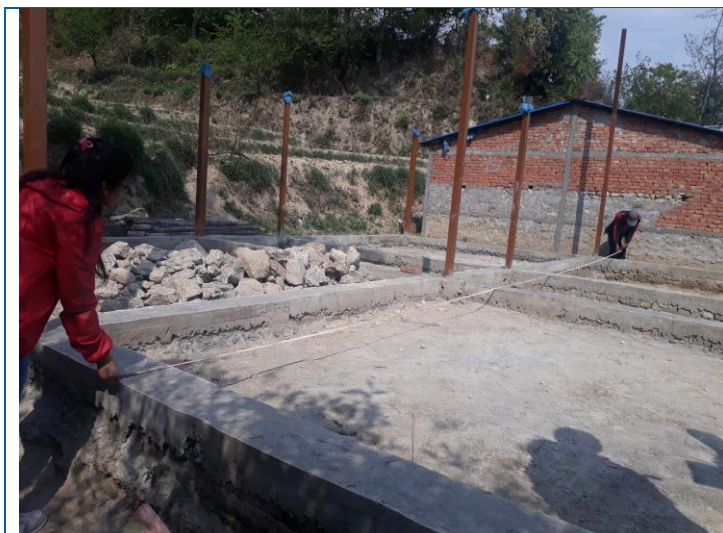
| Date | Location | Participants | | |
|---|---|---|---|---|
| Duplicate picture was attached on inspection form by beneficiary | | Local bodies should control the fake evidence at local level. DLPIU engineers should also be careful of such issues and need to check reality in the field. | Beneficiaries, local bodies, DLPIU. | M/E, CLPIU, HRRP and DLPIU engineer visited the house in the same day of the application registered, and found different and non - compliant. |

Ekka tole, Gagalfedi, Ward No. 1, Kageshwari Manahara N.P. House started 2 years ago has applied for inspection on 17<sup>th</sup> April 2018. M/E (CLPIU), HRRP and DLPIU engineer monitored observed and inspected it same day. This beneficiary had attached the different photo of the DPC which has not steel post as it is on reality. M/E consultant suggested necessary corrective measures.

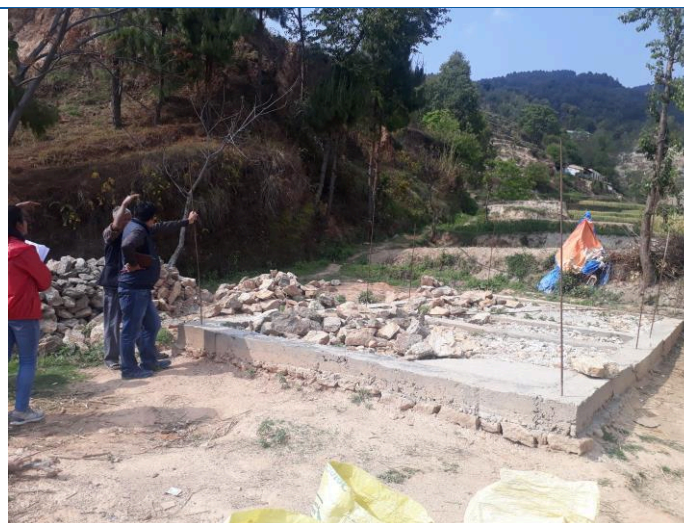
Ekka tole, Gagalfedi, Ward No. 1, Kageshwari Manahara N.P. SMC, 2 rooms, completed DPC 5 months ago. Insufficient vertical reinforcement especially in the opening has delayed the inspection and there are no site plan/location map and building permit as well.
