# Draft Report on Collaborative Project of ICCR-DRR between NSET and BNU

February 2017

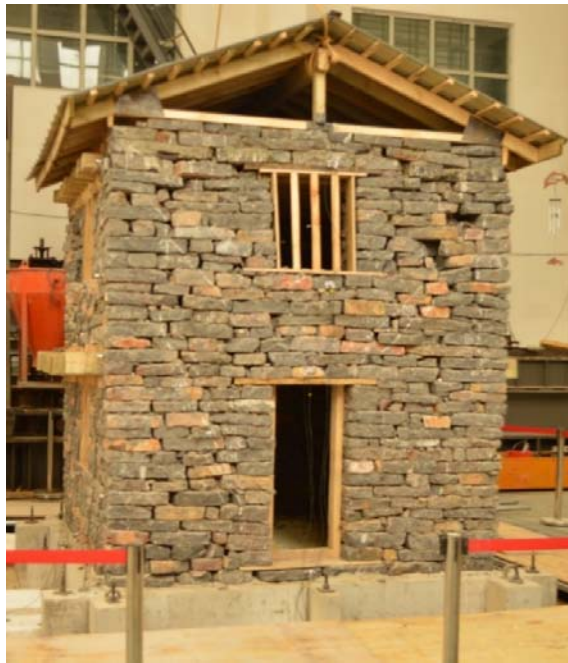
| Building Model | Failure Mode at the Expected level of Shaking |
|---|---|
| Unreinforced (Model 1) | Out-of plane failure in upper story |

Damage to **Unreinforced Building** at 0.31g

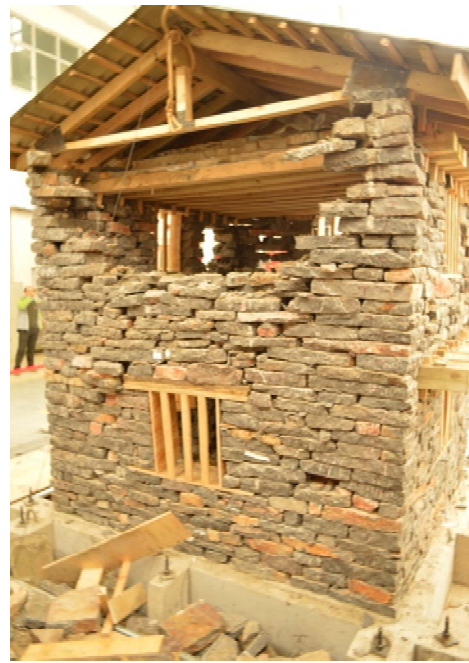
Damage to **Unreinforced Masonry** at 0.40g

1. Unreinforced stone masonry building (Model 1) cannot ensure Life Safety in the building.

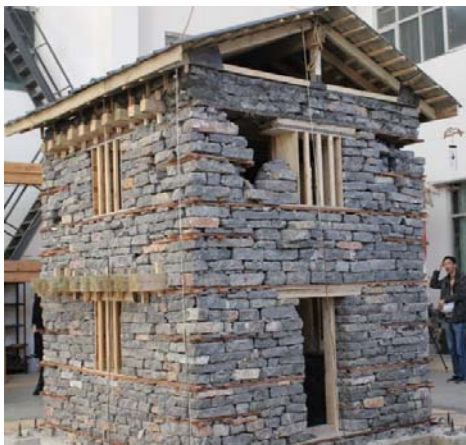
| Building Model | Failure Mode at the Expected level of Shaking |
|---|---|
| Wooden Bands and Posts as per NBC 203 (Model 2) | Local failure of walls in between the bands |

| <p>Damage to the <b>Building with Wooden Bands and Posts</b> at 0.51g</p> | <p>Damage to the <b>Building with Wooden Bands and Posts and gabion wire meshing</b> at 0.62g</p> |

2. Stone masonry building with wooden bands and posts as per NBC: 203 (Model 2) also cannot ensure Life Safety in the building due to the local failure of stones in between the bands. The more irregular and round the stones are used, more is the risk to the building occupants due to collapse of stone walls in between the bands.

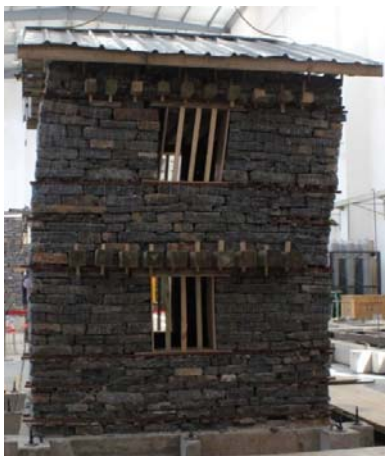
| Building Model | Failure Mode at the Expected level of Shaking |
|---|---|
| Wooden Bands and Posts and gabion wire meshing (Model 3) | Life Safety with sufficient ductility |

3. Stone masonry with wooden bands and posts as per NBC: 203 and gabion wire meshing (Model 3) can ensure Life Safety in the building with sufficient ductility.

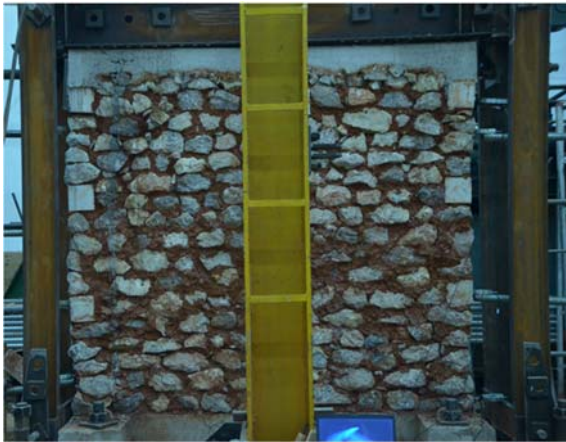
Wall # 1 Random Rubble Stone Wall before Testing

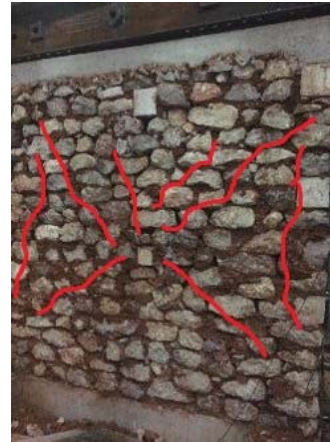
Movement of  
the wall at  
ultimate  
displacement  
of 32 mm

Wall #1 Ultimate Crack Pattern of Random Rubble Stone Wall

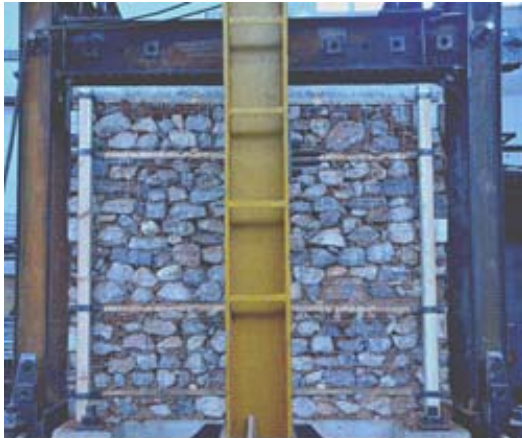
Wall # 2 Random Rubble with Wooden Band and post and Gabion Wire Meshing

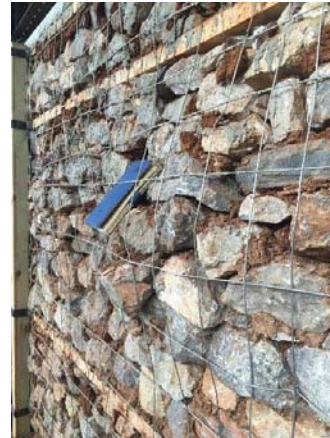
Movement of  
the wall at  
ultimate  
displacement of  
66 mm

Wall # 2: Stretching of Gabion Wire and Bulging out of Stone Wall

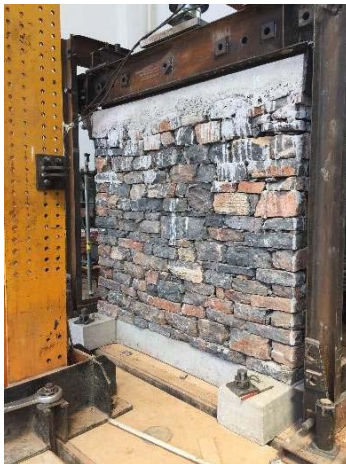
Wall #6: Unreinforced Flat Stone

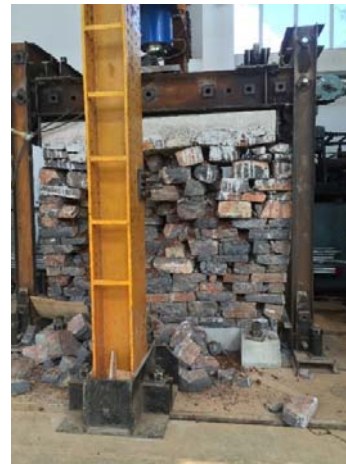
Movement of  
the wall at  
ultimate  
displacement  
of 48 mm with  
local failure of  
random  
rubble stone  
wall

Wall #6: Ultimate failure of Unreinforced Flat Stone
