## Monthly District Report

Lamjung, Tanahun, Kaski, Syangja

22 October – 21 November 2019

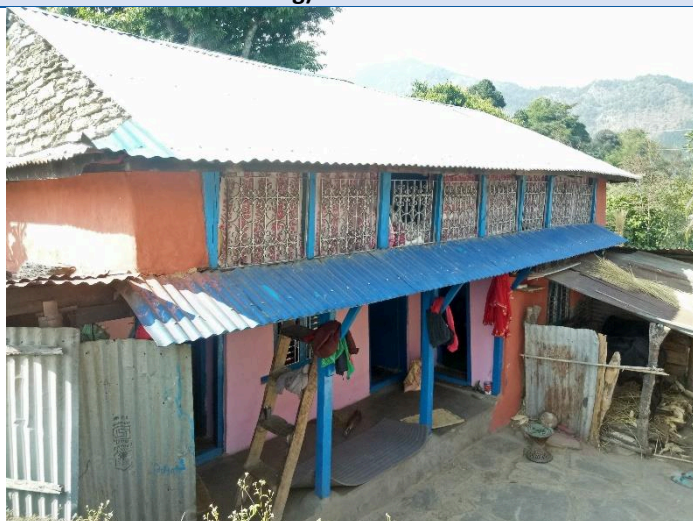
The beneficiaries have already received the first tranche and due to lack of information, technical assistance and vulnerability of the house, they have repaired their houses in their own way in the form of plaster, etc. The amount of first tranche has been spent in the repair and now after the dissemination of knowledge of retrofit they lack financial support as they must start the retrofit process on their own expense. Due to this reason the beneficiaries are repelling to retrofit their houses. Some of the beneficiaries under retrofit have demolished their houses completely and have reconstructed new house and want to get changed from RTR to RCB.

**Caption: Retrofitting beneficiary who has already repaired his house after getting the first tranche and financially has no support to further retrofit**

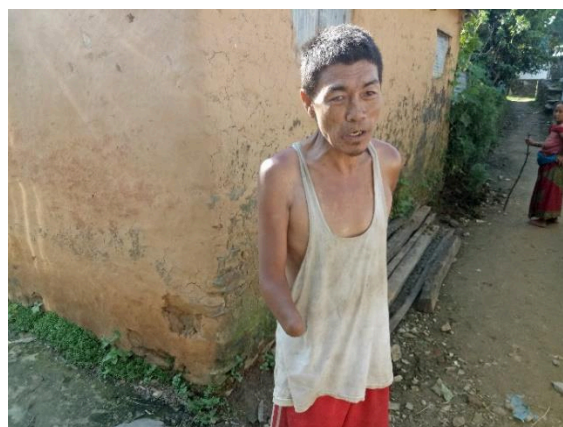
Ward number-1 , Rainas Municipality, Lamjung

Rajbir Gurung – a differently able beneficiary who lost both of his hands and partially damaged eye. His house was damaged in the 2072 earthquake and had been living in that house even after earthquake as he was not able to reconstruct new house. Due to his poor economic condition, and his poor physical condition, he was not been able to demolish his damaged house and start reconstruction. Thereafter he had been enlisted in the vulnerable list supported with top-up of additional 50,000 Rs by COPADEX. Recently, 8/9 months ago he had signed the agreement and received the first tranche and now demolished the old earthquake affected house and is looking forward for the vulnerable top-up support to start the reconstruction process.

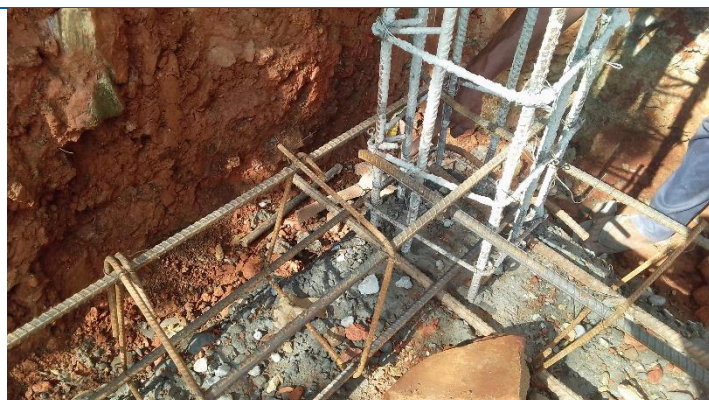
HRRP Kaski Team along the newly formed Retrofitting task force comprising of DSEs and Engineers (DLPIU Building) and technical staffs of Rupakot RM Kaski district. The field visit was mainly focused on the observation of the current status of the houses under retrofit and convincing the beneficiaries for retrofit. During the visit, it was found that the houses were repaired rather than retrofitted. In total 6 houses were visited of both retrofit and reconstruction. One house was case of repair, one house has added 1 section in all the columns, and one house had jacketing of the column. One of the repaired houses by plastering in the walls. One house under-going reconstruction for Tie beam. As only two days were left for the recommendation and inspection for second tranche the tie-beam was constructed in rush and in lack of trained masons as a result it was non-compliant. The rebar of beam was running outside the column in beam-column joint section and the spacing of stirrups was not according to the minimum requirement.

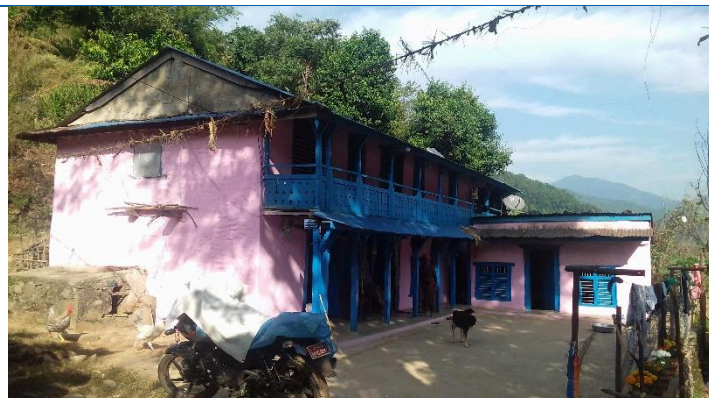
Ward no-4, Rupakot Municipality, Kaski  
The beneficiary is enlisted under retrofit and have plastered the house and is currently living.  
Housing Typology: Two Storey load bearing stone masonry in mud mortar.

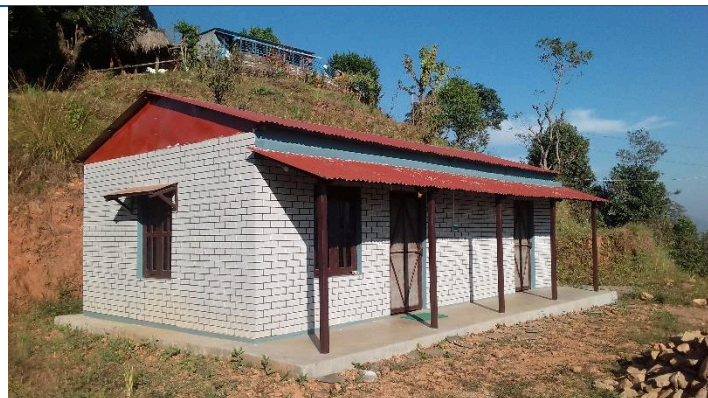
Ward no-4, Rupakot Municipality, Kaski  
The beneficiary has received the third tranche.  
Housing Typology: Load Bearing Brick Masonry in cement mortar.

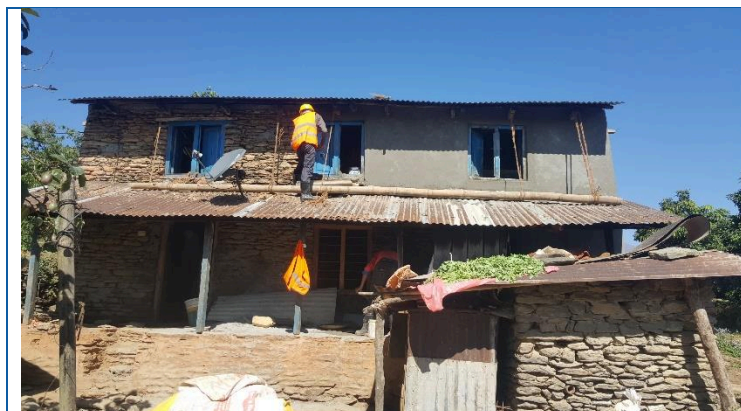
Ward No-2, Annapurna RM, Kaski Retrofit model house by Built Change  
The beneficiary has received the first tranche of GON retrofitting grant.

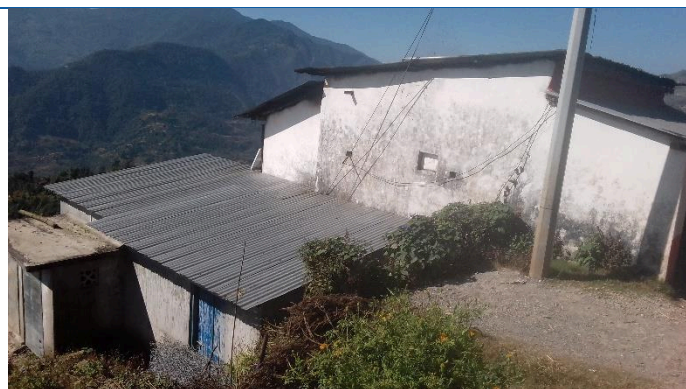
| Challenges / Issues Identified | Solutions Provided or Possible Solutions | Decision Taken | Responsible | Timeframe (specify the time taken to decide on the issues identified) |
|---|---|---|---|---|
| New houses constructed attached with the old earthquake damaged house. | Dismantling the old house or retrofitting and making those earthquakes resilient. | Not yet | NRA, CLPIU-GMaLI, Palikas | ASAP |

During the field visit one model house under retrofit was inspected by the Task-Force Kaski team at Annapurna RM. The model was load bearing stone masonry in mud mortar house. New houses constructed attached with the old earthquake damaged house. Proper monitoring on dismantling the old house or retrofitting and making those earthquakes resilient should be done.

Ward no-1, Annapurna RM, Kaski  
New houses constructed attached with the old earthquake damaged house.

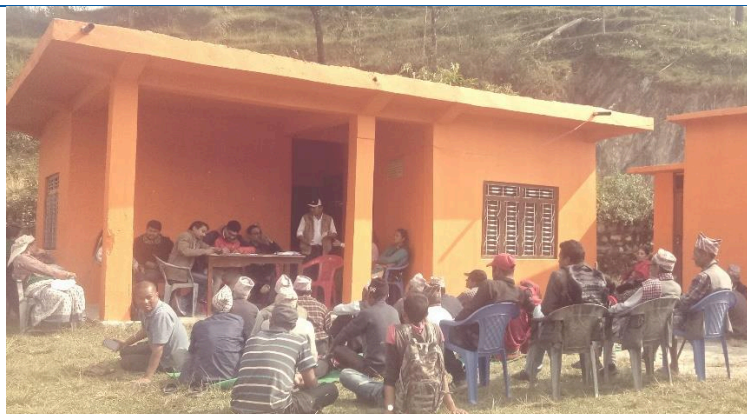
Ward no-13, Putalibazar Municipality , Syangja District  
Interaction and orientation Program with beneficiaries enlisted in retrofitting and ward level meeting in the chairmanship of Mr. Bisheshwor Prasad Regmi. The interaction and orientation program mainly focused on awareness on retrofitting, listing the technical feasibility, housing typology, interest of house owner on retrofit (if not then the reason why the beneficiary does not want to go for retrofit) in the presence of DLPIU technical, DSE and HRRP Team.

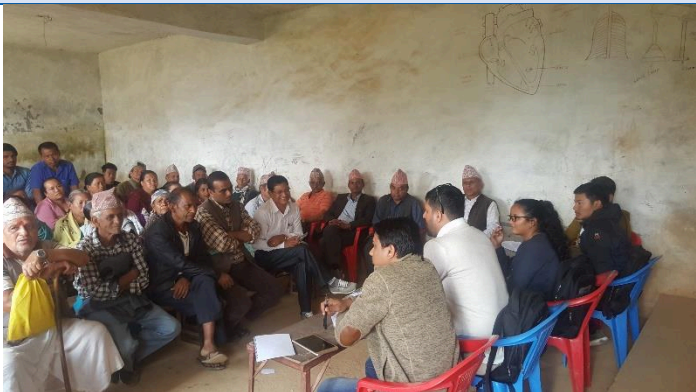
| <p>Ward no-13, Galyang Municipality ,Syangja District<br/>Interaction and orientation Program with beneficiaries enlisted in retrofitting and ward level meeting in the chairmanship of Mr. Netra Prasad Pandey.The interaction and orientation program mainly focused on awareness on retrofitting , listing the technical feasibility , housing typology, interest of house owner on retrofit(if not then the reason why the beneficiary does not want to go for retrofit) in the presence of DLPIU technical , DSE and HRRP Team.</p> | | | | |

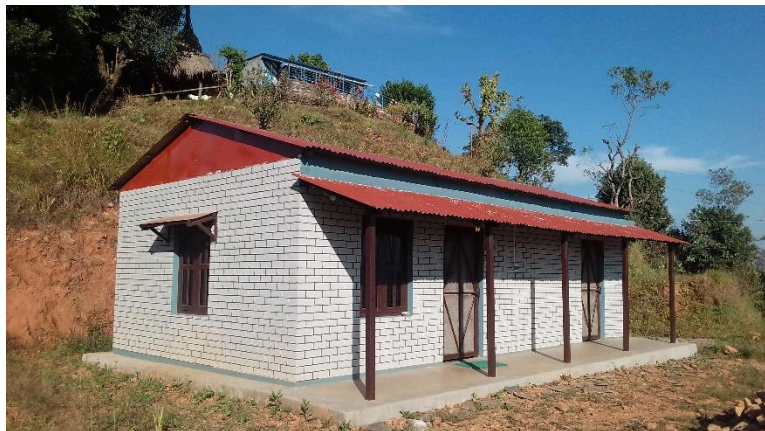
**Caption:** Ward no-4, Rupakot Municipality, Kaski  
The beneficiary has received the third tranche.  
**Housing Typology:** Load Bearing Brick Masonry in cement mortar.

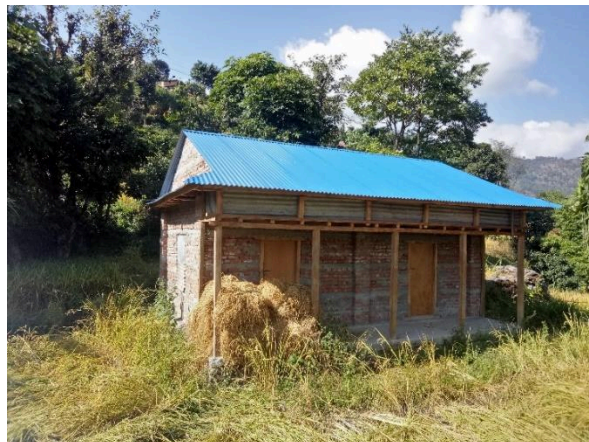
| <b>Summary</b> | | | | |
|---|---|---|---|---|
| Lack of gable band in the houses. | Addition of Gable band | The technical are requested to provide the technical assistance as for the given solutions. | DLPIU-Building | ASAP |

**Caption:** ward no-6, Besisahar Municipality, Lamjung District  
**Housing Typology:** Two rooms Load bearing brick masonry in cement mortar.  
The beneficiary has not received the third tranche as the house is missing the gable band and recommended for corrections.

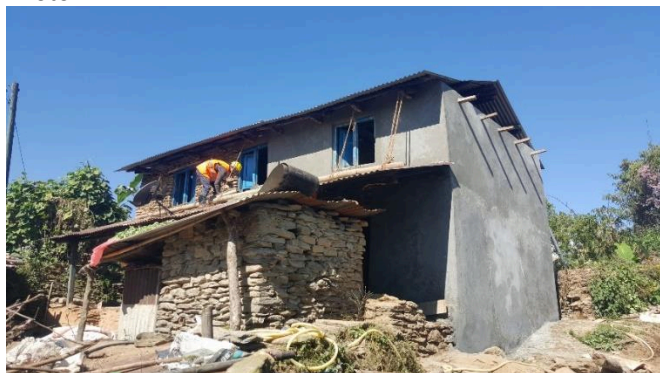
**Caption:**  
Ward No-2, Annapurna RM, Kaski Retrofit model house by Built Change  
The beneficiary has received the first tranche of GON retrofitting grant.

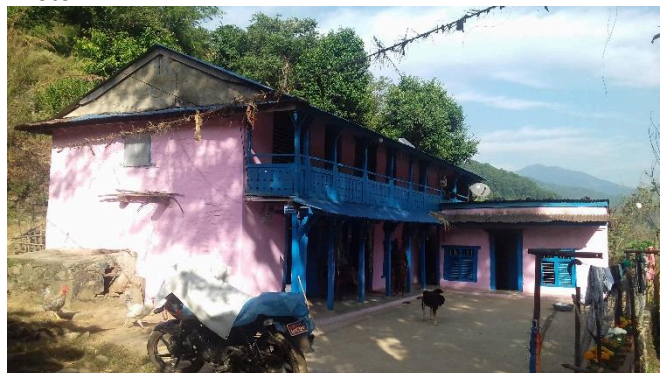
**Caption:**  
Ward no-4, Rupakot Municipality, Kaski  
The beneficiary is enlisted under retrofit and have plastered the house and is currently living.  
**Housing Typology:** Two Storey load bearing stone masonry in mud mortar.
