## Monthly District Report

### Kathmandu

14 June - 14 July 2019

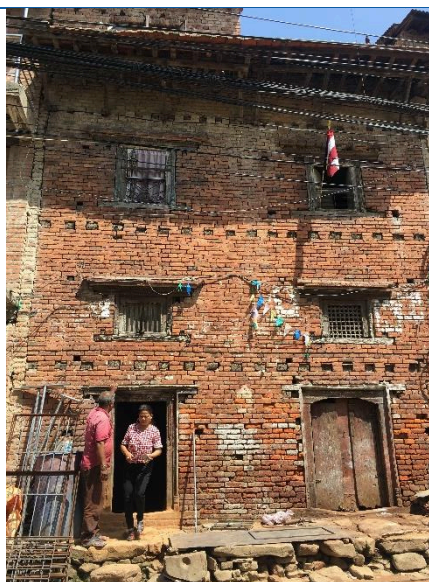
The house of Mr. Krishna Gopal Nakarmi, under the grievance was listed as Damage grade 4 during the resurvey and reverification collection in ward no 12, Chandragiri Municipality.

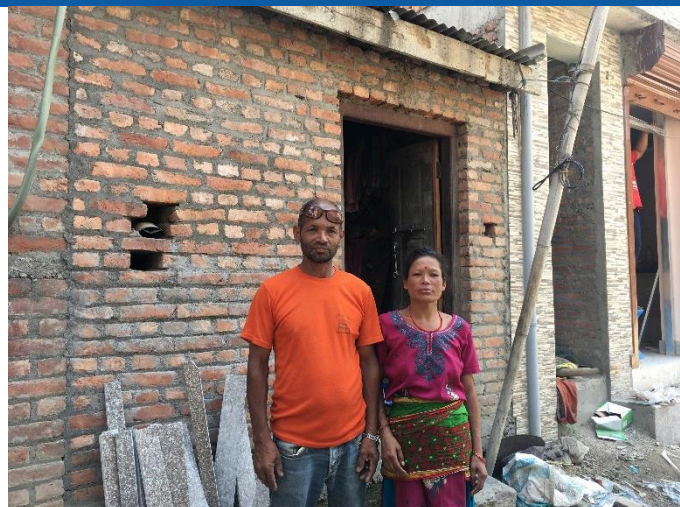
Beneficiary name: Shyam Krishna Maharjan, Balambu, ward no 12, Chandragiri Municipality. Load bearing brick in cement mortar structure. The structure is non-compliance as the corner stitch, bands and vertical reinforcement are missing. The correction measures were suggested during the visit.

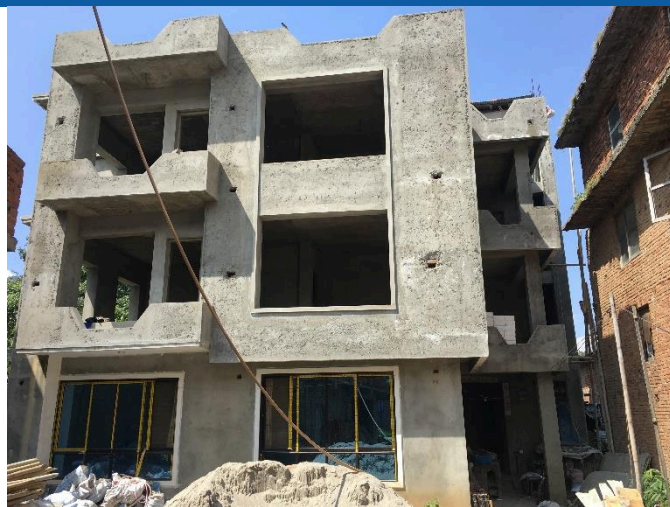
Beneficiary name: Rup Kumar Shrestha, Balambu, ward no 12, Chandragiri Municipality. The beneficiary has received all the tranches.

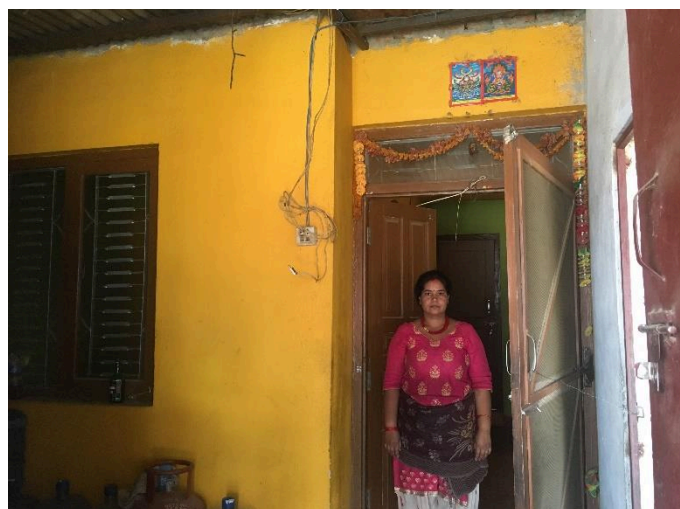
Beneficiary name: Pradip karki, ward no 1, Chandragiri Municipality. One storey load Bearing brick and cement Mortar Masonry. The house was found to be compliance and the technical inspection was conducted during the visit.

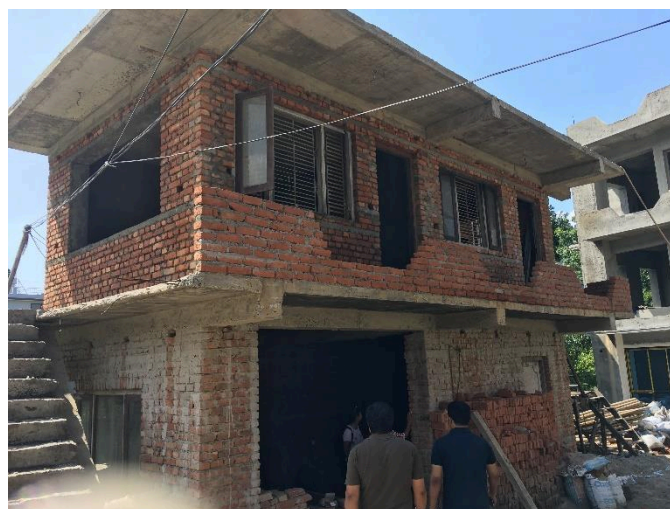
Beneficiary name: Rup Kumar Shrestha, ward no 12, Chandragiri Municipality. Two storey load Bearing brick and cement Mortar Masonry. The structure is listed as non-compliance due to larger opening. The beneficiary is planning to keep rolling shutter in the ground floor.

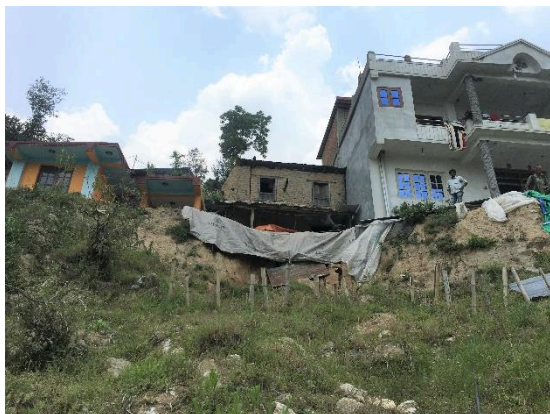
*The landslide area of Lapsiphedi, ward no 4, Shankharapur Municipality.*

During the rainy season of 2018 the continuous rainfall caused a loosened the soil in the slope which resulted in the landslide in Dhungana Tole (27.745N, 85.47861111E), Lapsiphedi ward no 4, Shankharapur Municipality. The landslide swept away the part of the hills nearby exposing the houses to the edge of the hill. As per the site selection for the implementation of the sub project of Environment and Social Management plan under the Environment and Social Management Framework for the earthquake affected beneficiaries, the application of the landslide protection measure was listed as the top priority from the municipality. The site verification of the landslide protection measure was carried out on 9-10 January 2019 (25-26/09/2075) along with technical team, Environment and Social development specialist and NRA Geo-technical survey team on 26 March 2019 (21/12/2075). As of the site verification by DL-PIU KTM and NRA Geo-technical survey team at Lapsiphedi, the settlement lies in Category II of the disaster-prone area. The total of 40 people in 10 households, all earthquake beneficiaries and already received all the 3 tranches of housing reconstruction but are at potential risk due to the landslide. The plan includes Gabion Toe wall, Drainage works, and Bioengineering works.

The landslide preventive work started from 29 May 2019 in presence of the technical team, DLPIU- GMaLI and HRRP and was completed in 2 July 2019. As per the plan the Gabion Toe wall of 108 cu. m was constructed, for drainage management and seepage control HDPE pipe wrapped with Geomembrane was used and finally as part of the Bioengineering work plantation of 150 *Amliso Rhysome* and 60 small shrubs were done. The budget for the project was provided by DLPIU GMaLI- Kathmandu (85%) and the user committee (15%). The project has benefitted total 10 households of Dhungana Tole, Lapsiphedi-4, Shankharapur.

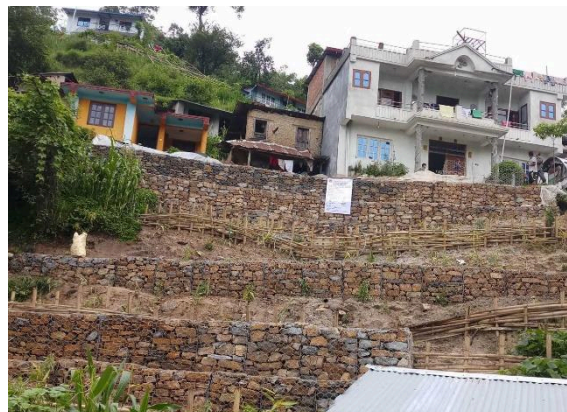
*The landslide area of Lapsiphedi, ward no 4, Shankharapur Municipality after the completion of the landslide mitigation measure.*
