## District Report

### Okhaldhunga

23 November - 6 December 2018

## Field Visit /Joint Field Monitoring Visit Reports

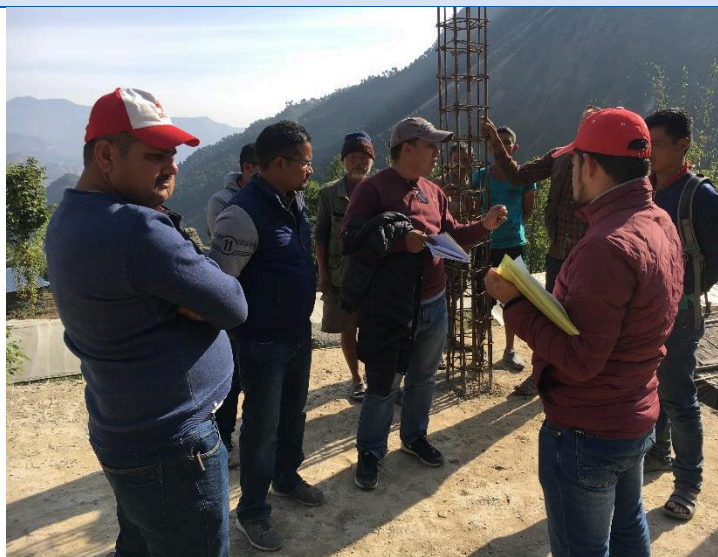
**Ward 3, Molung Rural municipality, Okhaldhunga:** DSE Bibek basnet CLPIU monitoring Kiran kumar mahart and Red cross officials during ground discussion on the topic of non compliance issues.

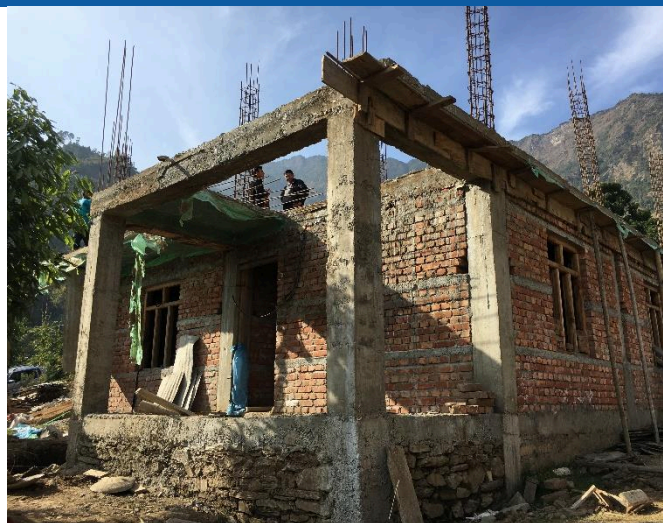
**Ward 3, Molung Rural municipality, Okhaldhunga:** Balaka Sunuwar is the house owner. He has only received the first tranche of the private house reconstruction grant. The RCC structure is a non compliance because of having the 4 -10 mm and 4 -12 mma bars in column.

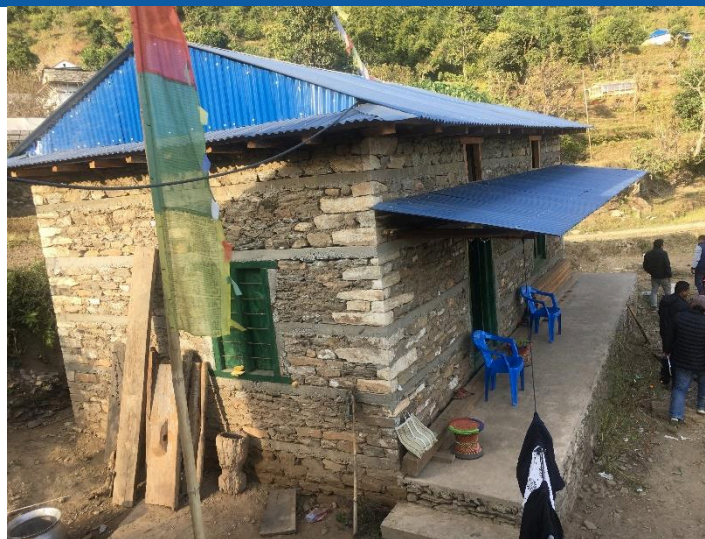
**Ward 3, Molung Rural municipality, Okhaldhunga:** Siri maya Tamang is the house owner. she has received all tranche of private house reconstruction grant. The two room SMM one plus attic structure is features with RCC bands and seems well.

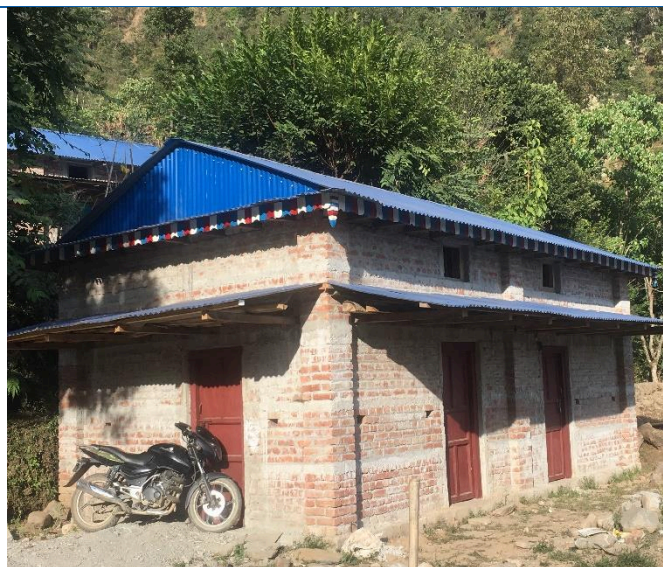
**Ward 3, Molung Rural municipality, Okhaldhunga:** Tanka Bahadur Sunuwar is the house owner. He has received all tranche of private house reconstruction grant. The two room BMC one plus attic structure is features with RCC bands and seems well.

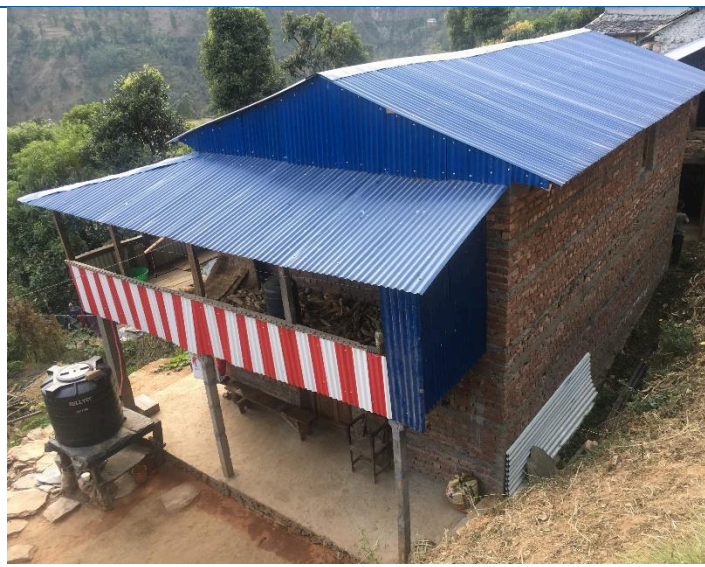
**Ward 3, Molung Rural municipality, Okhaldhunga:** Jeevan Phyual is the house owner. He has received all tranche of private house reconstruction grant. The two room BMC Two plus attic structure is features with RCC bands and flexiable roof.
