# Fortnightly District Report

## Sindhuli

1 - 14 February 2019

## Housing Typology Report

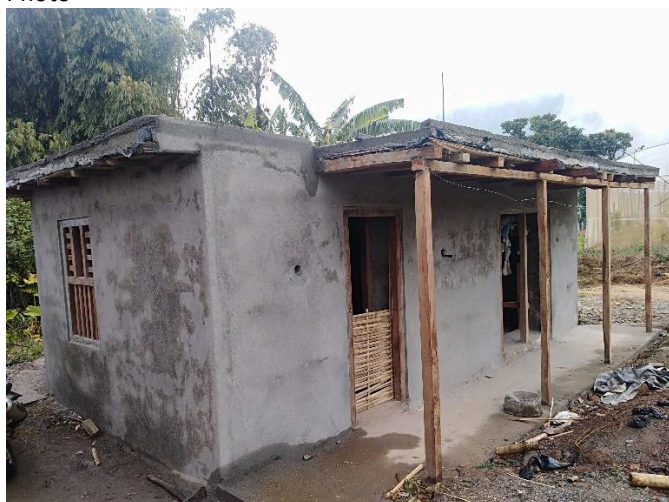
Photo

The house belongs to Mr. Rudra Bahadur Sarki, permanent residence of Bitijor ward no. 02, Golanjor Rural Municipality, Sindhuli. He has received 2<sup>nd</sup> tranche of GON housing grant. The house is constructed using Stone in Cement Masonry (SMC) with rigid floor. The house is non-compliance, since the RCC floor is casted without beam support.

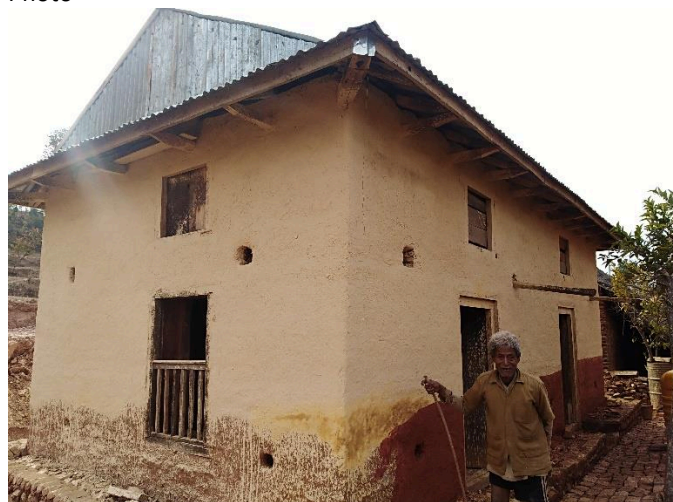
Photo

The house belongs to Mr. Tilak Bahadur Shrestha, permanent residence of Ramtar ward no. 05, Sunkoshi Rural Municipality, Sindhuli. He has received 2<sup>nd</sup> tranche of GON housing grant. Construction of the house is completed using Stone in Mud Mortar (SMM). Mercy Corps Sindhuli has provided top-up support and technical support (Rs. 50,000/-) for the construction of house.

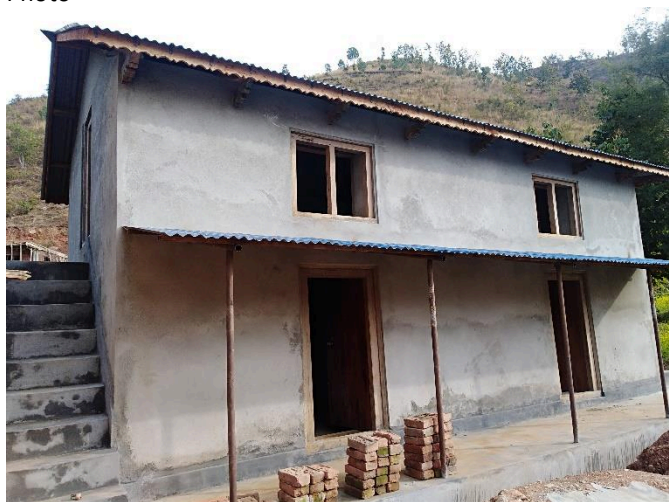
Photo

The house belongs to Mrs. Ambika Acharya, permanent residence of Ramtar ward no. 05, Sunkoshi Rural Municipality, Sindhuli. She has received 2<sup>nd</sup> tranche of GON housing grant. Construction of the house is completed using Stone in Cement Mortar (SMC) with flexible roofing. The house is non-compliant due to inadequate floor height. However, technical support was provided by Mercy Corps, beneficiary herself constructed against the technical staff's advice/suggestion.

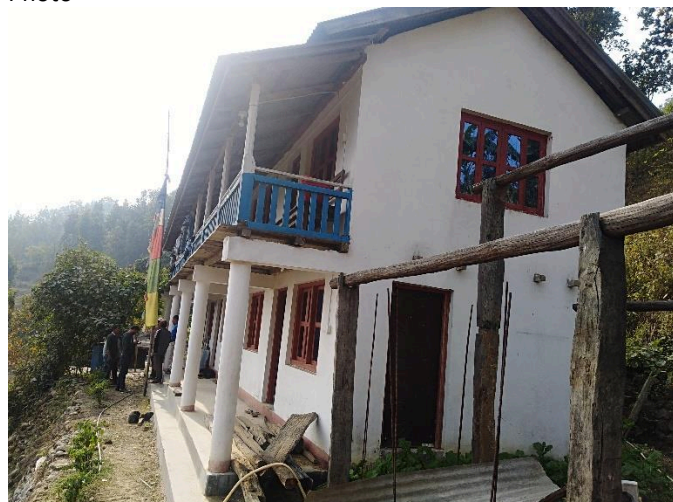
Photo

The house owner is from ward no. 06, Marin Rural Municipality, Sindhuli. He has received 2<sup>nd</sup> tranche of GON housing grant. Construction of the house is completed using Brick in Cement Mortar (BMC) with flexible roofing. The house is non-compliance due to inadequate Length: Breadth (L: B) ratio. Length of house is 45 feet and width is 13 feet, which seems length is greater than 3 times width.
