# District Report

## Kathmandu Valley

16-22 March 2018

## Field Visit Reports- Visit 1

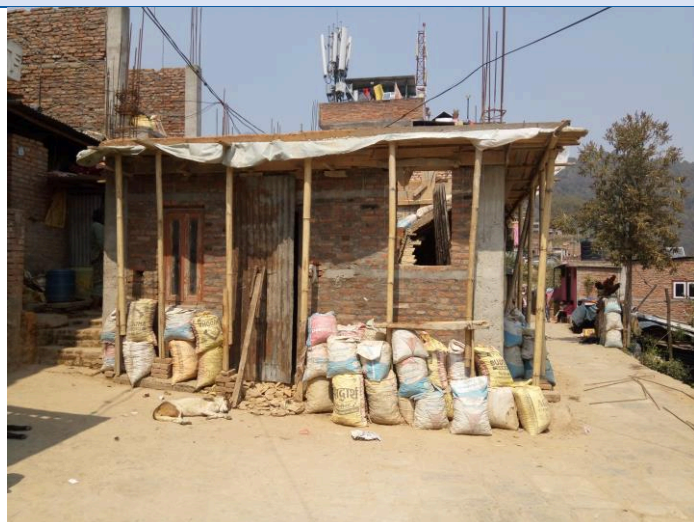
Ichangu, Halchowk, Ward No. 3, Nagarjun Municipality, RCC frame structure building. The house owner belongs to Putuwar community that stands on a firm rock structure at Ichangu, Halchowk. The house is in reconstruction phase without following the minimum requirement of national building code and the house owner does not possess building drawing map. The beneficiary has received 1<sup>st</sup> tranche.

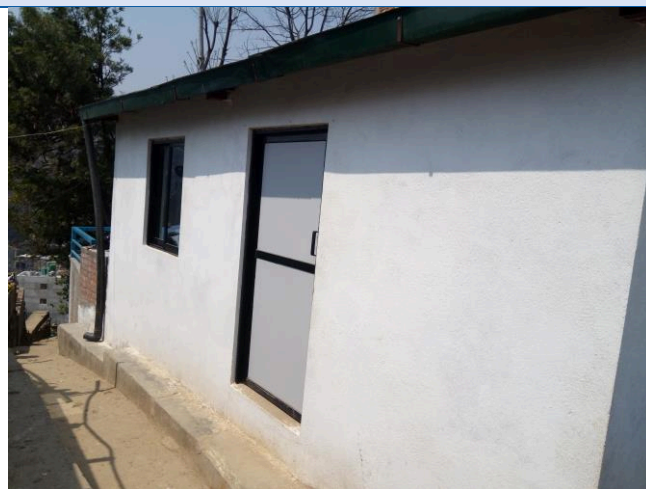
Ichangu, Halchowk, Ward No. 3, Nagarjun Municipality, BMC structure building. The house owner belongs to Putuwar community that stands on a firm rock structure at Ichangu, Halchowk. The house owner has reconstructed the house immediately after the earthquake damaged their previous building and without following the building code. The house owner does not possess approved building drawing. The beneficiary has received 1<sup>st</sup> tranche.

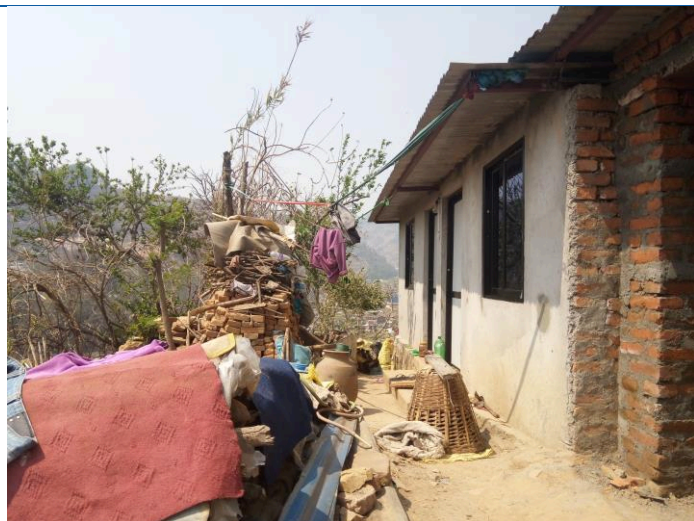
Ichangu, Halchowk, Ward No. 3, Nagarjun Municipality, BMC structure building. The house owner belongs to Putuwar community that stands on a firm rock structure at Ichangu, Halchowk. The house owner has received the 2<sup>nd</sup> tranche.

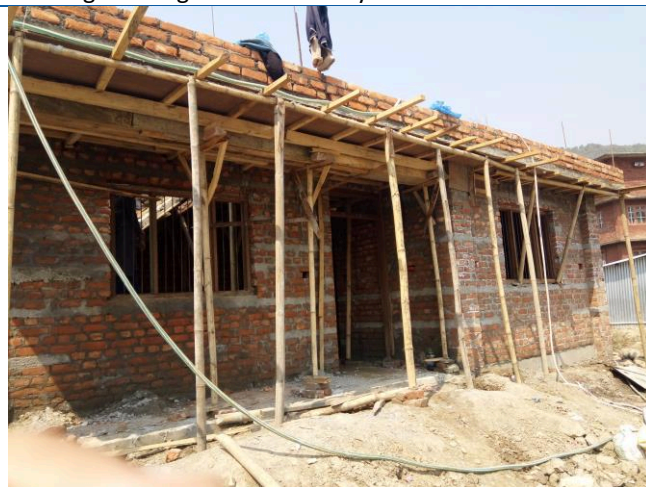
Ramkot, Fakshu, Ward No. 2, Nagarjun Municipality, BMC, wall system building. The house owner has forwarded file for 2<sup>nd</sup> tranche whereas the building drawing is under process. The house is compliance according to the building guidelines.

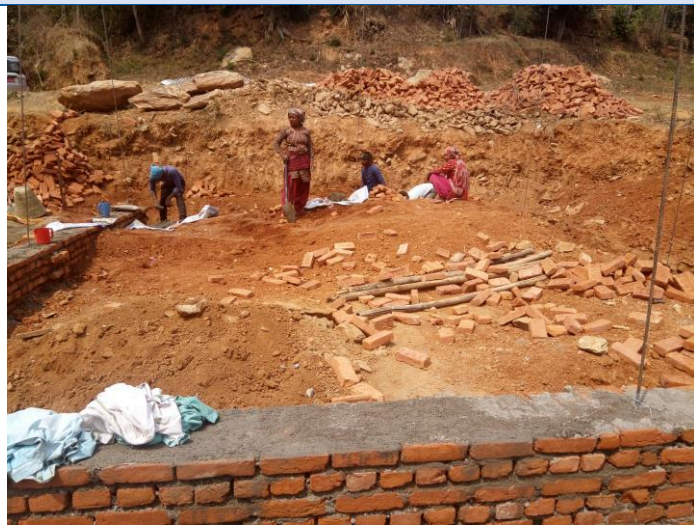
Dahachowk, Ward no. 1, Chandragiri Municipality, BMC structure, 3-room house targeted for wall system with CGI sheets as roof. The house owner do not possess building drawing map. The beneficiary has received 1<sup>st</sup> tranche.

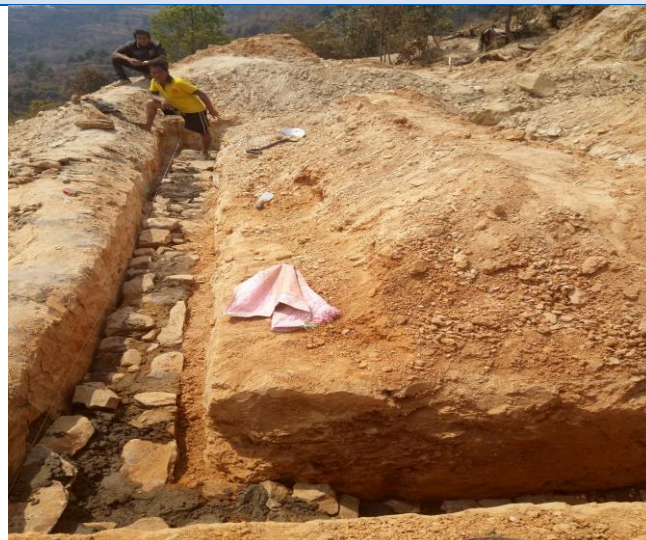
Dahachowk, Ward no. 1, Chandragiri Municipality, SMC structure at DPC level. The house owner do not possess approved building drawing. The beneficiary has received 1<sup>st</sup> tranche.

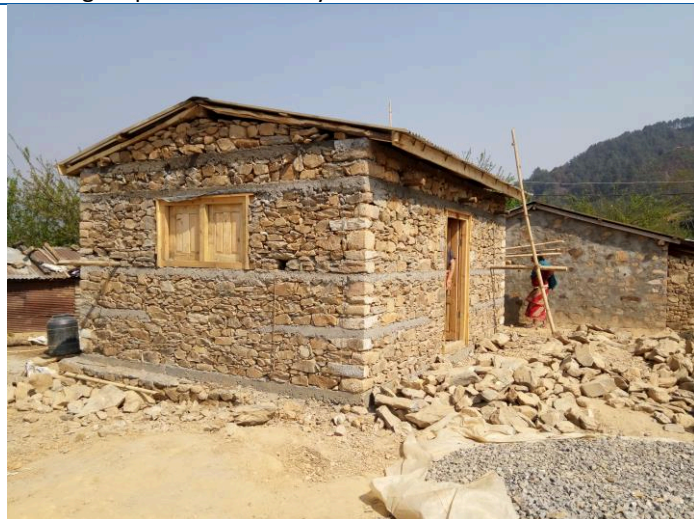
Jhyangajhiti, Ward no. 1, Chandragiri Municipality, SMC structure building with CGI roof. 1 room house having an area 140 sq km is found to have met the minimum requirements of national building code. The house owner were recommended to keep either RC band or replace the gable wall with CGI sheet in order to receive 2<sup>nd</sup> tranche.

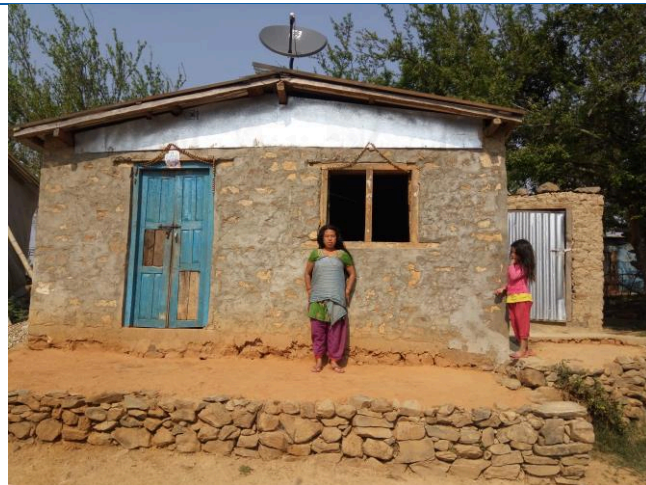
Jhyangajhiti, Ward no. 1, Chandragiri Municipality, SMC structure building with CGI roof. The house were reconstructed without following minimum requirements of national building code and the owner do not possess building drawing. The owner were recommended to follow retrofitting procedures from the concerned municipality in order to receive 2<sup>nd</sup> tranche.

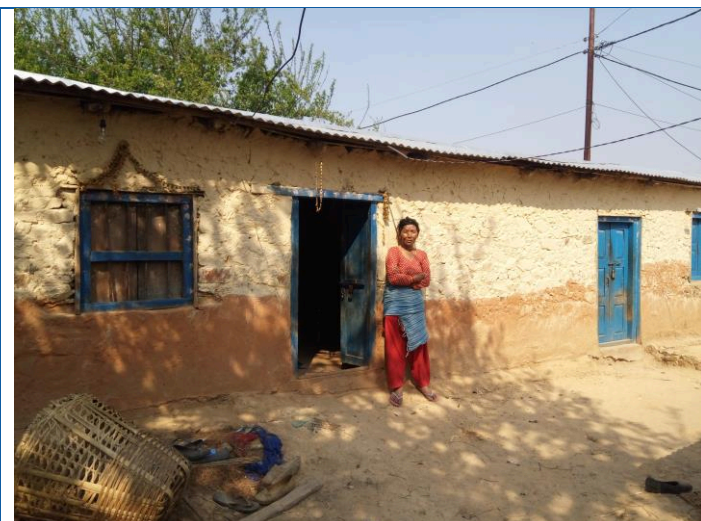
Jhyangajhiti, Ward no. 1, Chandragiri Municipality, SMM structure building with CGI roof. The house were reconstructed without following minimum requirements of national building code and the owner do not possess building drawing. The owner were recommended to follow retrofitting procedures from the concerned municipality to receive 2<sup>nd</sup> tranche.

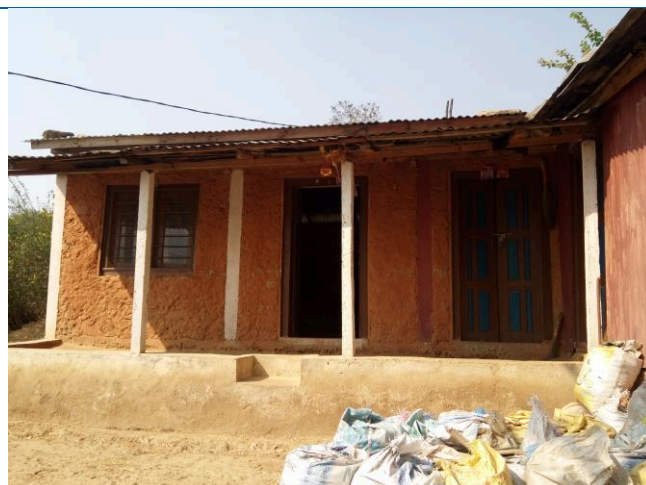
Jhyangajhiti, Ward no. 1, Chandragiri Municipality, SMM structure building with CGI roof. The house were reconstructed without following national building code and the owner do not possess building drawing. The owner were recommended to follow retrofitting procedures from the concerned municipality to receive 2<sup>nd</sup> tranche.
