# Fortnightly District Report

## Kathmandu Valley

1 – 14 February 2019

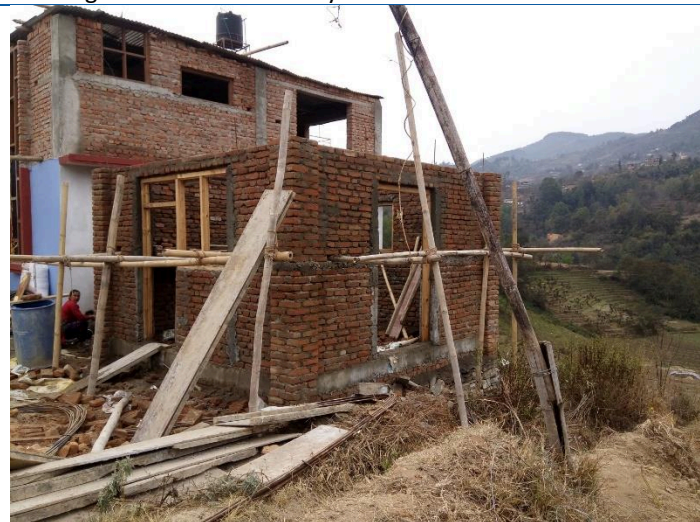
Beneficiary name: Laxman Rimal, Ward no .7, Yutiki, Dakshinkali Municipality. Single storey 1 room BMC house with CGI sheets has missed majority of bands. Beneficiary has received 1st tranche only and were suggested to keep bands to become eligible for further tranches.

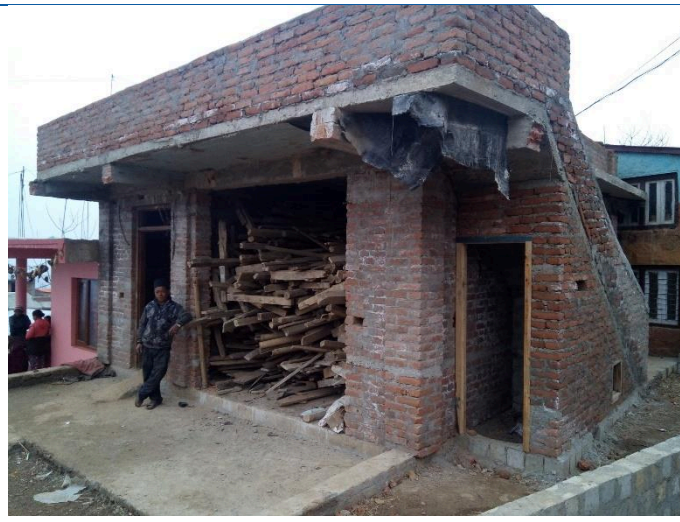
Beneficiary name: Kale Nagarkoti, Ward no. 1, Champadevi, Dakshinkali Municipality. Single storey BMC structure has 2 rooms with rolling shutters. M & E consultant has suggested to keep I- beam on two sides of shutters to make the structure safe. The beneficiary has received up to 2nd tranche from government.

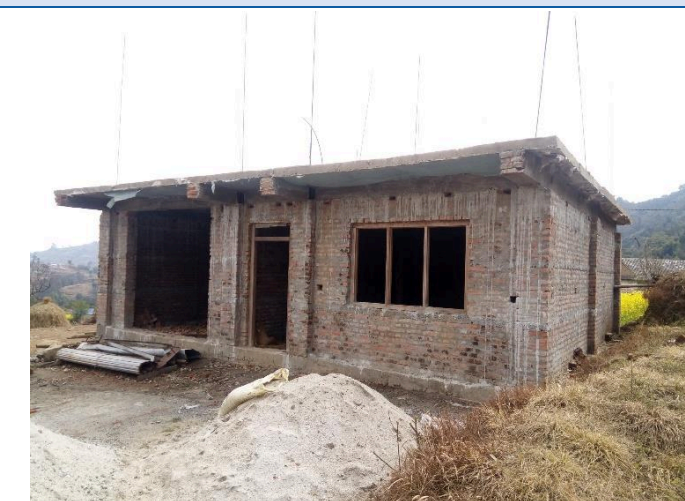
Beneficiary name: Gyanu Lama, Ward no. 3 Jaharsinghpauwa, Shankharapur Municipality, Kathmandu. Single storey, 4 roomed BMC house has plan to keep 1 rolling shutter. The beneficiary has received up to 2<sup>nd</sup> tranche. M & E consultant have suggested beneficiary to keep reinforcements and to do casting of 4 inch on two sides each to be eligible for the grant.

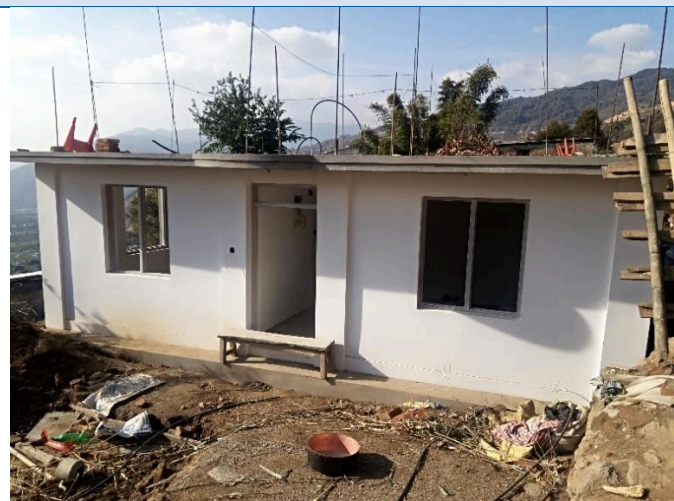
Beneficiary name: Biman Moktan, Ward no. 8, Moktan Tole, Bajrayogini, Shankharapur Municipality, Kathmandu. 4 roomed BMC house has approved building drawing up to 1<sup>st</sup> storey only. Beneficiary has received up to 2<sup>nd</sup> tranche. M & E Consultant have suggested this house as complaint house and is eligible for 3<sup>rd</sup> tranche too. Beneficiary were suggested not to add another storey.

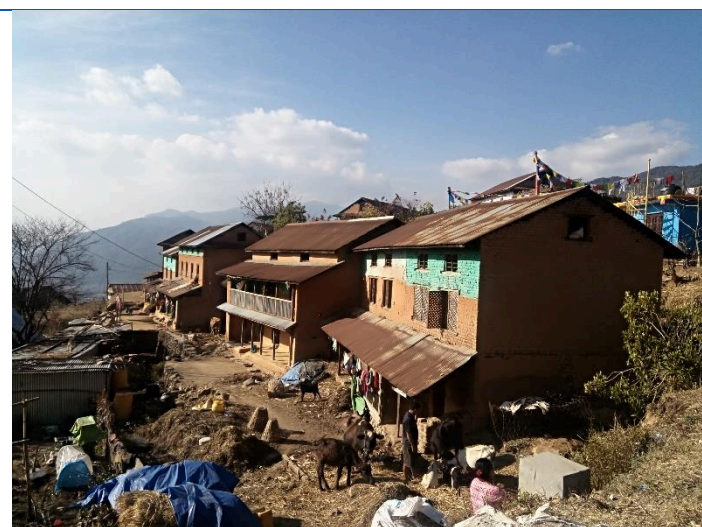
Ward no. 8, Moktan Tole, Bajrayogini, Shankharapur Municipality. Out of 591 beneficiaries of Ward no .8, around 60-65 houses belong to beneficiaries of Moktan Tole. 2015 Gorkha Earthquake had damaged most of the BMM 2 storey with attic houses in Moktan Tole. Majority of beneficiaries of Moktan Tole have received 1st tranche however very less have started reconstruction of their houses. Few beneficiaries have accessed up to 3rd tranche while few of them have submitted documents for 2nd and 3rd tranche together.

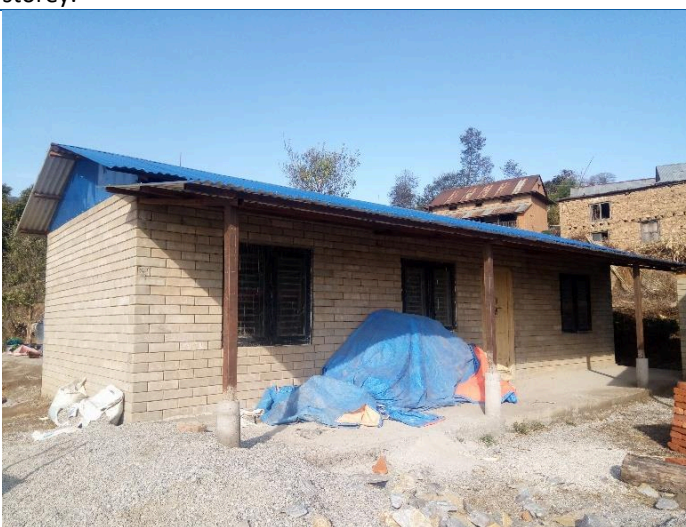
Beneficiary name: Som Maya Tamang, Ward no. 8, Moktan Tole, Bajrayogini, Shankharapur Municipality. 3 roomed single storey house is made of interlocking bricks with CGI roof. Beneficiary has accessed up to 2nd tranche. M & E Consultant have suggested this house as a complaint house and is eligible for 3rd tranche too and thus informed ward engineer to forward documents for 3rd tranche approval.

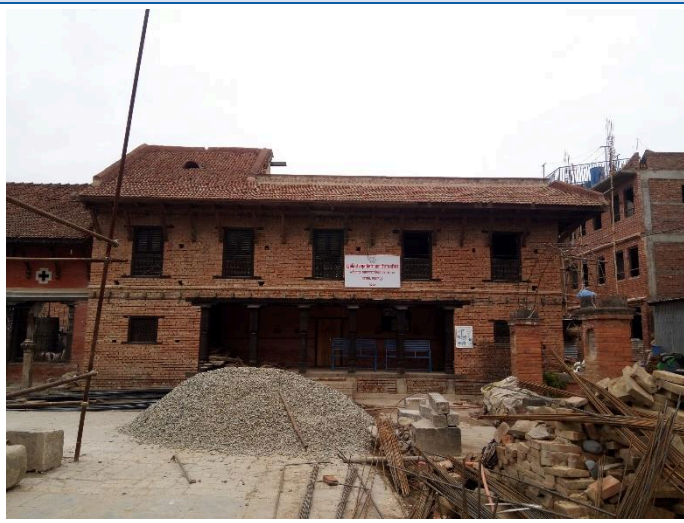
| The reconstruction and restoration project of the Rato Machhindranath Temple located at Ward no. 22 Bungamati, Lalitpur Metropolitan City is underway. Government of Srilanka is providing support for reconstruction of culturally important heritage monument. NRA is directly coordinating | | Photo: The reconstruction of <i>Satta</i> - in Nepali (religious houses in English) was supported by UN-Habitat after it was damaged by the 2015 earthquake. Cultural authenticity of this culturally important religious house was maintained during its reconstruction process. Bungamati Area Reconstruction | |

with Bungmati Area Reconstruction Development Committee (BARDEC) for reconstruction of Bungamati temple as well as regeneration of other heritage monuments.

Development Committee (BARDEC) has set up its contact office in the 2<sup>nd</sup> floor of the *Sattal*.

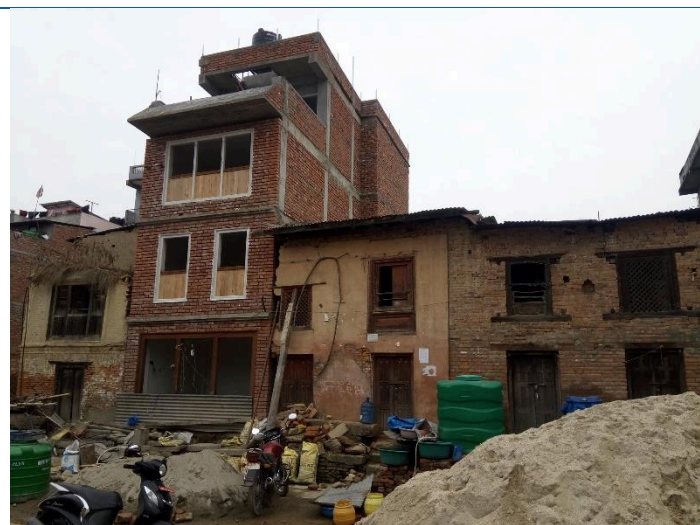
This house on reconstruction process is standing alone in between the earthquake damaged BMM houses on same row at Ward no. 22 Bungmati, Lalitpur Metropolitan City. The earthquake damaged houses belongs to multiple beneficiaries who are still residing in temporary shelters.

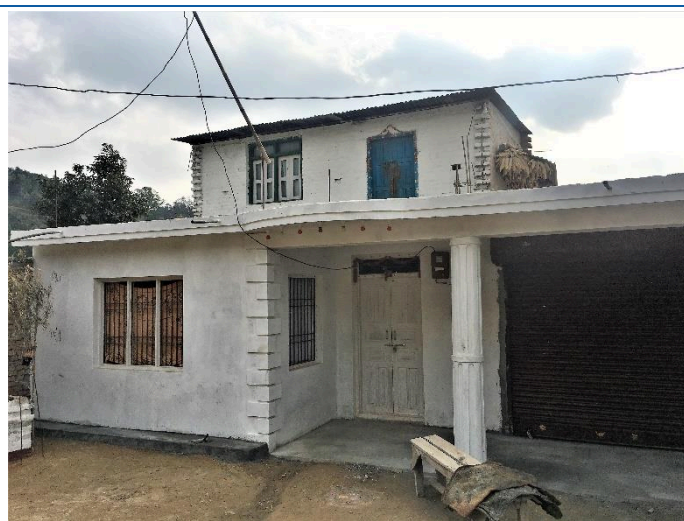
Beneficiary name: Ajay Khadka, Ward no 10, Suryabinayak Municipality. Load bearing wall system BMC house, single storey with 14 inch and with rolling shutter with proper connection.
