## Monthly District Report

Solukhumbu, Okhaldhunga, Khotang

9 May - 13 June 2019

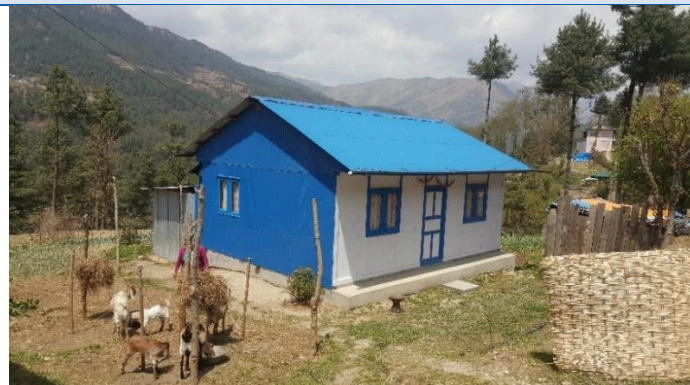
Solu Dudhkunda Municipality ward-6, Dorpu Solukhumbu : Chabinarayan Rajbhandari he has built this two roomed single storey house immediately after the earth quake the house is built providing foundation of stone in mud mortar and walls of wooden planks with column of wood and the design has been approved by the Municipality asper house owner. No any horizontal bands have been provided the beneficiary has already received all three tranche of government and waiting for the completion certificate. As per the engineer of NRA most of the houses are of same typology in that area.

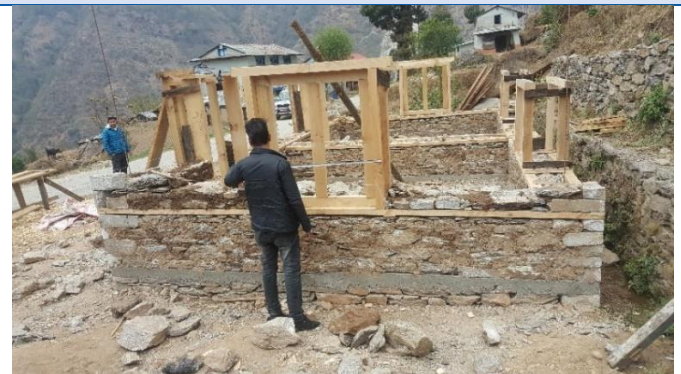
Thulung Doodhkoshi RM ward no 1 Nele Solukhumbu :Bhesh Bahadur Karki house under construction with RCC band at the plinth level and wooden bands at the wall and the vertical bar used is of 12 mm only due to lack of technical assistance.evethough the engineer has visited that house twice till now The Beneficiary has received first and second tranches.

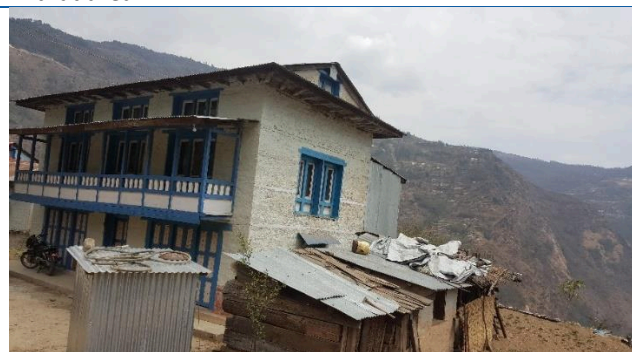
*Thulung Doodhkoshi Rural Municipality ward no 1 Nele Solukhumbu: Lalit Bahadu rai: Non-compliance two storey house constructed on stone mud mortar typology and corrections to be made based on correction/exception manual. Beneficiaries are not interested to do correction as they have finished their construction and blaming government for not providing technical assistance during construction period. The beneficiary has already received his first tranche from the government.*

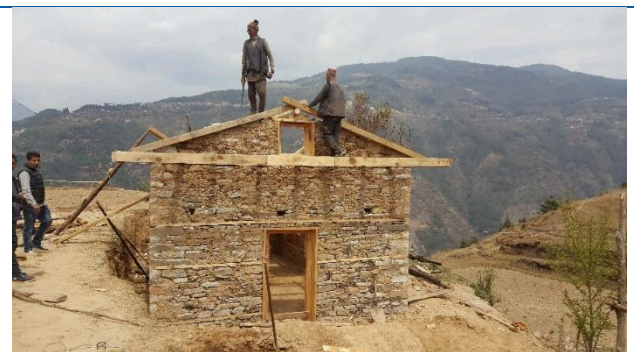
*Thulung Doodhkoshi RM ward no 1 Nele Solukhumbu: Gyan Bahadur Khadka: Under construction This stone mud-mortar house is about to complete without any inspection and is noncompliance due to more attic height. There was no any inspection and the beneficiary built the house as per his own knowledge learned from the radio program. He has no idea about the engineers it is clear that the house is noncompliance due to lack of technical assistance. Beneficiary has received first tranche.*

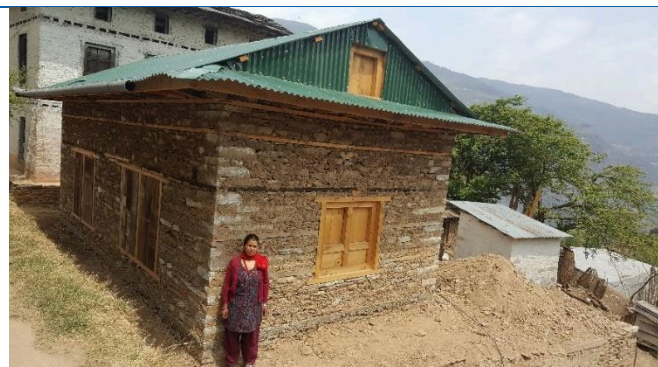
Thulung Doodhkoshi RM ward no 1 nele Solukhumbu:Kirti Bahadur Thapa : this house has been completed about 3 month ago without any technical assistance from the government. The house is noncompliance due to higher percentage of opening. Beneficiary has received first tranche and waiting for the second and has no idea about this second tranches. Suggestion from the beneficiary was if government cannot send the technical person in the village to prevent other houses form being noncompliance please provide one model house in each ward which will be compliance so that other beneficiary themselves can learn from that house and could built compliance house learning from that even without technical support.

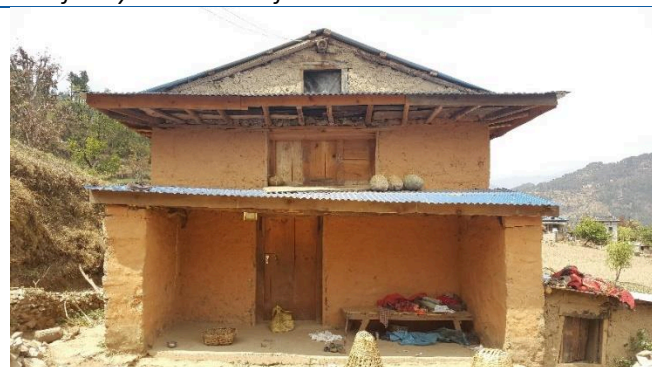
Thulung Doodhkoshi RM ward no 1 Nele Solukhumbu :Rajendra tamang: Build this house one after the earthquake he waited for the government for one year leaving in tent house since his house was completely collapsed after the earthquake of 2015. House is built with stone in mud mortar and is noncompliance since the attic height and the opening in the first floor is not appropriate. The beneficiary has already received first trance and waiting for the second hoping that for those house which were build already will receive other tranches without any correction. As per the Beneficiary the cost of construction of this house was 5 lakhs.
