# High Altitude Problems, Research Findings and Recommendations

**HRRP Meeting**

**02 April 2017**

**Ramesh Guragain, PhD**  
**Deputy Executive Director, NSET**  
**Program Director, Baliyo Ghar Program**

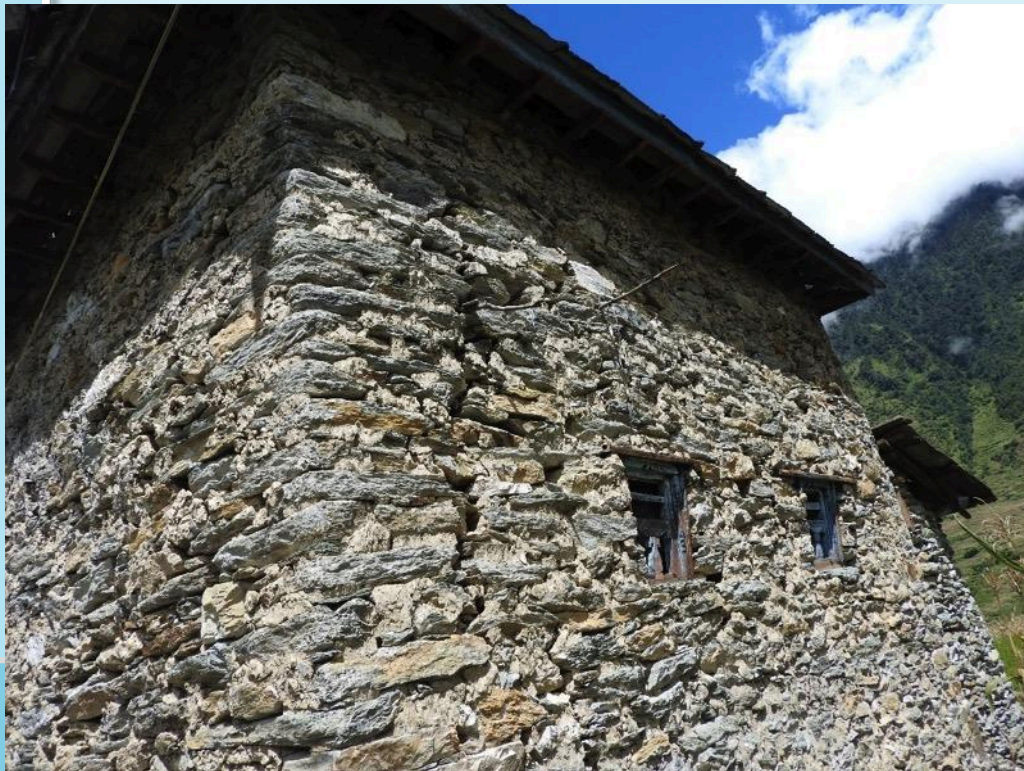
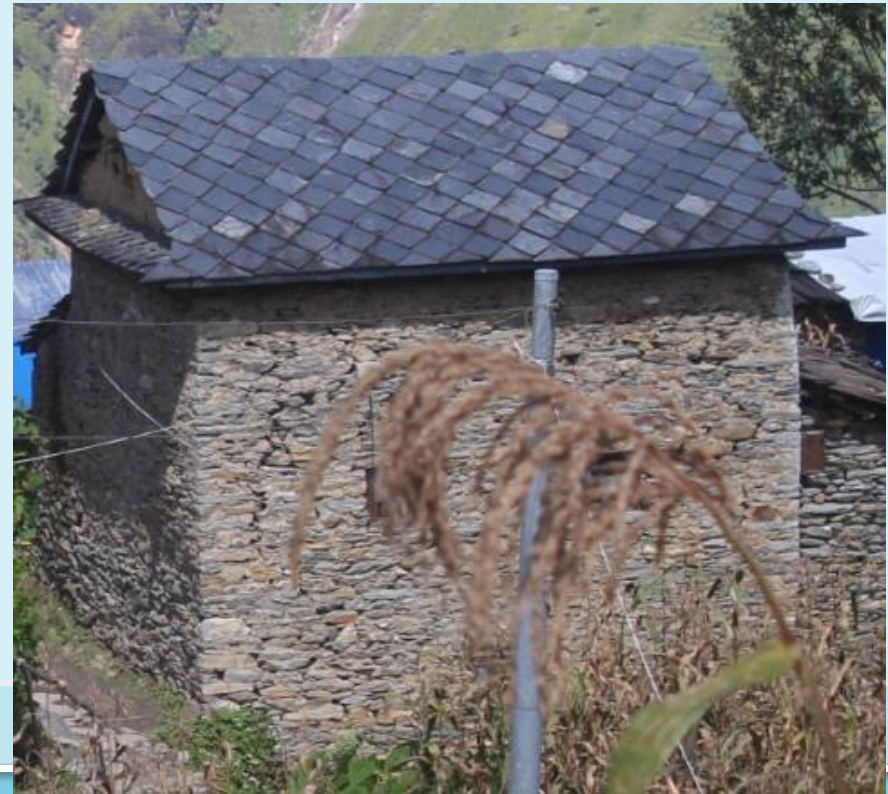
# Existing Building typologies

- Dry Stone masonry or Stone in mud buildings with heavy Stone roofs
- Presence of corner stones

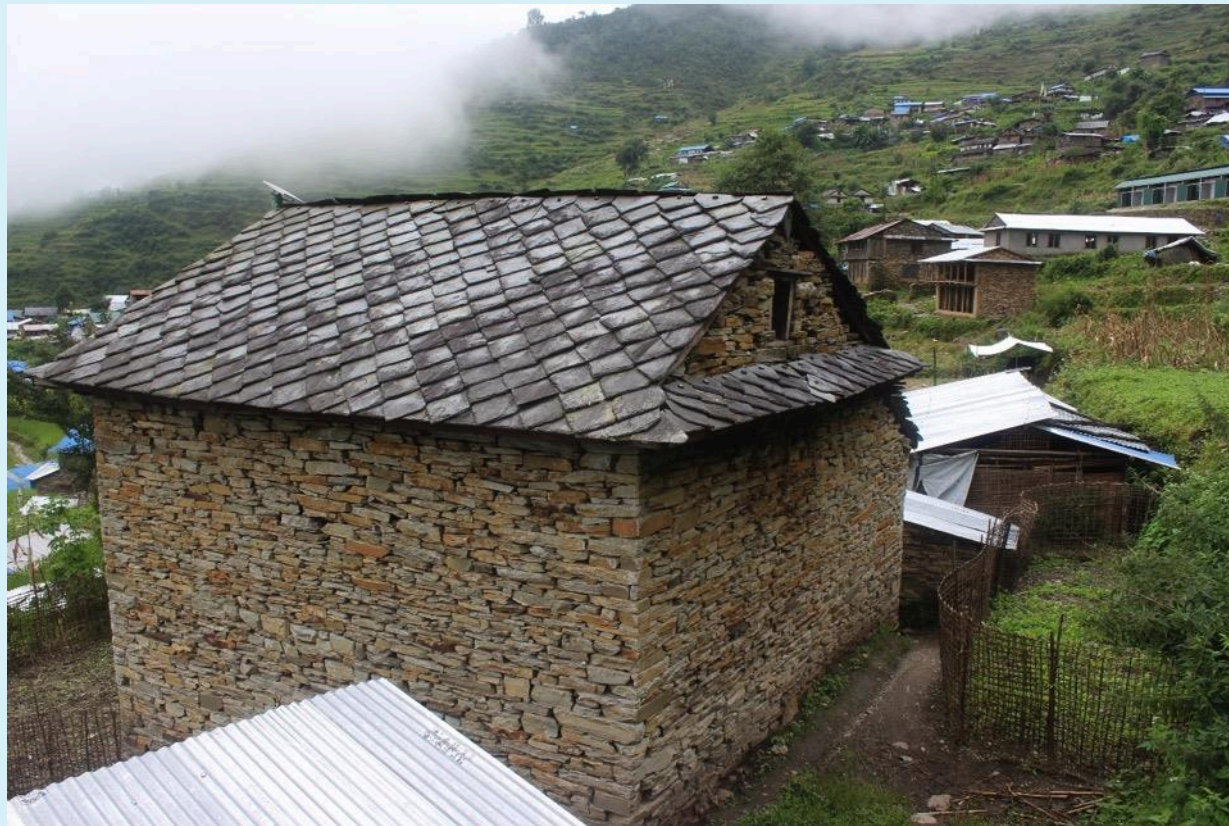
# Existing Building typologies

- No other Earthquake Resisting Element

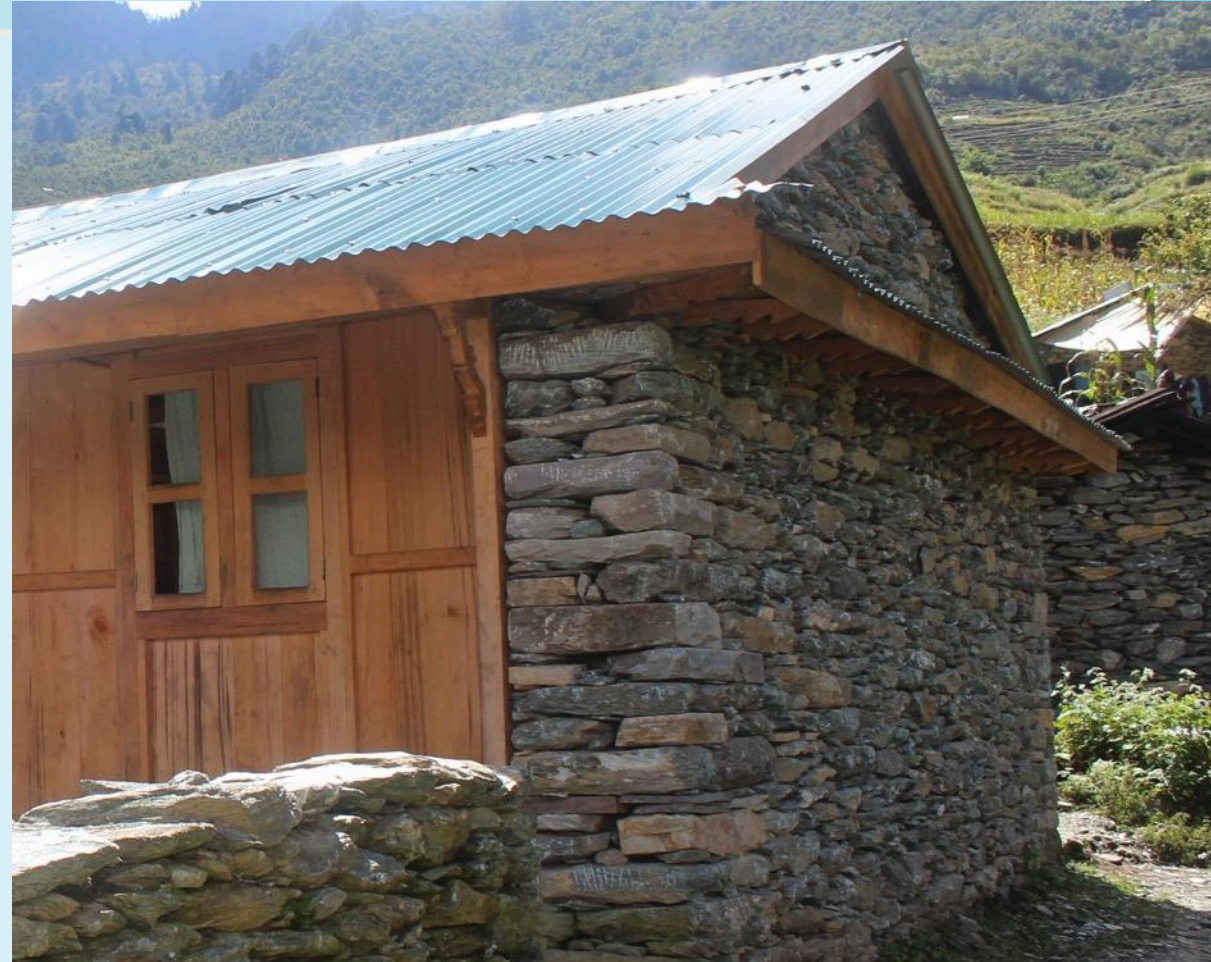
# New Building typologies

- Dry Stone masonry with light CGI sheets
- No earthquake resisting elements
- Presence of corner stones
- Use Gable wall

## New Construction after Earthquake

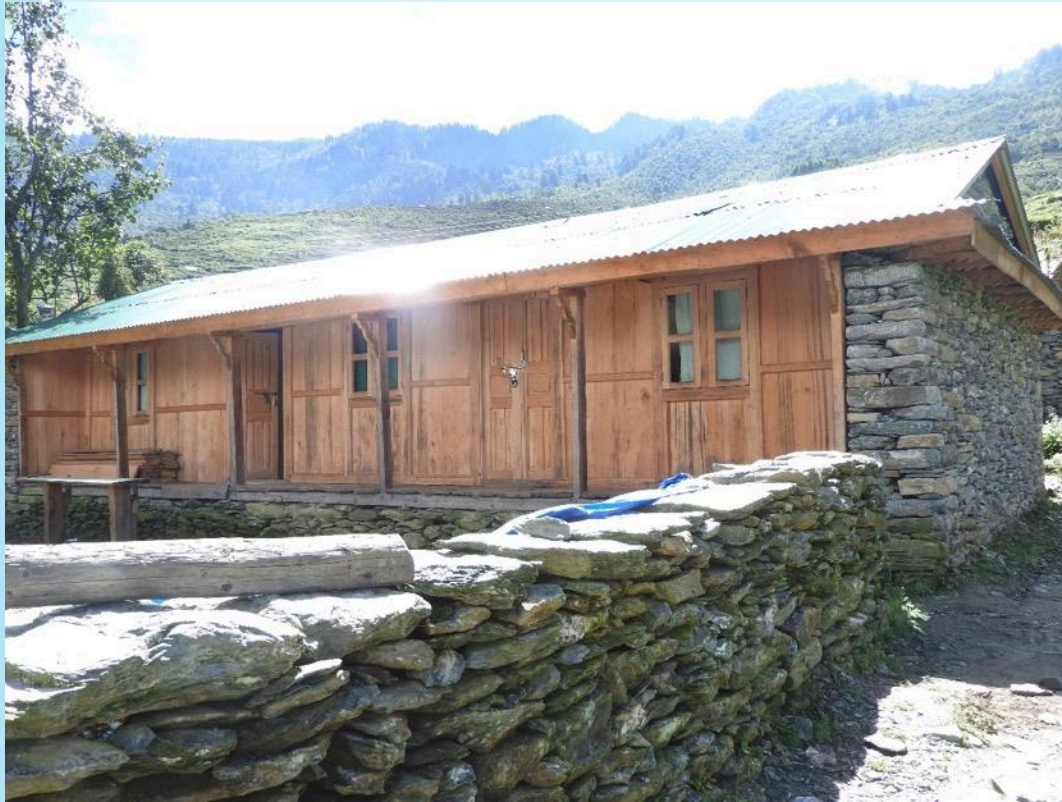
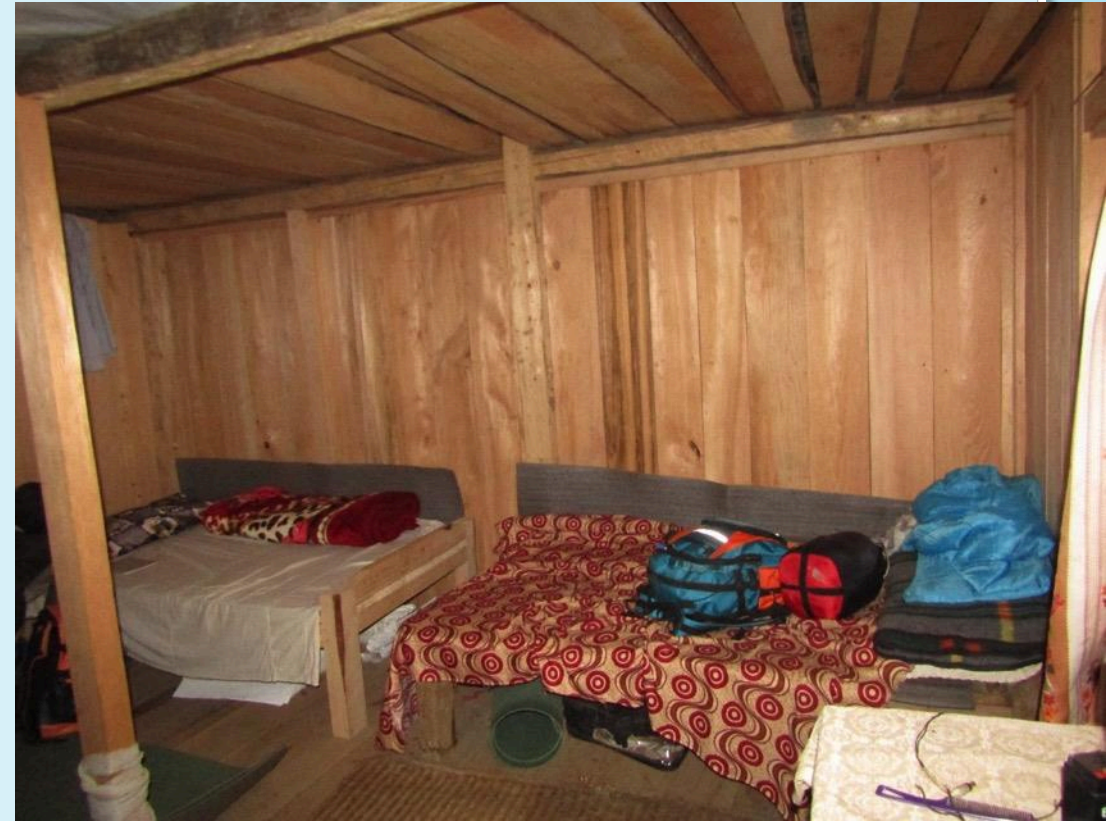
# New Building typologies

- Timber walls at the front part and inner side of all stone walls

**Many Buildings!**

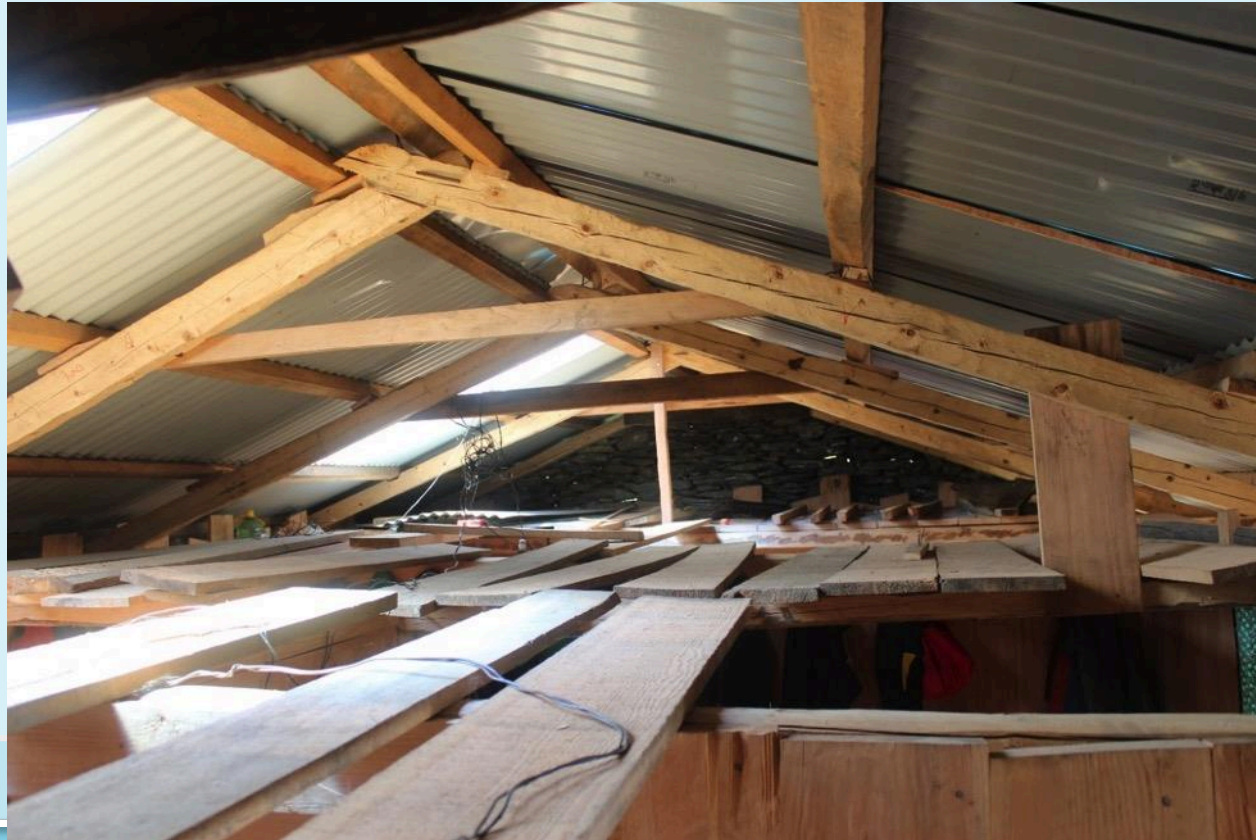
# New Building typologies

- No proper connection of ridge beam, rafter and bottom chord
- No proper connection of roof elements with wall

- Hence instead of placing timber inside the wall in bands and vertical elements, it can be placed on outer faces of wall on both side and then connect them with gabion wires or steel bolts
- But it requires wider technical discussions to finalize
- This new system should be included in policy documents or checklist also
- The connection of roof timber elements with each other and with the wall also needs to be improved

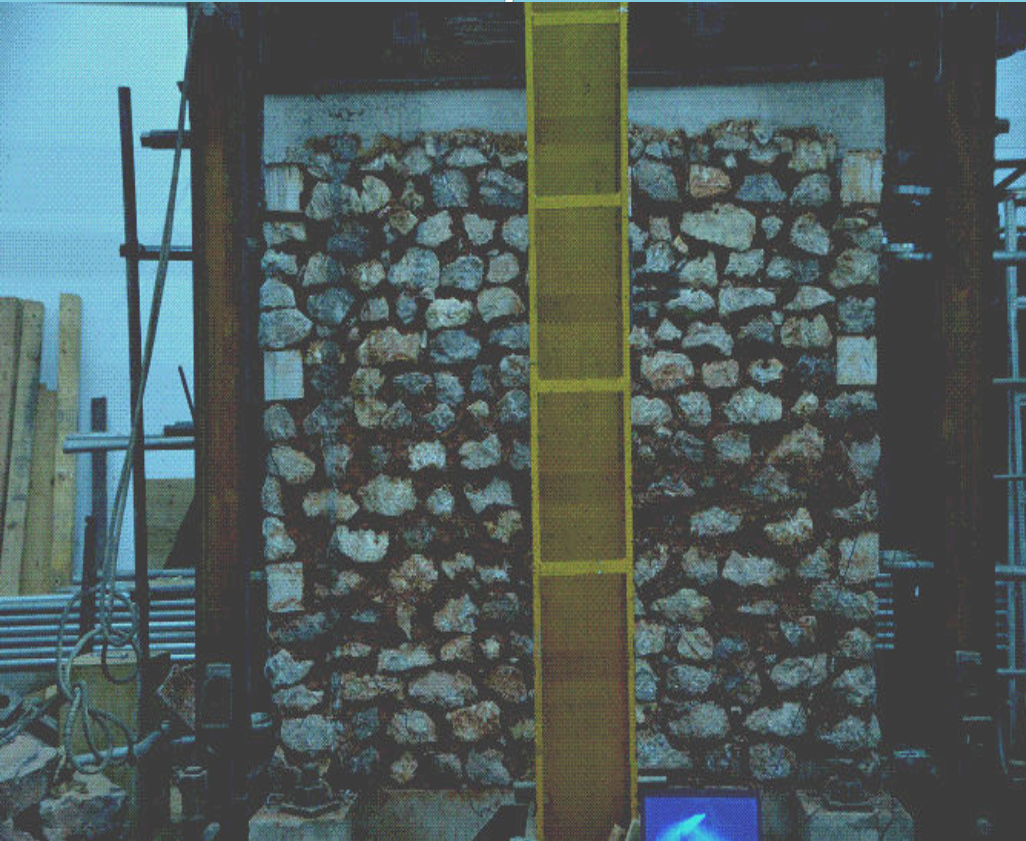
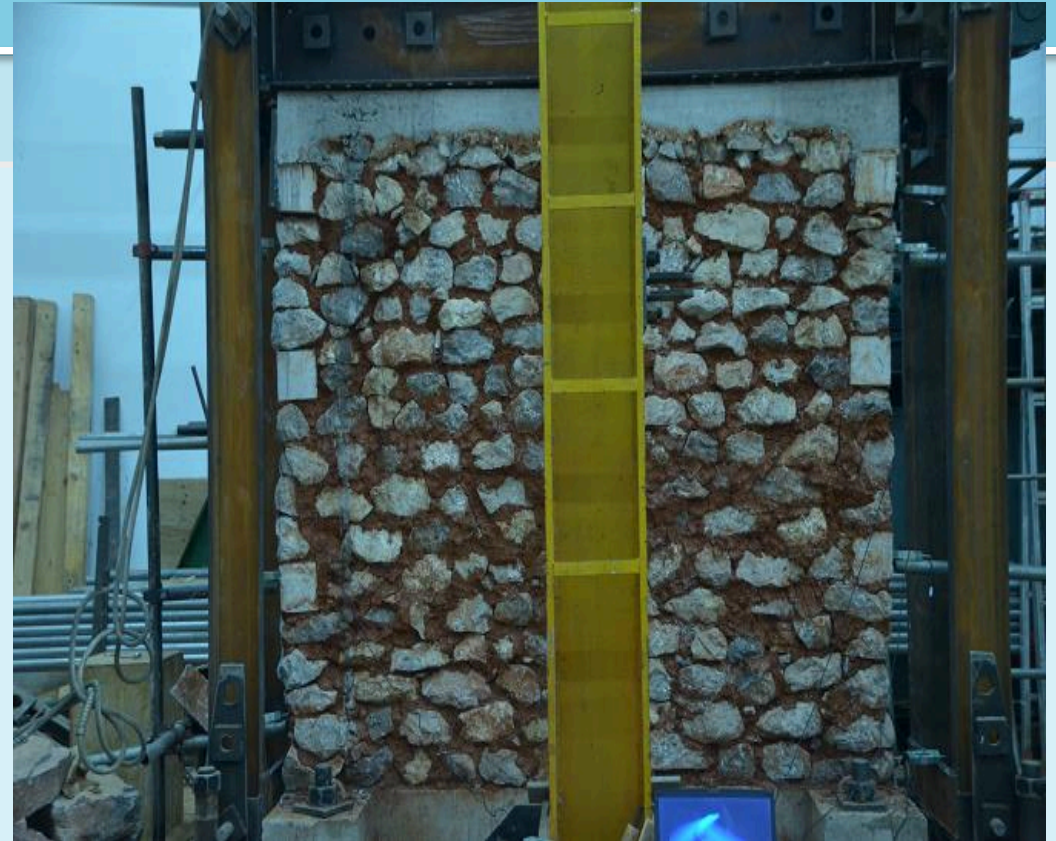
## Progress: Test #1: Round Stone wall test

Movement of the wall at a ultimate displacement of 32mm

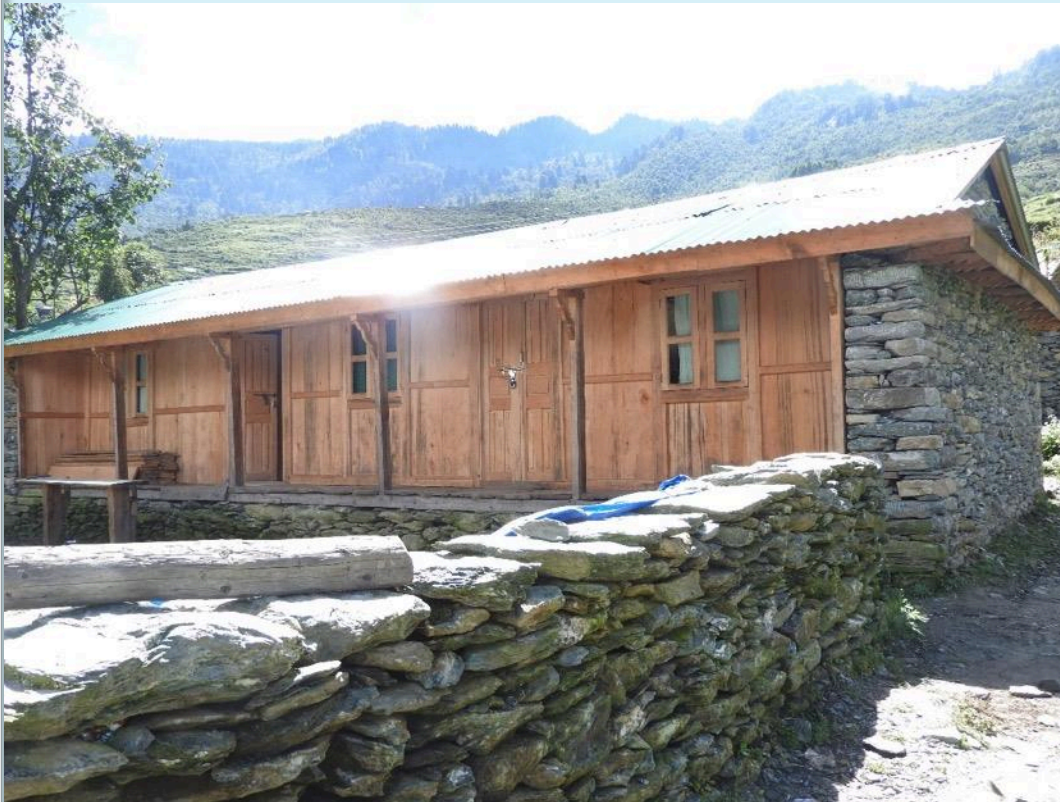
# New Building typologies

- Timber walls at the front part and inner side of all stone walls

**Timber Plank s from Inside is Common**

- To increase the longevity of those soft timbers, protect the timber by seasoning, drying or using bitumen based paint
- Even then, in 10 or 15 years period time, the timber will get decayed. So, the other idea is to replace the timbers after it gets decayed
- Timber can be used as timber frame in such a way that they can replace it periodically
