# District Report

## Okhaldhunga

19 – 22 February 2018

## Housing Typology Report

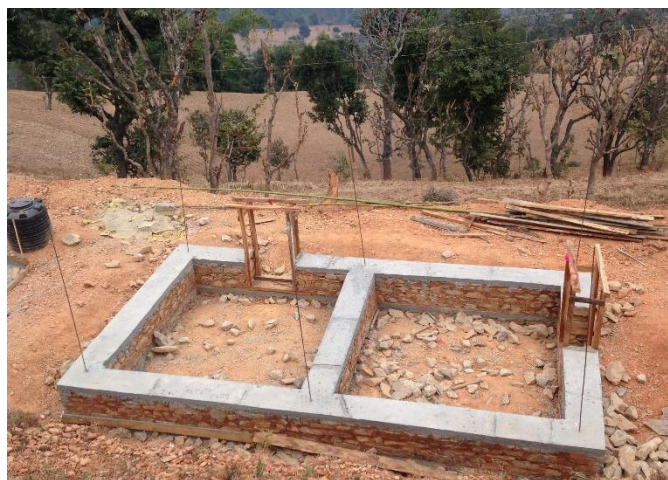
**Ward 3, Chishankhu Gadhi Rural municipality, Okhaldhunga:** Dhanapati Dhungana is the house owner. He has only received the first tranche and forwarded the file for the second tranche. The stone masonry structure in mud mortar is in progress of rapid construction, some problem on transportation of materials and scarcity of the labor are the main obstacles for the construction said mr. Dhungana.

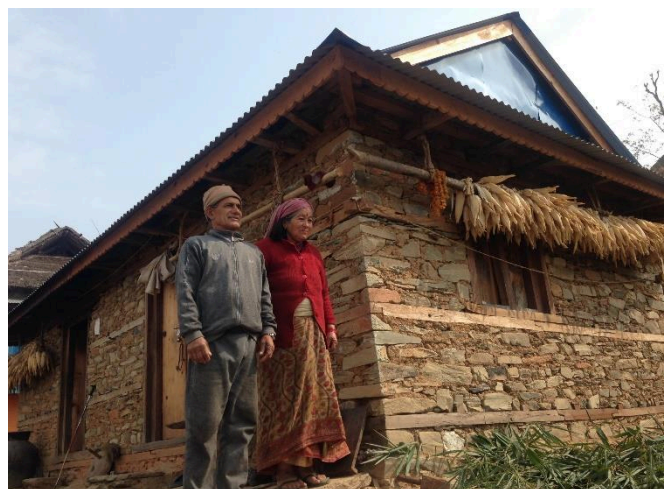
**Ward 3, Chishankhu Gadhi Rural municipality, Okhaldhunga** : House owner is Dhruyodhan Karki. He has received third tranche. The stone masonry structure with wooden band is the first house constructed in this ward. Mr.Karki is happy with the technical monitoring and guidance provided by the NRA engineer. Only he is afraid on how to protect the wooden band from water and termite. We suggest him to use enamel paints or black tar.

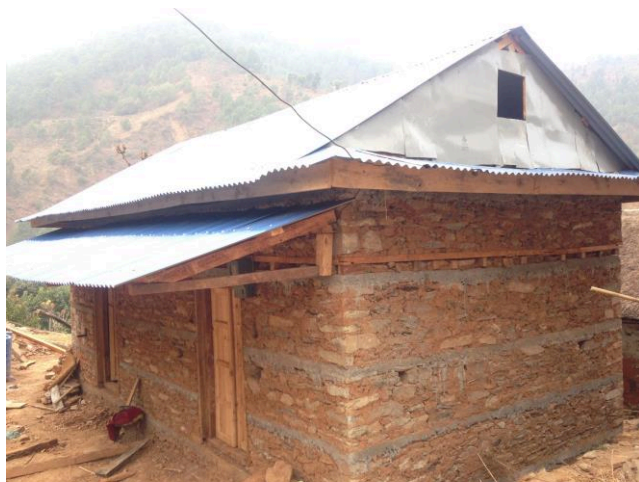
**Ward 3, Chishankhu Gadhi Rural municipality, Okhaldhunga:** The owner of the house Govinda Parsad Dhungana. The house is almost completed the construction procedure and eligible for the third tranche but he could not even receive second tranche. We asked him why he did not receive the second tranche yet, he said that there is problem in PA number and the name corresponding to the Pa number. The second tranche of Dhungana is transferred to the person Sher bahadur magar who is not a respondent beneficiary to receive the Tranche. Knowing all the problem we transferred this problem to NRA Oghaldhunga for further help

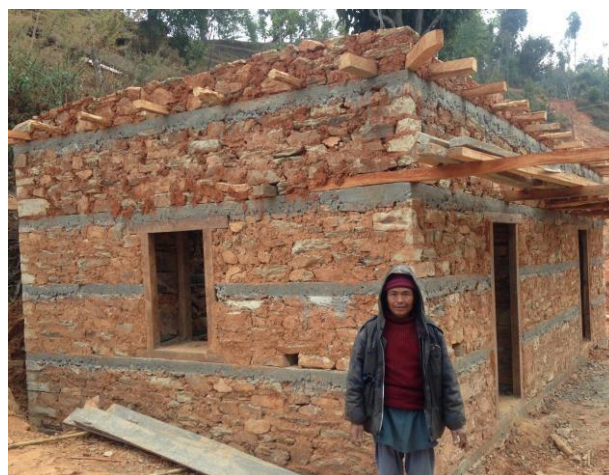
**Ward 3, Chishankhu Gadhi Rural municipality, Okhaldhunga:** Harka Bahadur Magar is the house owner. He has received Second tranche. The stone masonry structure in mud mortar is in progress of completion and only the roof band is remaining before placing the roof.
