## District Report

### Gorkha

4 – 17 January 2019

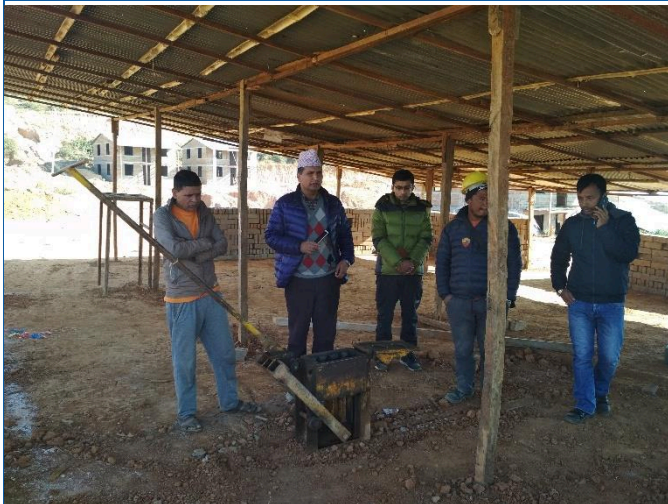
Caption: Er. Ram Sharan Acharya, Chief, GMALI Gorkha, interacting with local people and mobile mason of EHRP JICA regarding CSEB construction.

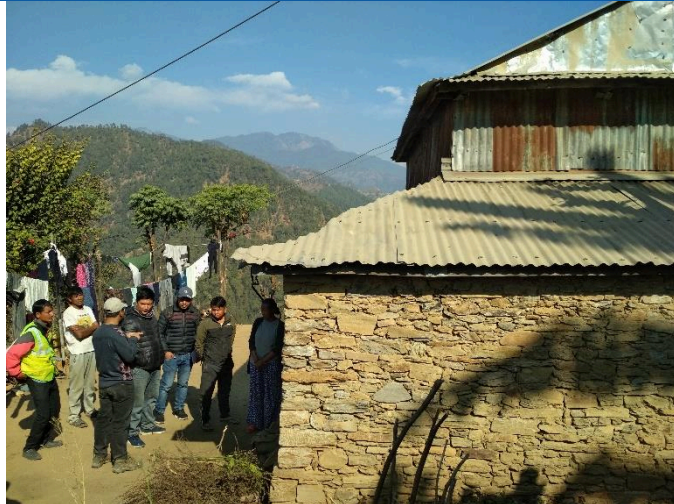
Caption: Joint monitoring team taking background information about the house (owner Suraj Singh Wasti) to know about the details of key components of house.

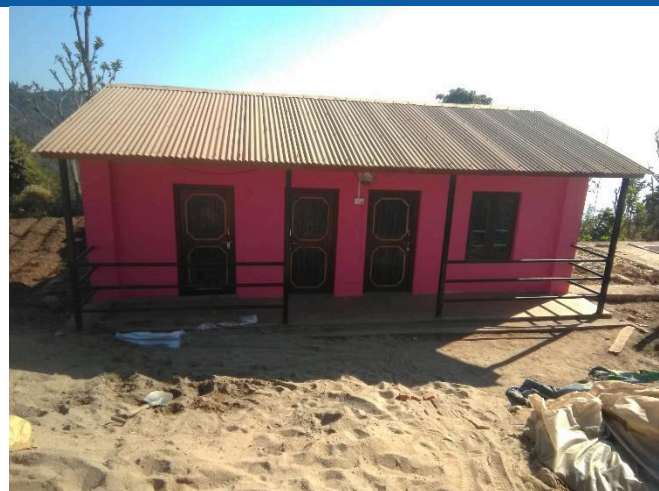
Caption: Shiva Lal Shrestha's brick masonry cement mortar house in Gandaki rural municipality ward no. 6, Bhumlichowk. The house owner has received all tranches.

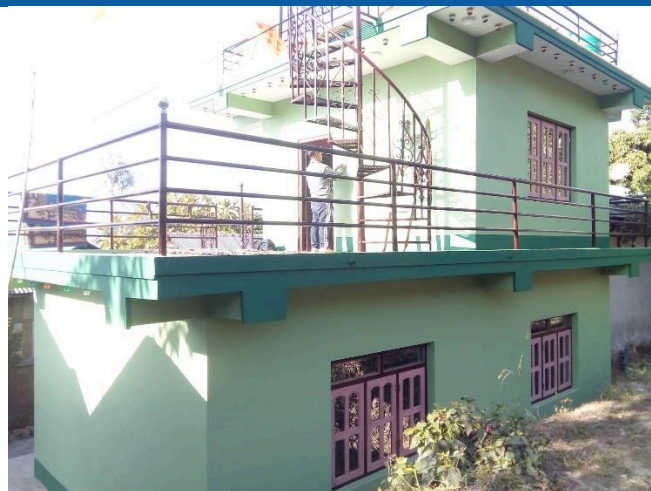
Caption: Chandra Man Shrestha's RCC house in Gandaki rural municipality ward no. 1, Makaisingh. Tranche status of the house unknown.

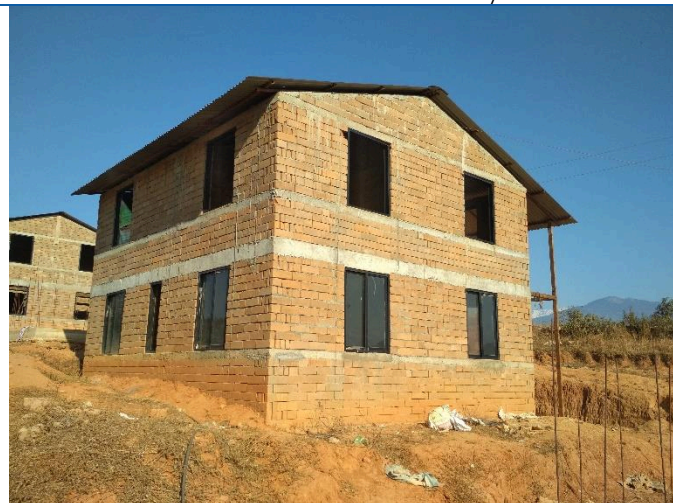
Caption: 2 story houses in integrated settlement of Milan Basti in Bhimsen Thapa rural municipality, ward no. 5, Baguwa. Name of the house owner and tranche status unknown. This house has been constructed with CSEB blocks with RCC band.

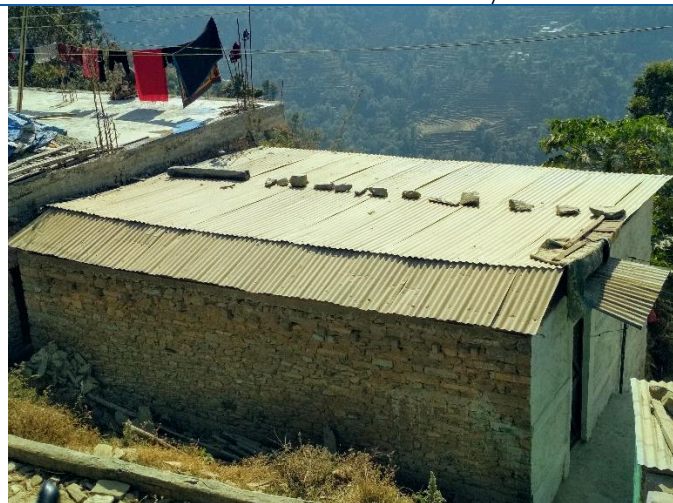
Caption: Yogendra Bhatta's stone masonry mud mortar house in Bhimsen Thapa rural municipality ward no. 1, Masel. The house is constructed without any bands and vertical reinforcement. This house has been forwarded for structural analysis and the house owner has not received second and third tranche.

| Challenges / Issues Identified | Action Required | Responsible | Time Frame |
|---|---|---|---|
| Correction of non-complaint houses | Need to do structural analysis and based on the report do correction if necessary | DLPIU Building and DSE | As soon as possible |

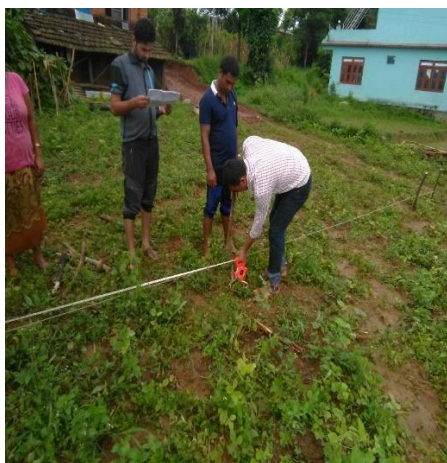
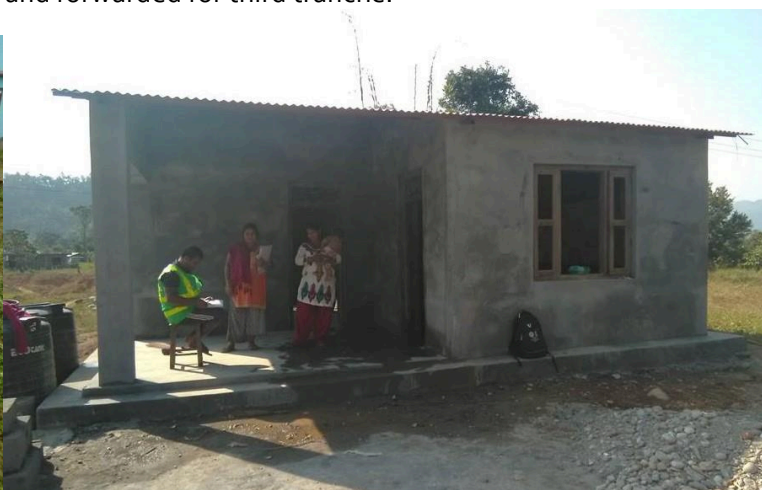
Parbati B.K's house at Layout stage and Present stage
