Housing Recovery and  
Reconstruction Platform

# 18 Moderately Affected Districts

Updated Overview, July 2018

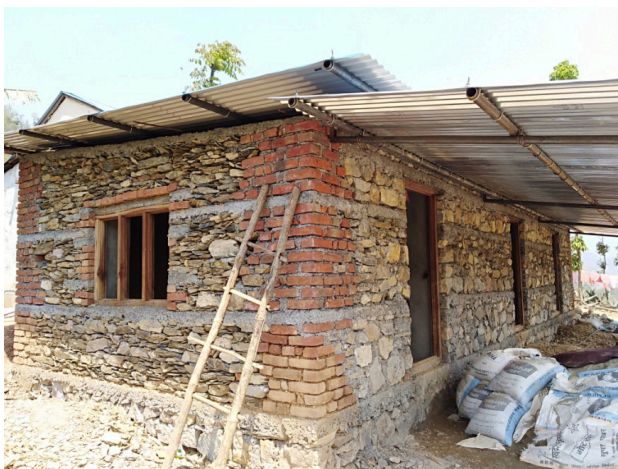
**Santoki Kumar, Sandhikhark 7, Markakhola, Arghakhanchi:** hybrid structure with stone and brick masonry and a mix of mud and cement mortar. The owner brick masonry in the corners to reduce labour requirements and constructed the rest of the house himself. The wall to roof connection is poor and the DLPIU engineer listed the house as non-compliant. However, the engineers are not able to support with implementing correction and exception techniques as they have not received any training on this.

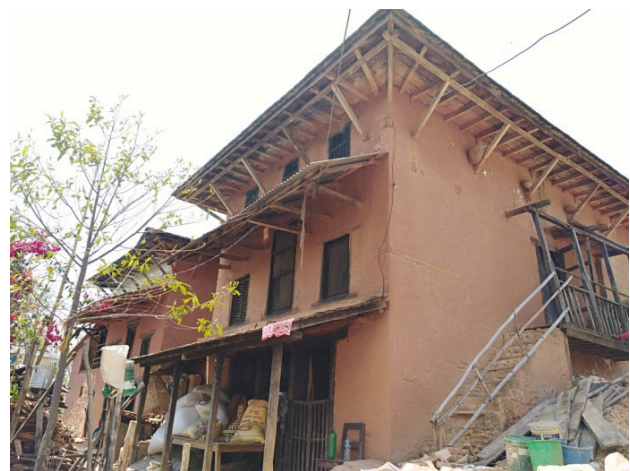
**Arghakhanchi:** stone and mud mortar masonry house of 2.5 storeys and therefore non-compliant.

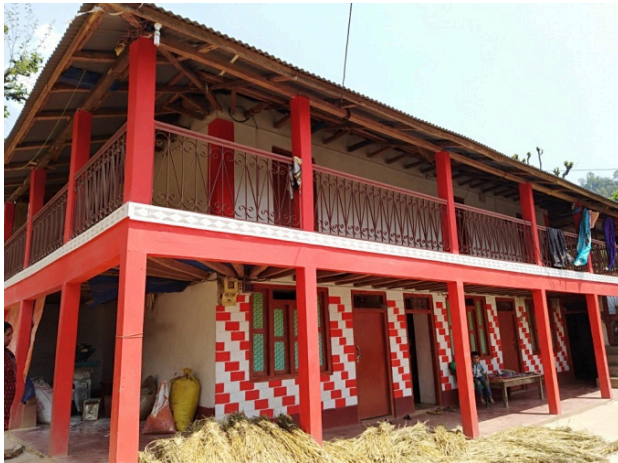
**Arghakhanchi:** hybrid structure using multiple materials.

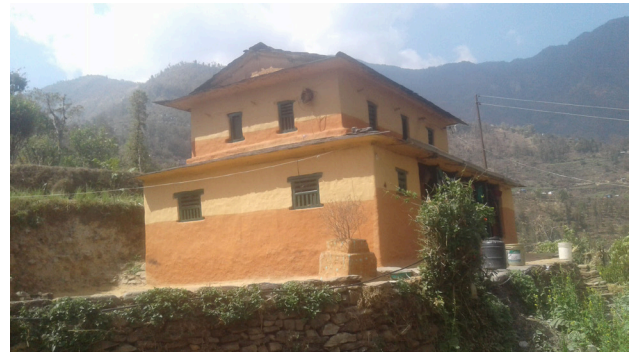
**Jayamuni Municipality (Ward-9), Baglung:** non-compliant stone and mud mortar masonry house constructed without technical guidance. The household have received the first tranche of the GoN housing reconstruction grant but they now need to apply corrections based on the Corrections and Exceptions Manual to receive the remaining tranches.

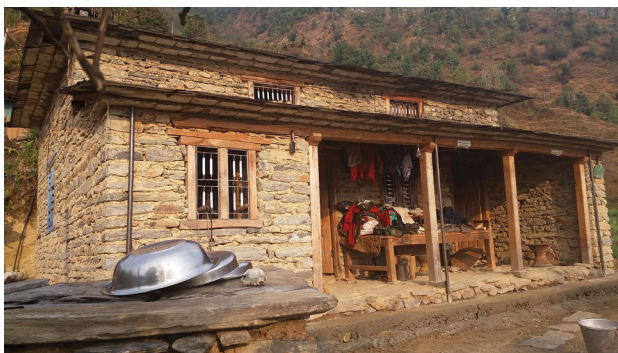
**Jayamuni Municipality (Ward-3), Baglung:** non-compliant stone and mud mortar masonry house constructed without technical guidance. The household have received the first tranche of the GoN housing reconstruction grant but they now need to apply corrections based on the Corrections and Exceptions Manual to receive the remaining tranches.

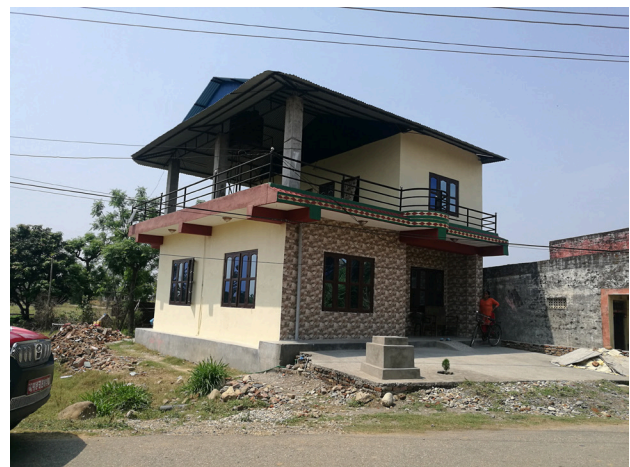
**Khairahani Municipality 2, Ladari, Chitwan:** home owner has received all three tranches of the GoN housing reconstruction grant.

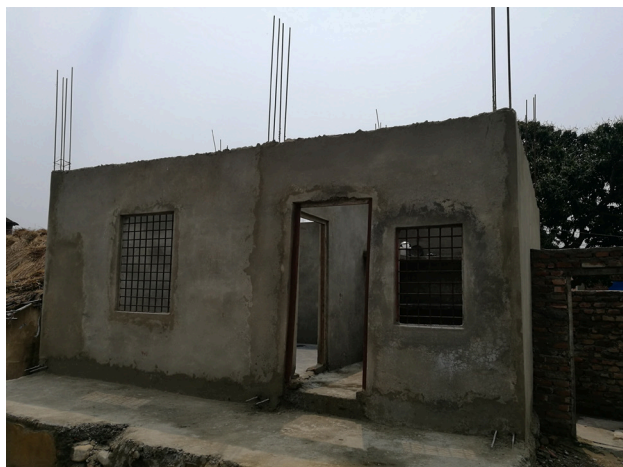
**Sunawal 9, Bankattiya, Parasi:** RCC frame structure house under construction. As per the comments from the DLPIU engineers during the visit the house will be eligible for next tranche immediately after the roofing is completed (third tranche does not require roof to be released).

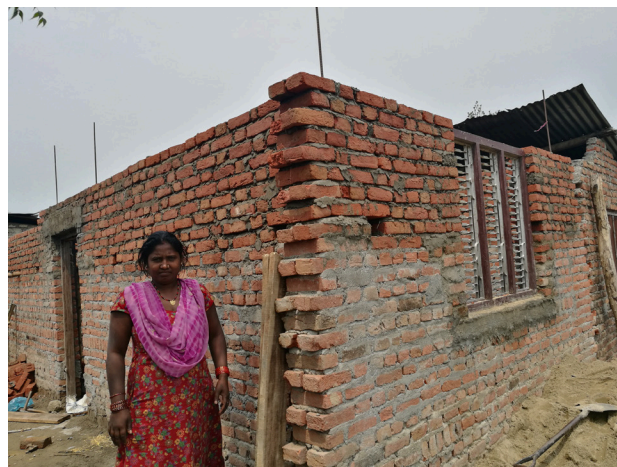
**Sunawal 2, Mukhiya Tole, Parasi:** the home owner has received the 2nd tranche but vertical and horizontal reinforcement has not been properly implemented and so the house has not been recommended for the third tranche. During the visit the DLPIU sub-engineer said they had been providing regular follow up to the household but the home owner has not been willing to follow the guidelines and their suggestions.

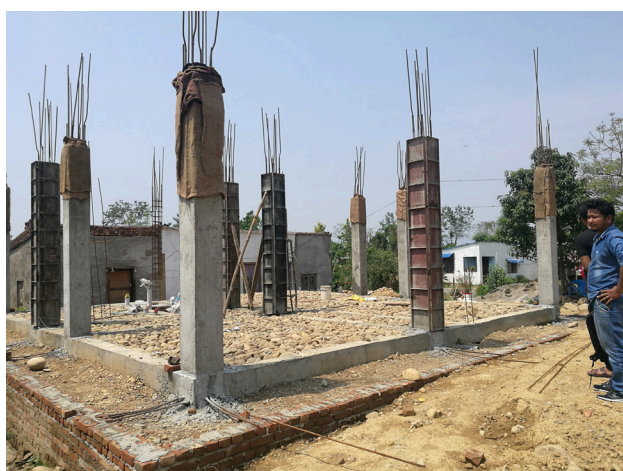
**Chitwan:** RCC frame structure under construction. The home owner has applied for the second tranche of the housing reconstruction grant and the application has been forwarded to the municipality.

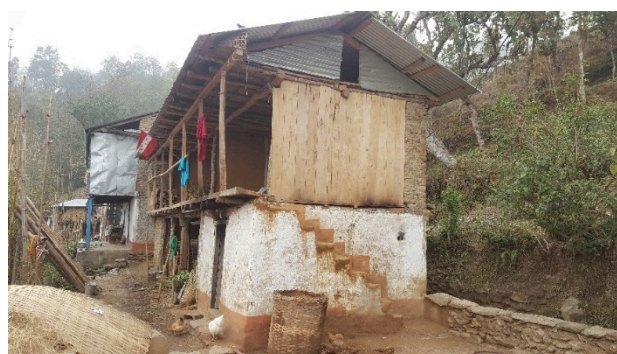
**Diktal Rupakot Majhuwagadhi Municipality ward-I, Khotang:** non-compliant hybrid structure with ground floor having stone and mud mortar masonry walls on three sides with one open side and the first floor walls are constructed with timber and CGI sheets. The home owner built the house in early 2017 with no technical support. They have applied for the second tranche of the reconstruction grant but will not be able to receive it without carrying out corrections.

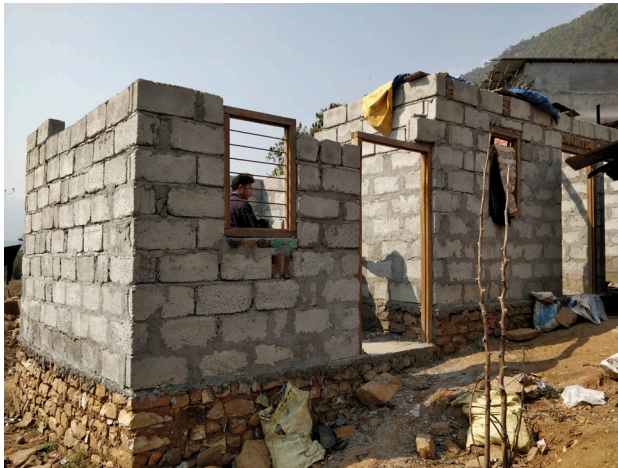
**Lekhnath Municipality, Pokhara, Kaski:** more than 600 houses have been constructed using hollow concrete blocks in Kaski. Households regularly ask the GoN engineers for designs and they have been providing the designs from the DUDBC Design Catalogue Volume 2, but households are not building according to these designs. There is a lot of hollow concrete block production in Kaski, with many of the biggest and oldest producers in the district. Blocks from Kaski are sent to Tanahun, Lamjung, Gorkha, and Parbat.

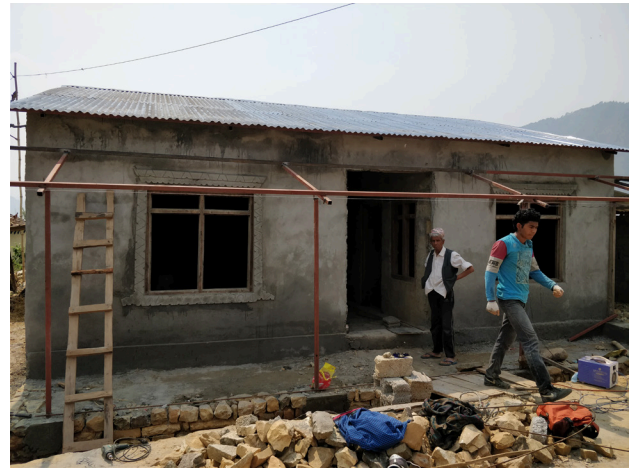
**Modi Rural Municipality, Ward No. 6, Parbat:** the home owner started construction of this 5-room house, with steel frame structure and hollow concrete blocks for the infill walls, just 1 month after the 2015 earthquake. He is still going through the grievance mechanism and he didn't know that this house would not be in line with government standards as there was no guidance available previously and the inspection engineers had just been deployed at the time of the visit.

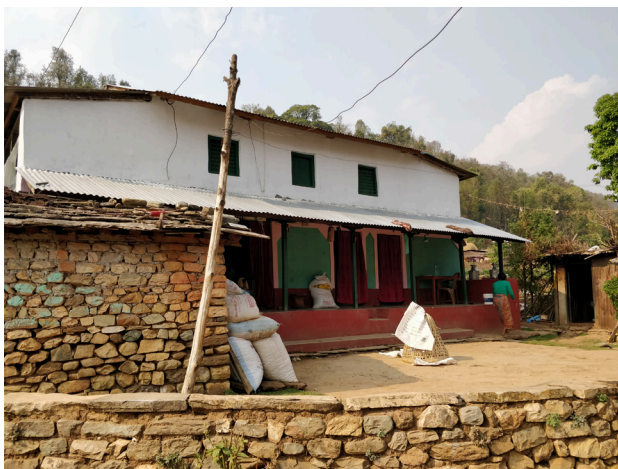
**Modi Rural Municipality ward-6, Parbat:** this two storey, stone and cement mortar masonry house is non-compliant and the home owner has only received the first tranche of the housing reconstruction grant. NRA, Building DLPIU engineers are facing challenges to provide correction solutions for these types of houses.

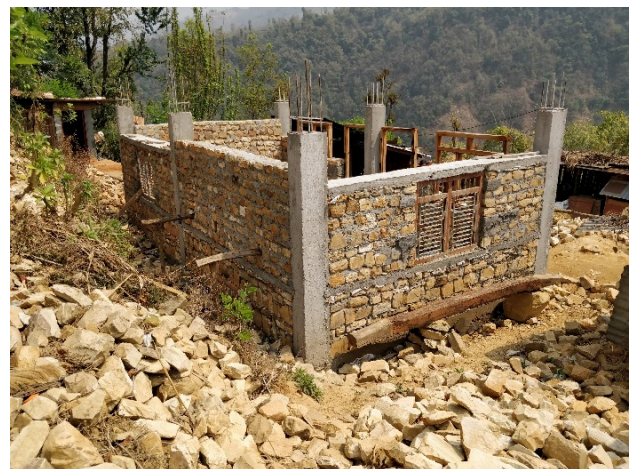
**Modi Rural Municipality ward-6, Parbat:** this hybrid structure has a semi-RC frame with 6 rebar in 9"x12" column and is a 2 room, 1 bay house. The home owner has been seeking technical support from the NRA, Building DLPIU engineers on whether to construct a rigid slab or flexible roof with CGI. People were very conscious after the earthquake of the need to construct a strong and safe house and some contractors influenced people to construct this type of house based on this. In this area 15-20 houses were built in this way.

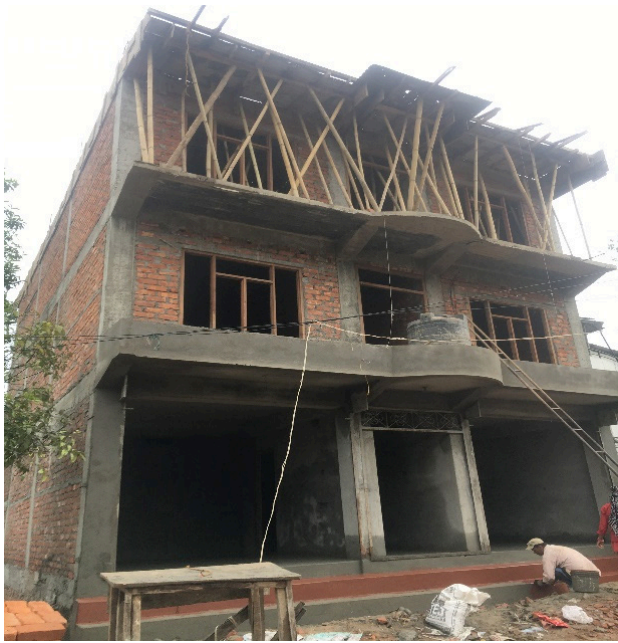
**Khandbari Municipality, ward-8, Sankhuwasabha:** RCC frame structure with 998 sq. ft. plinth area, and 16 nos 12" \*12" Columns. The house is 3 storeys with underground. The NRA, Building DLPIU engineers are confused about whether it is compliant or not but the structure has been approved by the municipality office.

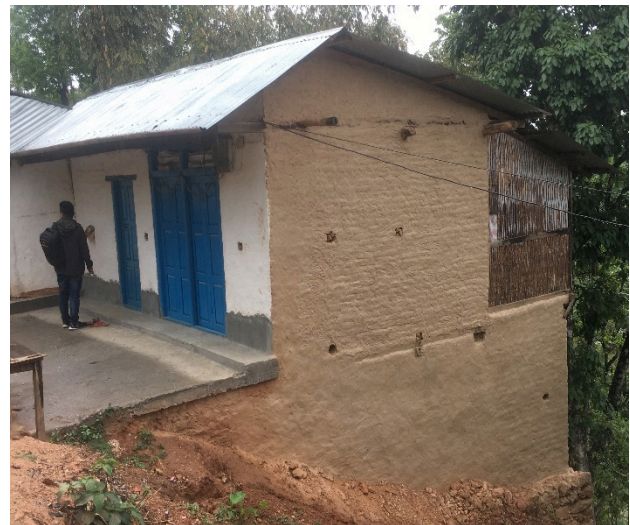
**Khandbari Municipality ward-8, Sankhuwasabha:** non-compliant house constructed with stone and mud mortar masonry on the ground floor and sun-dried bricks for the first floor. This house was constructed before technical assistance in the district. The home owner has received the first tranche and applied for the second.

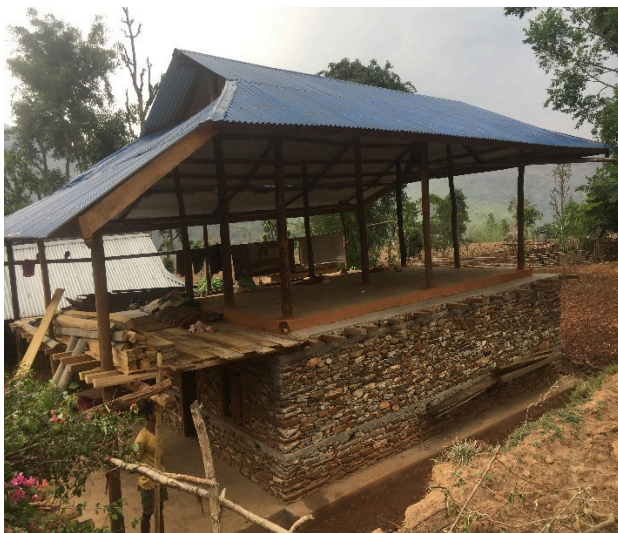
**Chainpur Municipality ward-II, Sankhuwasabha:** non-compliant Hybrid Structure with ground floor built in stone in mud mortar masonry and first floor with timber frame and open walls for now. The house was completed in early 2017 with no technical assistance. The home owner has received just the first tranche of the housing reconstruction grant.

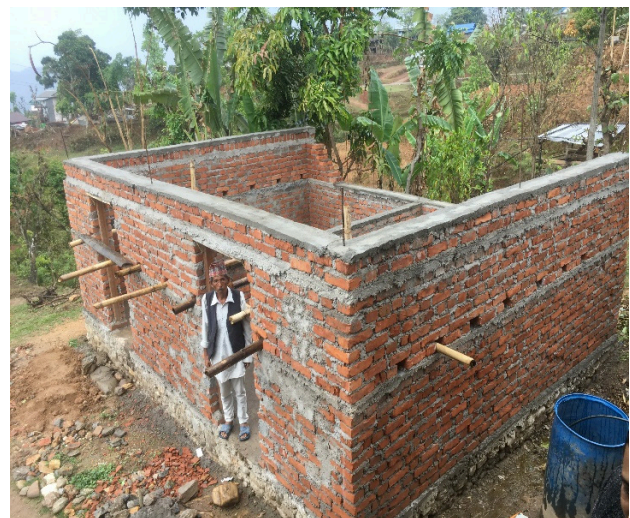
**Khandbari Municipality ward-8, Sankhuwasabha:** a brick and mud mortar masonry house with RC banding under construction. This house is being constructed under the supervision of NRA field engineer with the help of trained masons. The beneficiary has received the first tranche and is waiting for the second tranche. The house is considered compliant so they should receive the second tranche.

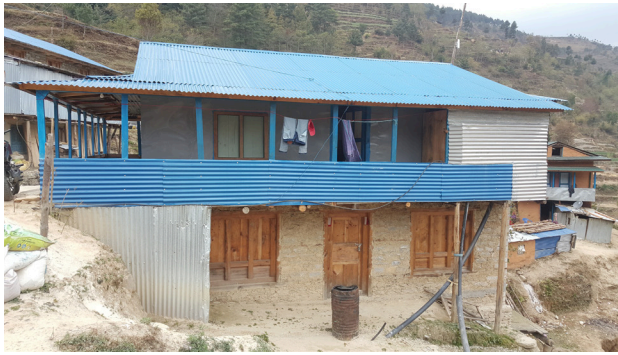
**Solu Dudhkunda Municipality ward-II, Tignasa Solukhumbu:** non-compliant Hybrid Structure built in early 2016 with no technical assistance. The ground floor is stone and mud mortar masonry and the first floor is timber frame with CGI sheets. RCC bands have been used at the plinth and timber bands at the lintel and sill level and the openings are not appropriate. The home owner has just received the first tranche of the housing reconstruction grant.

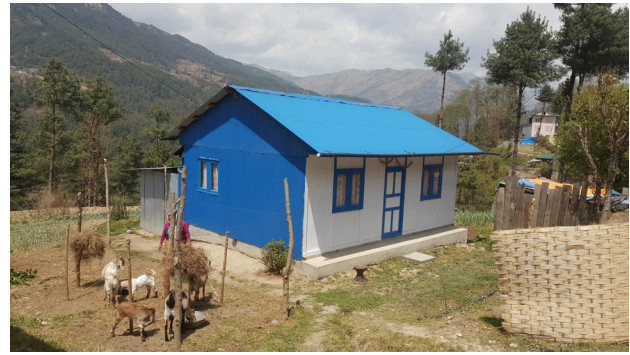
**Solu Dudhkunda Municipality ward-6, Dorpu Solukhumbu:** this two room, single storey house was built immediately after the earthquake with stone and mud mortar masonry foundation and walls of timber planks with timber frame. The design was approved by the municipality. The home owner has just received the first tranche. According to the engineer, the majority of houses in this area are built in this way.

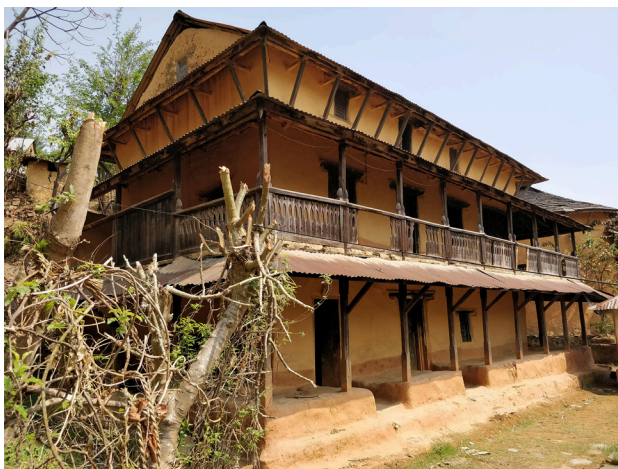
**Waling Municipality (ward-5), Syangja:** this stone and mud mortar masonry house has survived three earthquakes; one in 1990 B.S., one in 2045 B.S., and one in 2072 B.S. The house is still standing despite the earthquakes and being more than 80 years old. The construction quality is quite good with support from timber bands at floor and roof level i.e. 2 bandings per floor.

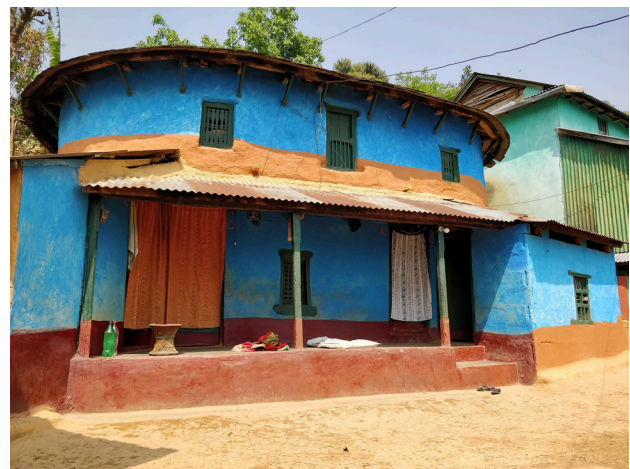
**Waling Municipality (ward-5), Syangja:** the home owner reduced their circular 3 storey house to one and a half storeys after it was damaged by the 2015 Gorkha earthquake. They are now planning to construct a new house and the government technical staff have said that the damaged house will have to be demolished before the third tranche of the GoN housing reconstruction grant can be released.

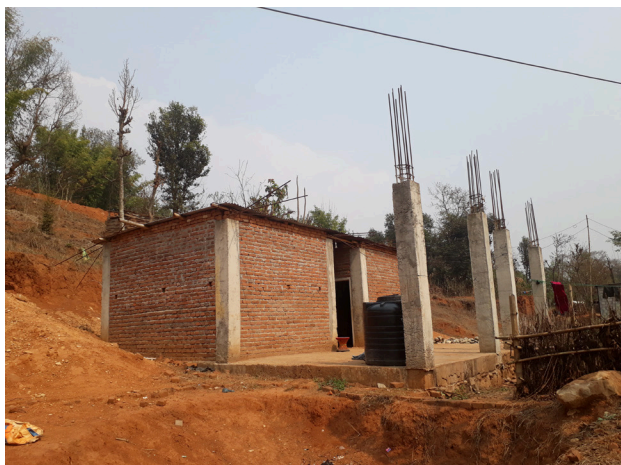
**Bhanu Municipality, ward-2, Tanahun:** house reconstructed with RCC structure but due to road right of way conflict and formation of new municipality and its building requirements the home owner is not allowed to construct rigid floor and even they constructed RC frame structure beneficiaries were living by putting CGI roofs and brick infill walls.

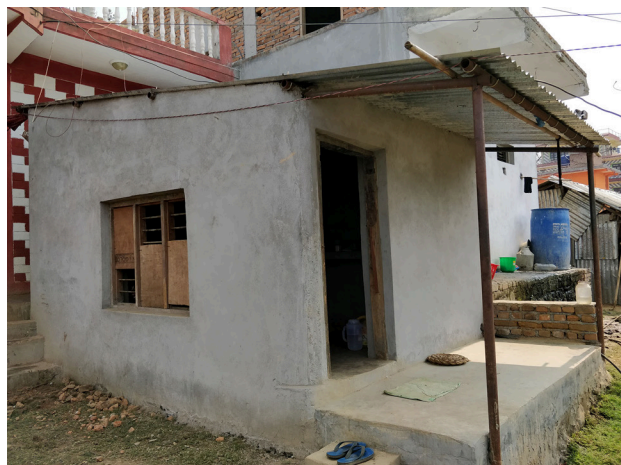
**Bhanu Municipality, Ward No. 2, Tanahun:** Ujeli B.K. has received the first tranche of the GoN housing reconstruction grant and does not know anything about the process to receive the second tranche of the grant. He has already reconstructed this one room house with a steel frame and flexible roof structure and the house has not yet been inspected by the government engineers.
