## Monthly District Report

### Lalitpur, Bhaktapur

22 October – 21 November 2019

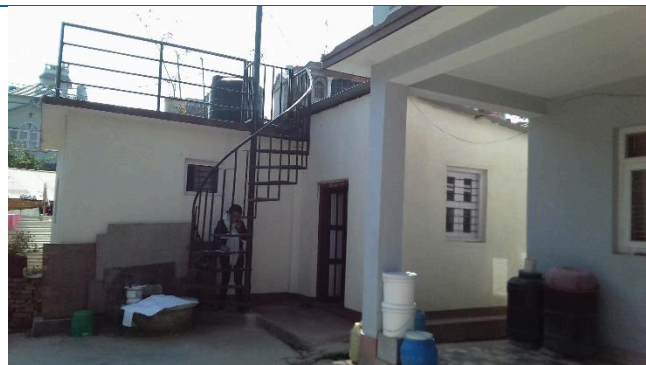
Beneficiary name: Indira Thapa, Ward no. 15, Khumaltar, Lalitpur Metropolitan City, single storey 3 room wall system BMC house have party rigid roof and flexible roof too. The owner is a single women, accessed 1<sup>st</sup> tranche and was reconstructed soon after earthquake and before deployment of engineers.

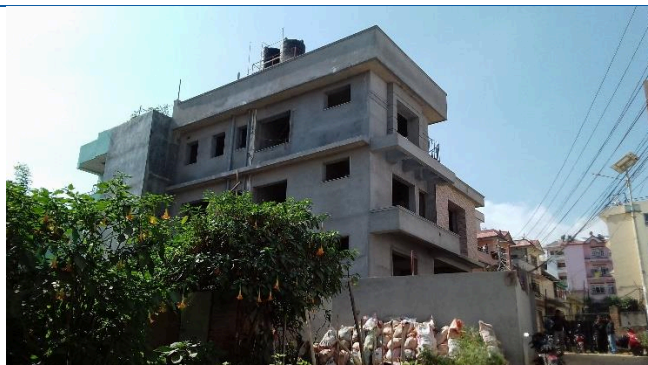
Beneficiary name: Babu Ram Bogati, Ward no. 15, Khumaltar, Lalitpur Metropolitan City, 2.5 storey RCC house has 7 rooms in total. The house is compliant and have received 1<sup>st</sup> tranche too. The owner had earthquake damaged house at Mahankal Rural Municipality and received building drawing approval for plot at Ward no. 15, Khumaltar, Lalitpur Metropolitan City. The owner still resides in rented place at Balkhu, Kathmandu.

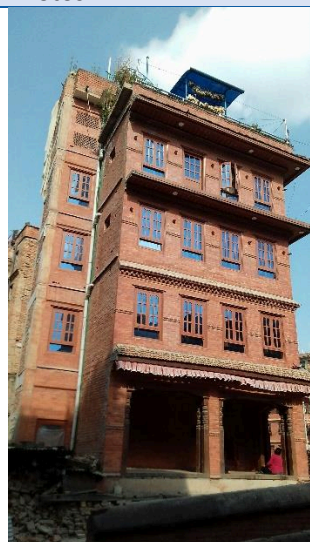
Beneficiary name: Ram Laghu, Ward no 2, Byasi, Bhaktapur Municipality. 4.5 storey RCC house is complaint and has received all three tranches from government. Cladding is done for outer finishing works.

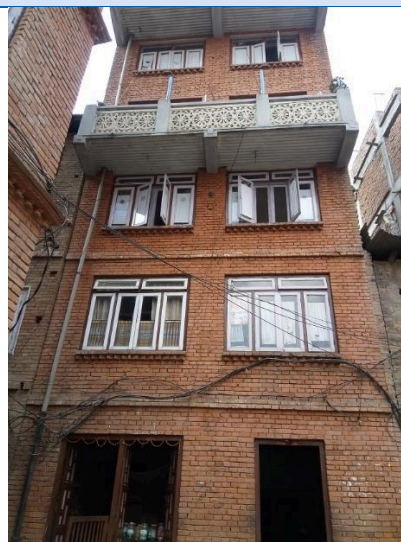
Beneficiary name: Laxmi Das Basukala, Ward no 2, Byasi, Bhaktapur Municipality. 5 storey BMC wall system house is in retrofitting category. After observing this house by DSE, the owner was recommended to reduce the stories height (upto 2 stories) and to raise RCC wall from ground floor throughout.

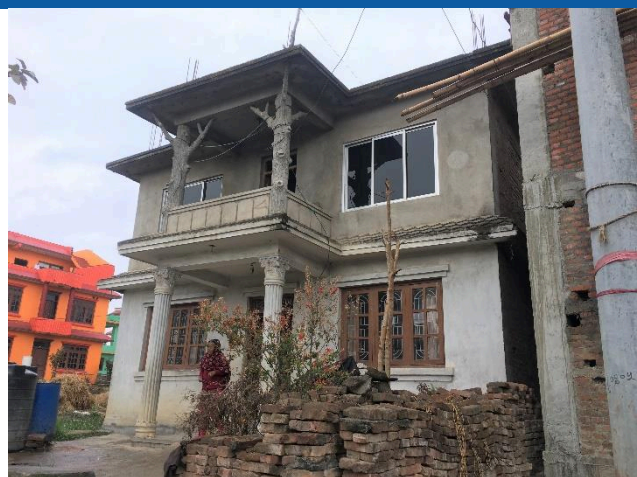
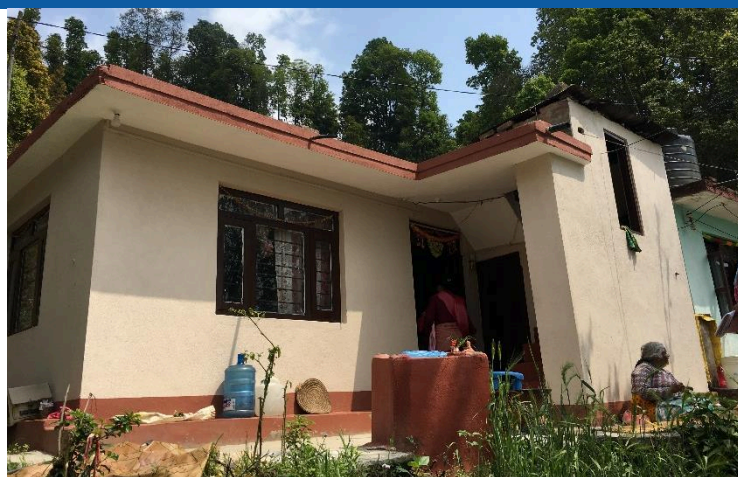
| Beneficiary name: Kale Bhandari, Ward no 2, Chagunarayan Municipality, Bhaktapur, RC frame structure, Non-Compliance (9"X12" column- unsafe during analysis, constructed Immediately after earthquake | Beneficiary name: Pavitra Poudel, Changunarayan Municipality, Ward no 4. Non-Compliance (Missing beam, bands, constructed immediately after earthquake |

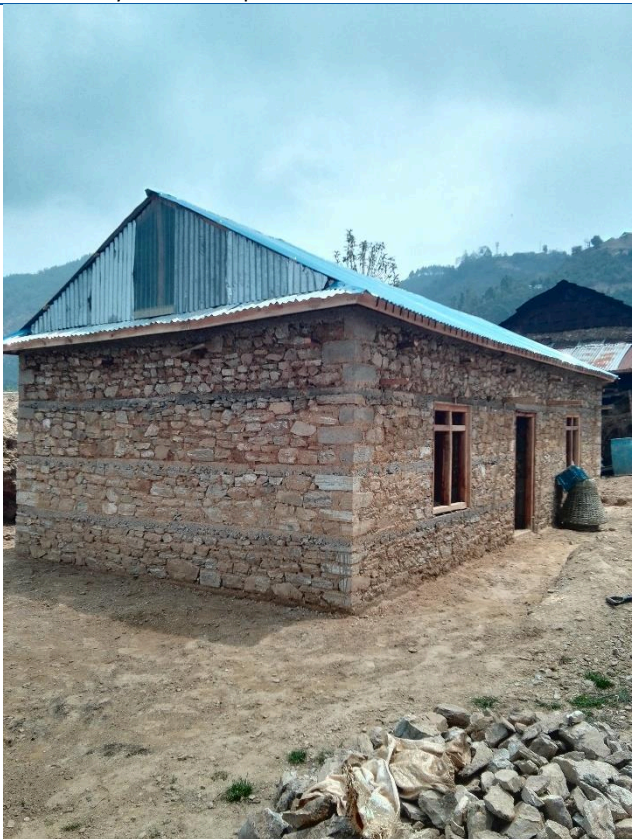
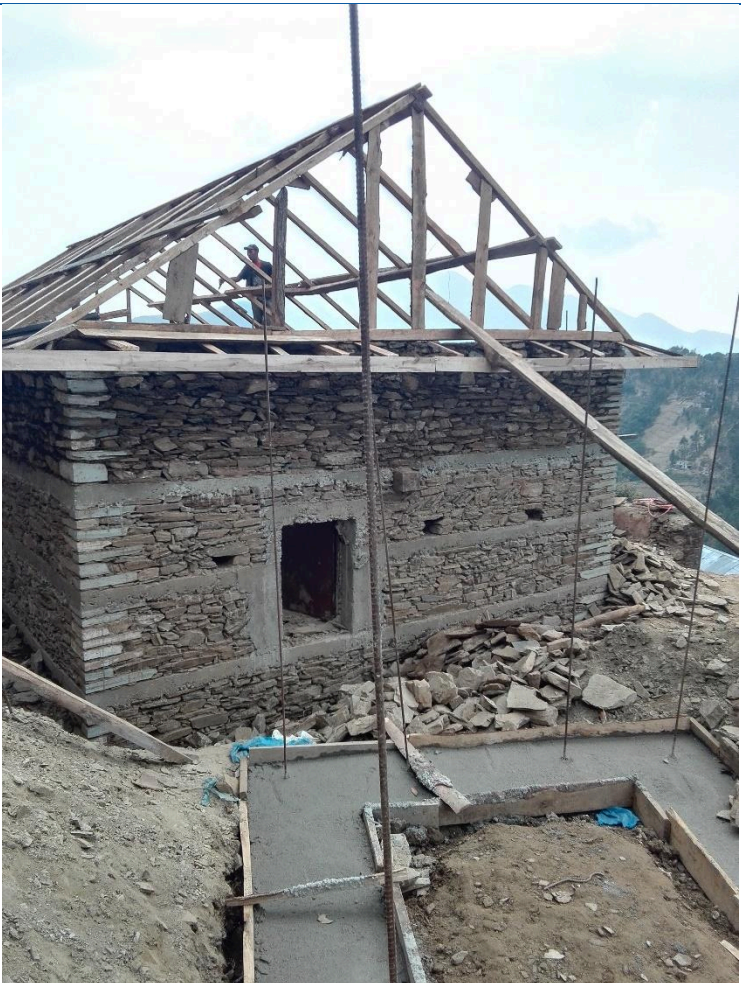
| Beneficiary Name: Bhumi Nanda Timilsina, Ward no 4, Kaleshwor, Mahankal Rural Municipality. 1 storey plus attic SMM structure has kept RC bands. The beneficiary has requested for 3 <sup>rd</sup> tranche during time of inspection | Beneficiary Name: Bishnu Prasad Dulal, Ward no 4, Kaleshwor, Mahankal Rural Municipality. 1 storey plus attic SMM structure has kept RC bands properly. The beneficiary has requested for 3 <sup>rd</sup> tranche during time of inspection |
