# District Report

## Ramechhap

2 -8 February 2018

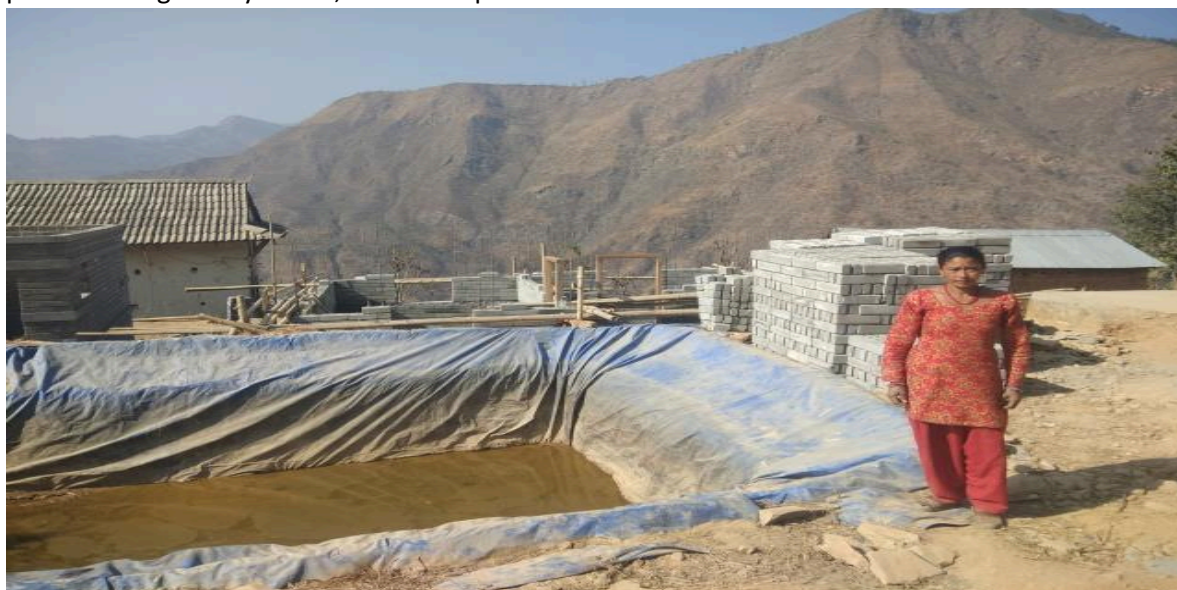
Figure 1. Sundari Shrestha with her plastic pond and her house being reconstructed on background

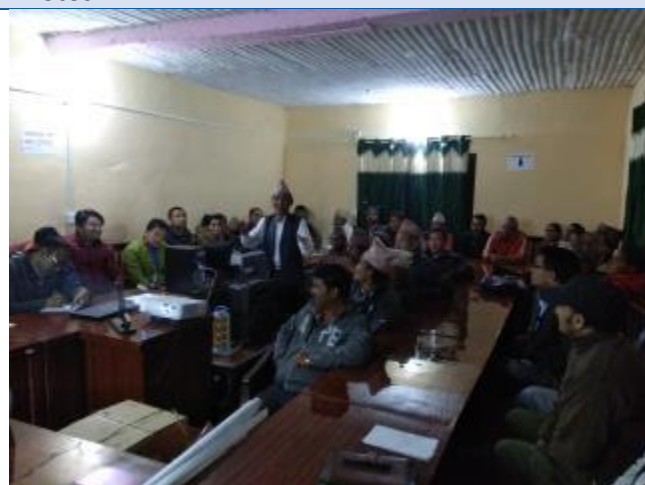
Caption: The Palika level meeting organized in the meeting hall of Khadadevi Rural Municipality in Makadum, Khadadevi Rural Municipality.

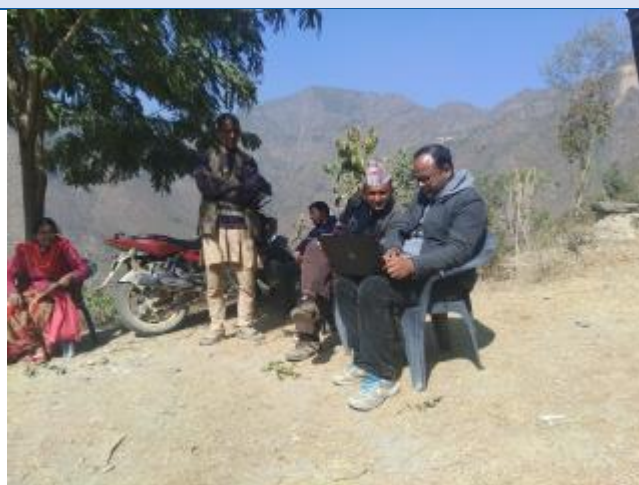
Caption: Interaction with Ward Chairperson of Bhirpani regarding the low construction rate.

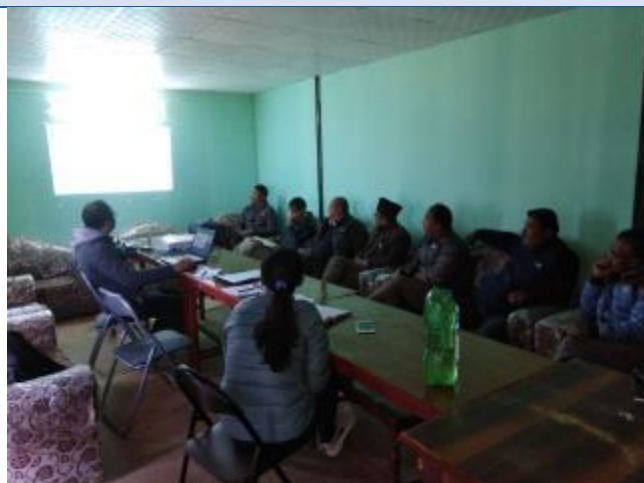
Caption: The palika level meeting at Sunapati Rural Municipality meeting Hall, Hiledevi, Sunapati.

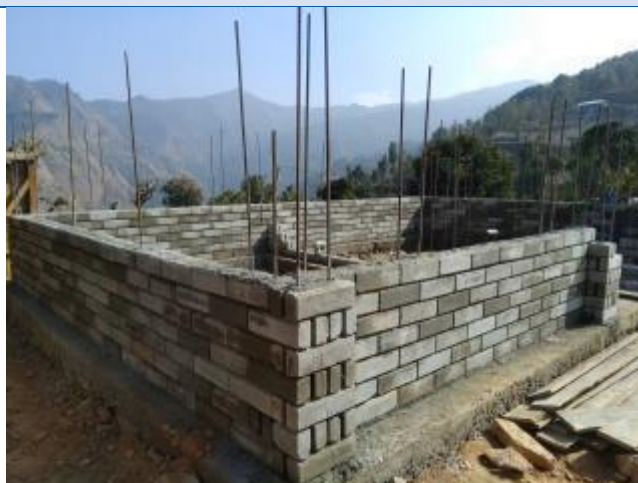
Caption: The two room structure of Garud Singh Tamang, resident of Hiledevi, Sunapati Rural Municipality-3 being constructed by using CSEB interlocking bricks. The blocks are produced by vendor in Mulot and have been constructing the earthquake resilient house at 6.5 Lakhs with free transportation within 10 km area. The house owner has received first tranche. Since he had constructed the plinth level after the Poush end deadline, he has not been verified for second tranche and not been able to receive the second tranche

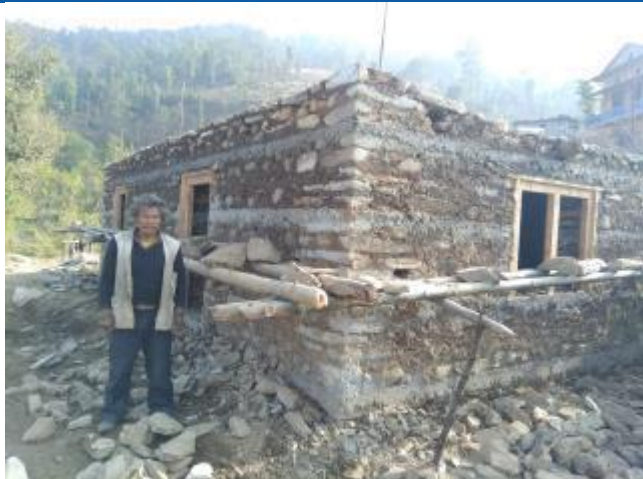
Caption: The two room structure of Brish Bahadur Tamang, resident of former Khadadevi VDC being constructed using stone in mud mortar. The RC Bands have been provided to the house as seismic parameters. He has received second tranche on first week of Asar 2074.

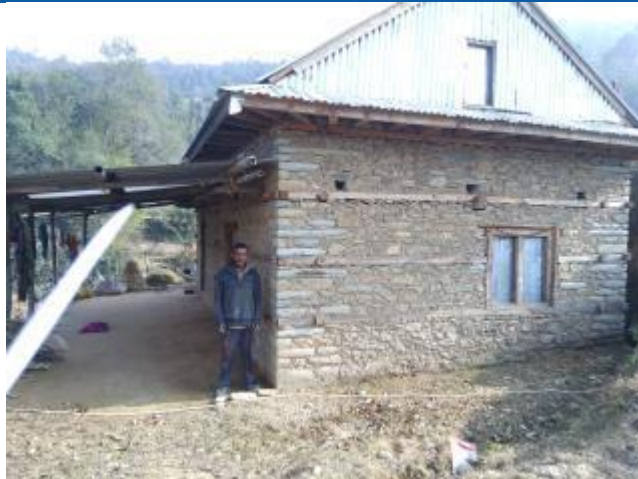
Caption: The constructed house of Chamar Singh Tamang, resident of ward number 7, Khadadevi, of Khadadevi Rural Municipality. The house is constructed using stone in cement mortar. The RC bands have been provided to the house. He has received third tranche of reconstruction grant on 24<sup>th</sup> Poush 2074. The house was completed in 6 lakhs

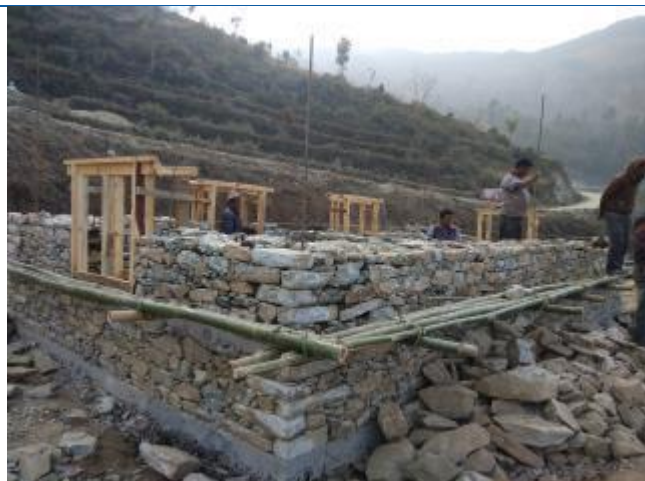
Caption: The house of Durga Bahadur Shrestha, resident of ward number 7, Khadadevi, Khadadevi Rural Municipality being constructed using stone in mud mortar. The RC Bands have been provided to the house. The owner has received the second tranche on magh and is expected to be completed by end of falgun.

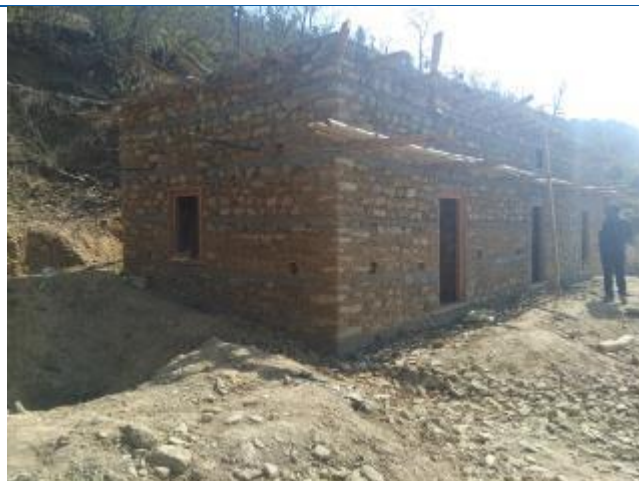
Caption: The three room house of Tek Bahadur Thapa, resident of ward number 3, Bhirpani, of Khadadevi Rural Municipality. The house is being constructed using stone in cement mortar. The RC bands have been provided to the house. He has received second tranche of reconstruction grant on 2<sup>nd</sup> Poush 2074. The house is expected to be completed in 8 lakhs.

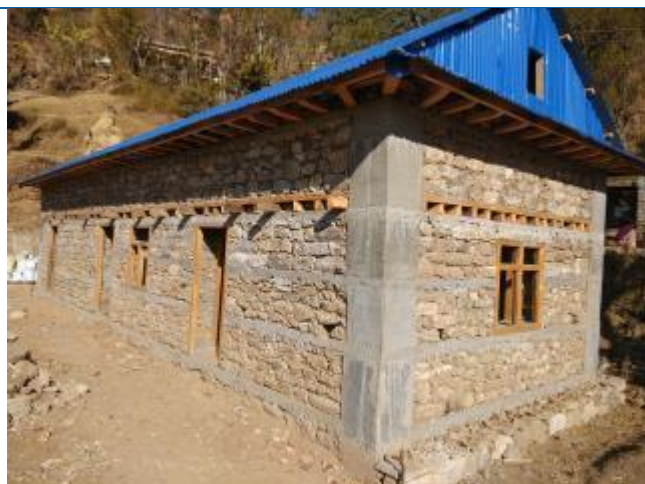
Caption: The three roomed house of Shankar Pandit, Tokarpur, of Doramba Rural Municipality. The house is being constructed using stone in cement mortar. The RC bands have been provided to the house. The RC columns have been provided on the corners. The file has been forwarded to District Support Engineer for the safety analysis.

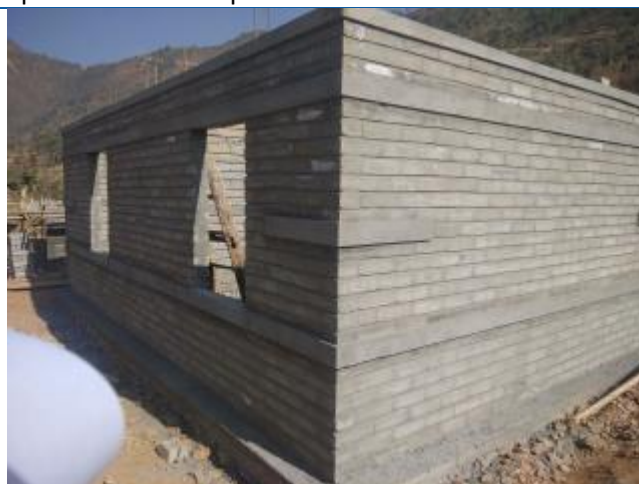
Caption: The two room structure of tranche Ram Bahadur Shrestha, resident of Bhirpani, Khadadevi Rural Municipality-3 being constructed by using CSEB interlocking bricks. The blocks are produced by vendor in Mulot and have been constructing the earthquake resilient house at 6.5 Lakhs. The house has been recommended for second tranche on Mangsir 2074 but has not received the tranche yet.

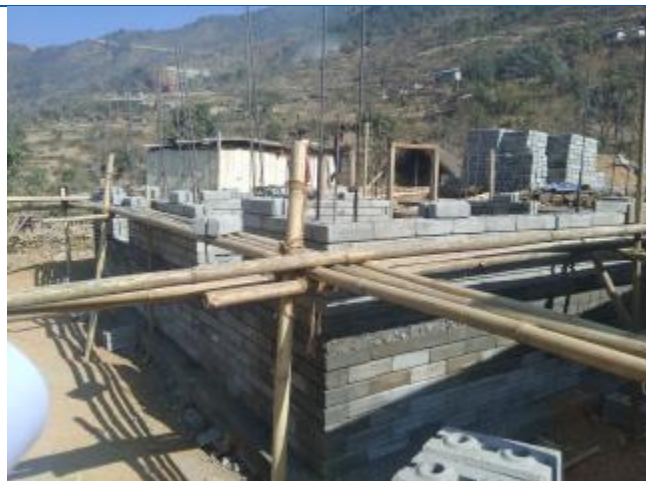
Caption: The two room structure of tranche Keshar Bahadur Shrestha, resident of Bhirpani, Khadadevi Rural Municipality-3 being constructed by using CSEB interlocking bricks. The blocks are produced by vendor in Mulot and have been constructing the earthquake resilient house at 6.5 Lakhs. The house has been recommended for second tranche on Poush 2074 and has not received the tranche yet.

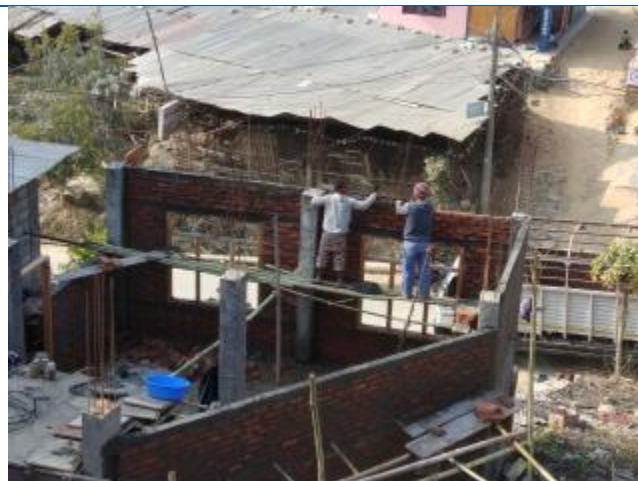
Caption: The RC frame house being constructed on Manthali Municipality has reinforcement missing on the horizontal Bands.
