# Gorkha North Field Report Summary

CRS Shelter and Settlements Team

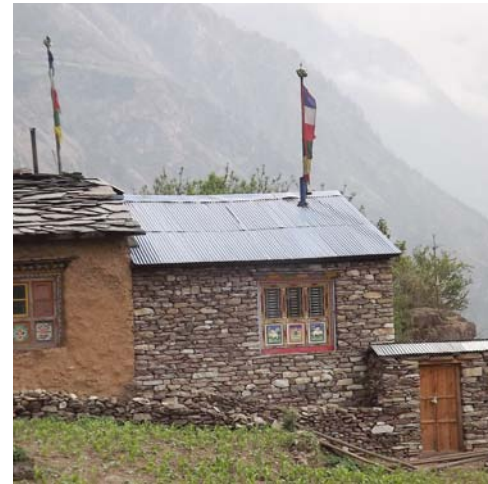
New CGI roofs replacing vernacular details

| COST | ISSUE | RECOMMENDATION |
|---|---|---|
| 10 | Traditional stone tiled and timber shingle roofs leak and are not airtight. | Support the vernacular traditional building style by maintaining stone tile or timber shingles where possible, issues of water ingress could be mitigated by the inclusion of a moisture control membrane (black) beneath. Green CGI is preferred over blue or natural if used |

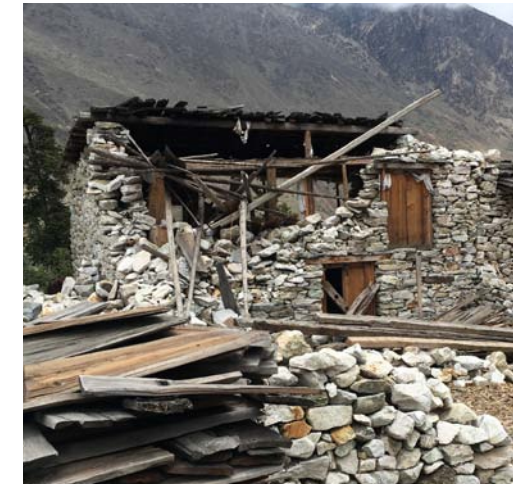
Collapsed gables and verandah wing walls

| COST | ISSUE | RECOMMENDATION |
|---|---|---|
| 2 | Gable stonework is unsupported and is a common point of collapse | Use lightweight gables - Timber truss structure should replace the stonework above the top plate |
| 8 | Stone walls at first floor to verandahs collapsing | Replace stonework with timber |

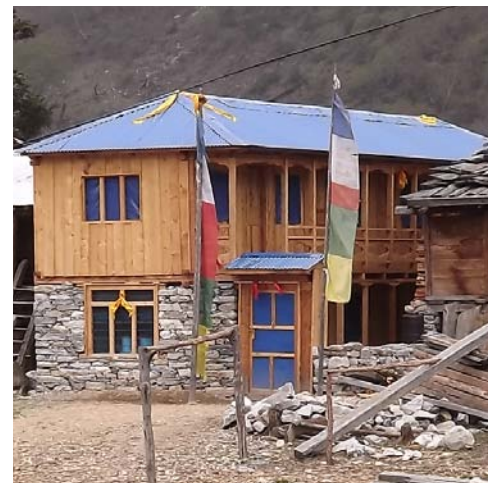
Timber first floor constructions only found on hotel buildings

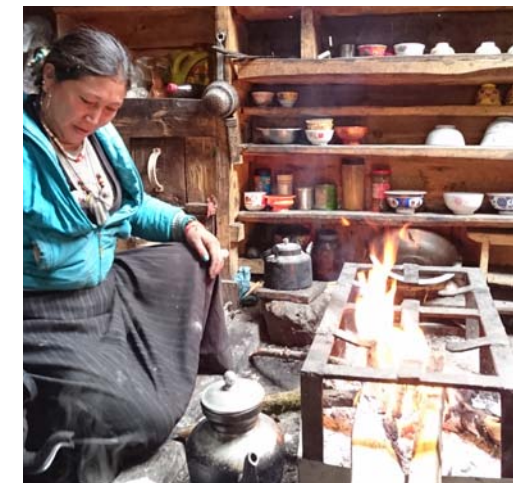
Open fires for cooking/ heating

| COST | ISSUE | RECOMMENDATION |
|---|---|---|
| 7 | Internal air pollution | Replace open fires with stove and flue for cooking and heating |
