# District Report

## Rasuwa

### 22 June - 5 July 2018

## Field Visit Reports

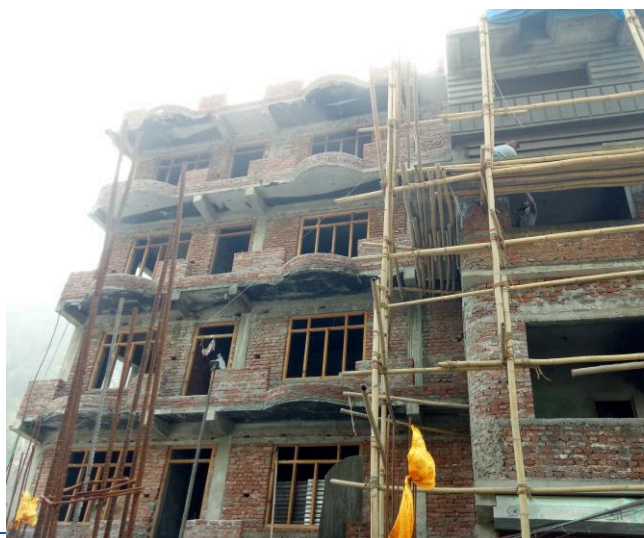
Caption : Pema Sangmu Ghale, Ward no 2, Gosaikunda RM Timure. 3 storey RC frame structure. The building is a multi-storeyed RC frame structure and also second tranche is taken but the house is attached with another 3 storeyed building without any seismic gap. The attached building consisting of shutter belongs to Mr. Chewang Renchen Tamang and he has also taken the second tranche. Both of the buildings have all columns 12" x 12" which makes them non-compliance. Proper structural analysis must have been done in order to determine the proper size of structural components and receive all government tranches.

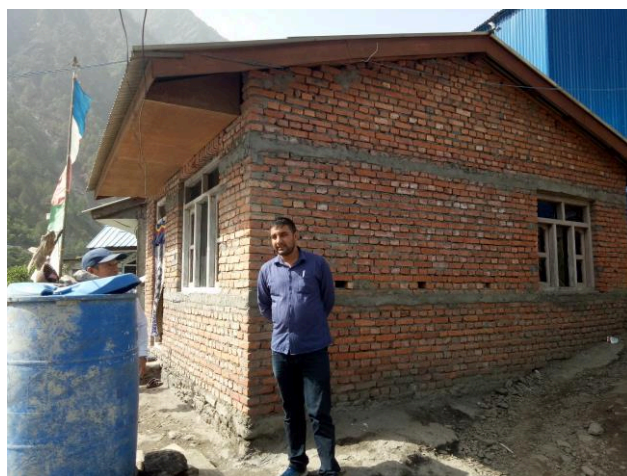
Caption : Nangang Nagaroti , ward no 2 Gosaikunda RM, Timure. Received the second tranche of the government housing. House typology BMC.

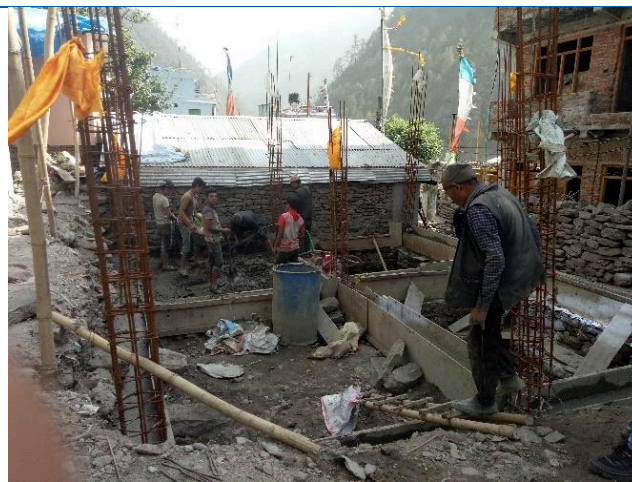
Caption : Sonam Chiring Ghale, ward no.2, Gosaikunda RM Timure. Received the second tranche of the government housing. Construction completed upto the DPC level and further construction was going on.

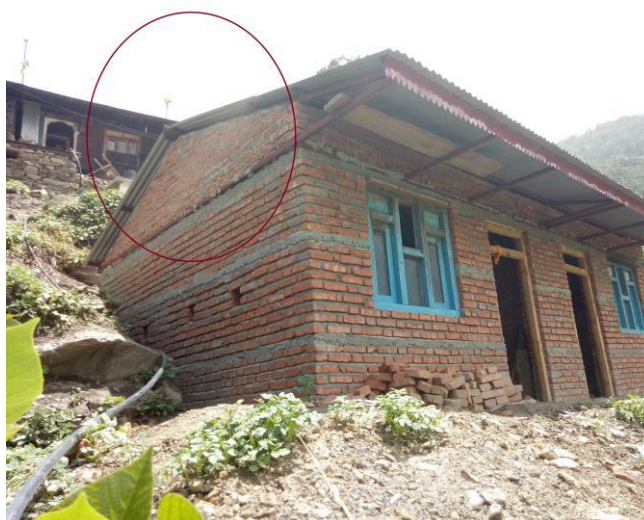
Caption: Aamochhodingmo RM ward no.5 . House owner name =Kumar Tamang. Tranche Received =2nd. Gable band is missing.

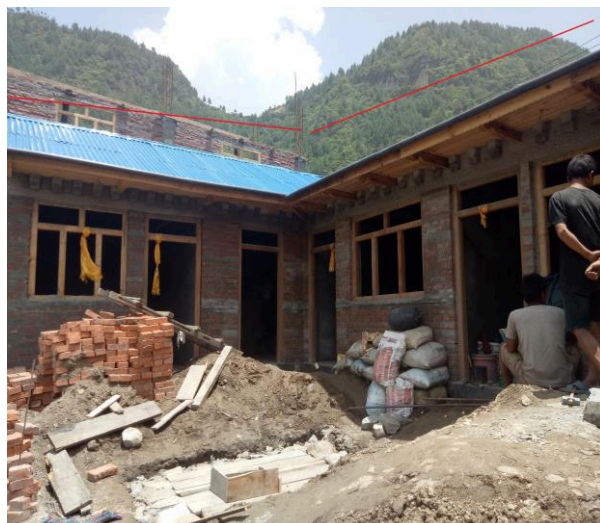
Caption: Aamo Chhodingmo RM ward no. House owner name = Ram Badhur Tamang. Tranche received = 3<sup>rd</sup>. L shape house. Non -compliance

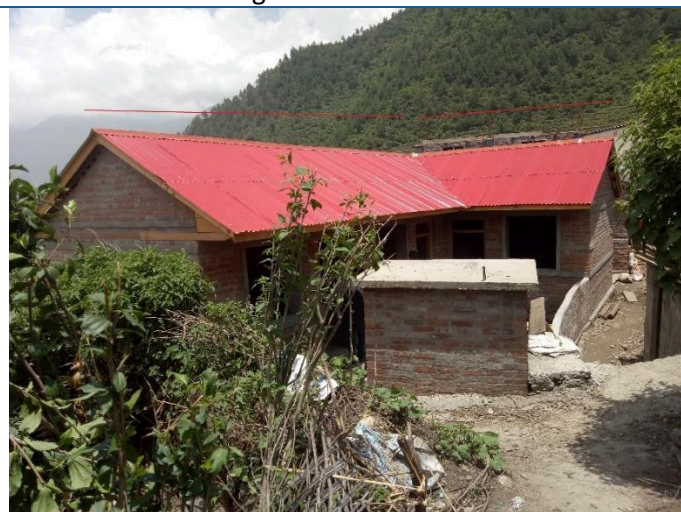
Caption:Aamo Chhodingmo RM ward no.5 . House owner name = Roshan Tamang.Tranche received = 2<sup>nd</sup> . L -shape house. Noncompliance.

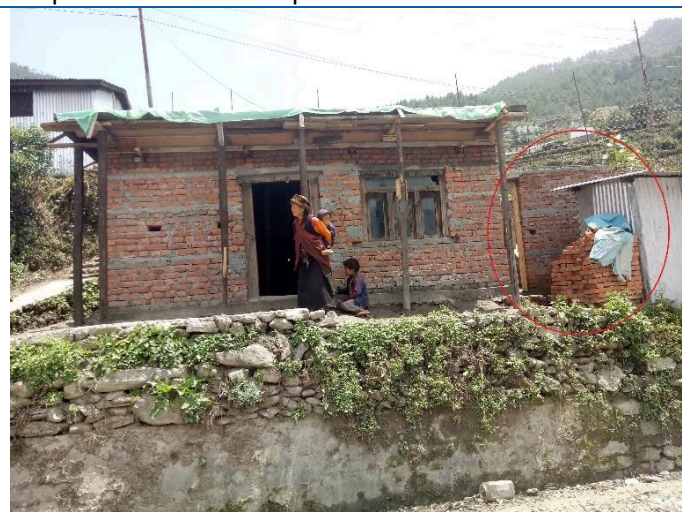
Caption: Aamo Chhodingmo RM ward no 5 .Two houses . House owner name = Dawa sangbo Tamang. received 1<sup>st</sup> tranche and another big house = Kunar Tamang 2<sup>nd</sup> tranche received. Relation of house owner is mother and son.
