## Fortnightly District Report

### Okhaldhunga

1 - 14 February 2019

## Housing Typology Report

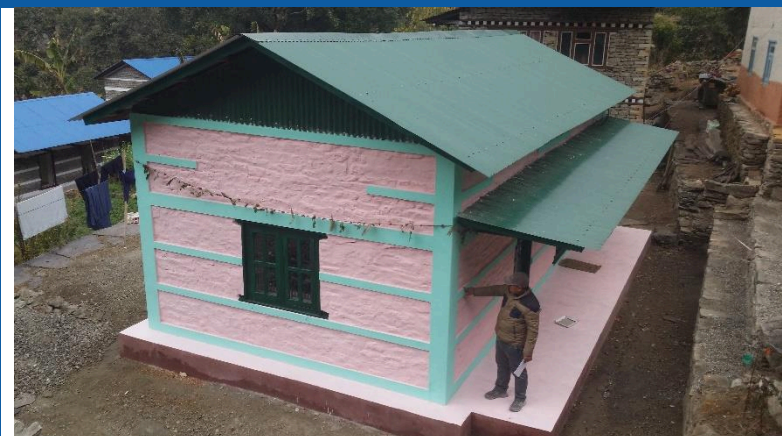
*Figure 1 House of Indra Narayan Shrestha Khijidemba Rural Municipality Ward no 2 Salpu*

House is constructed with Stone in Mud Mortar providing RCC Band properly and the Beneficiary has received all three tranches and waiting for the Completion Certificates as per the beneficiary the total cost of this building was 7 lakhs

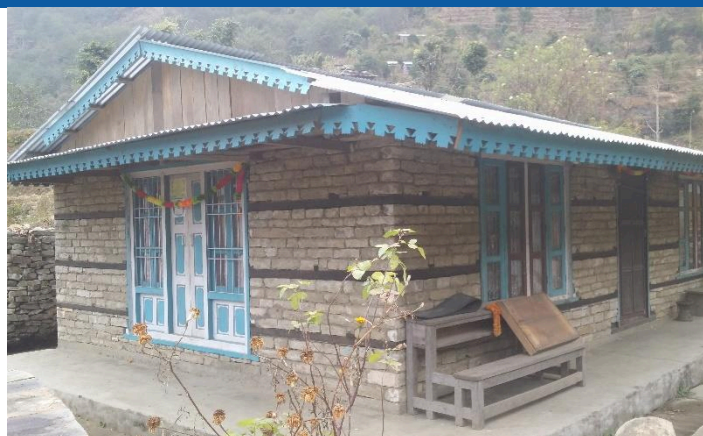
*Figure 2 House of Inderia Shrestha Khijidemba Rural Municipality ward 1 Salpu.*

House is noncompliance with stone in mud mortar with wooden bands provided properly and has received first and second tranche of the government and third tranche has not been recommended by the engineer since the beneficiary has not applied correction as per the suggestion of engineer.

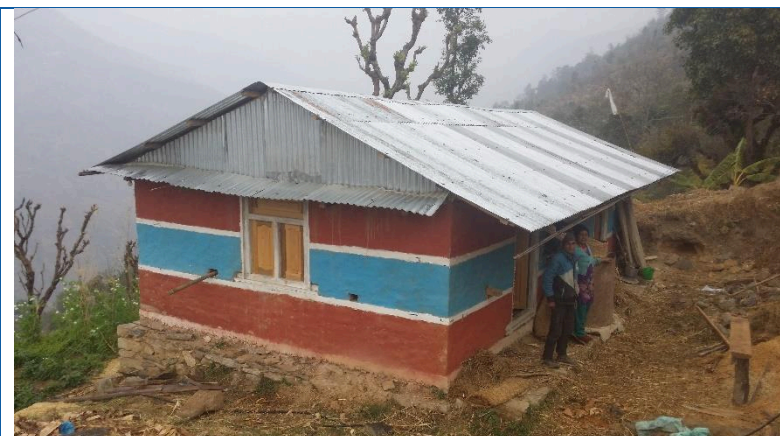
**Figure 3** House Owner Tej Narayan Shrestha Khijidemba Rural Municipality ward no 1 Chapleti

This house Compliance made up of Stone in Mud Mortar and wooden Bands provided at the appropriate location and the Beneficiary has received all three tranches provided by the Nepal Government.

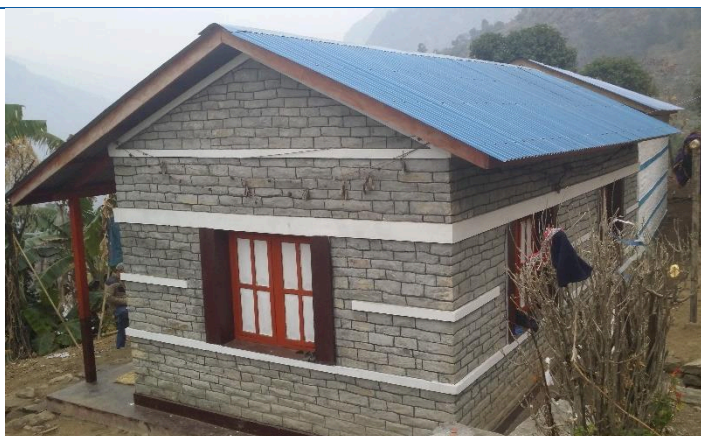
**Figure 4** House of Chandra Bahadur Sunuwar Khijidemba Rural Municipality Ward no 1 dadagaun.

The beneficiary has built this house under the Support of (GWS) Gorkha Welfare Society. The house is made up of in mud mortar with RCC bands provided The Beneficiary has also received all three tranches from the Nepal Government.

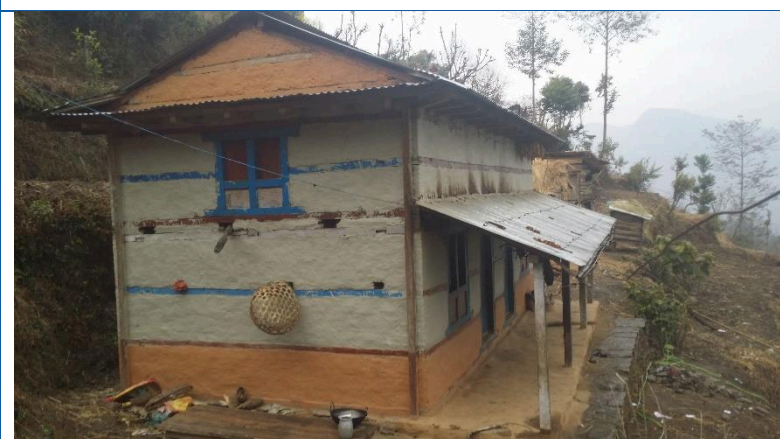
**Figure 5** Dilli Bahadur Nepali khijidemba Rural Municipality ward no 3 Patule Khijichandeswori

This house is noncompliance since the attic height is more than 3 feet and has not received third tranche The house is made up of stone in mud mortar with wooden band .DSE has suggested correction by applying vertical support on both side above the floor for the house for third tranches.

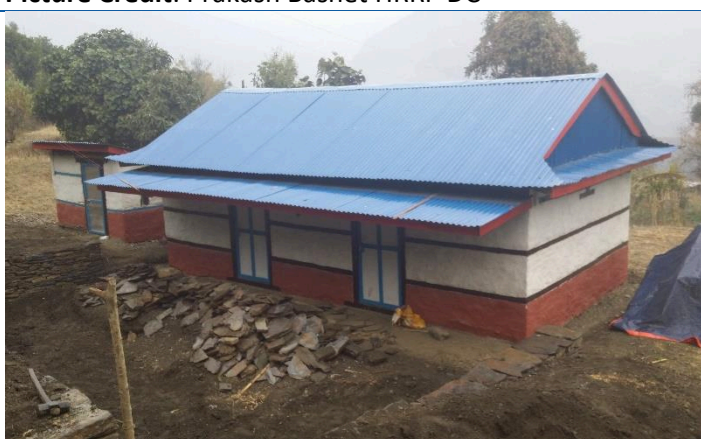
**Figure 6** House of Bhakta Bahadur Sunuwar Khijidemba Rural Municipality ward no 3 Chandeswori

House made with stone in mud mortar with wooden bands Provided at appropriate place. The beneficiary has received first and second tranches from the government and third tranche is

has been recommended by the field engineer five months ago but the beneficiary has not received yet

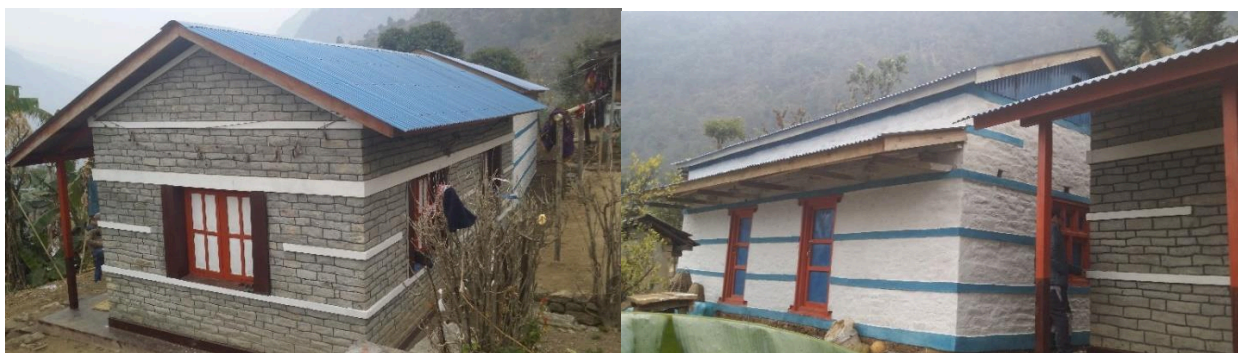
The case story is of Mr. Chandra Bahadur Sunwar permanent residences of Khijidemba Rural Municipality ward no -01, Ragani. According to the beneficiary he used to live with his two sons and three daughter family members in the house. On 12th Baisakh 2072 his house was totally collapsed the house and after the earthquake the survey team had visited his house and distributed Nissa card and they remarked his house as totally collapsed. But immediately after earthquake British Gorkha Welfare has been distributed NRs. 5,00,000.00 to construct the new house. After completion of house from the grant of British Gorkha welfare, again he has received also grant from NRA to construct the new house. He has now two houses. One is Constructed from the grant of British Gorkha Welfare and another is constructed from the Grant of NRA. It was seen than than if British Gorkha Welfare has distributed grant to beneficiaries why again he received the grant from NRA?

*Figure 1 House of Chandra Bahadur Sunuwar Made with the support of Gorkha Welfare Society (GWS) and Nepal Gov. Gran*
