# District Report

## Kathmandu Valley

4- 10 May 2018

## Field Visit Report

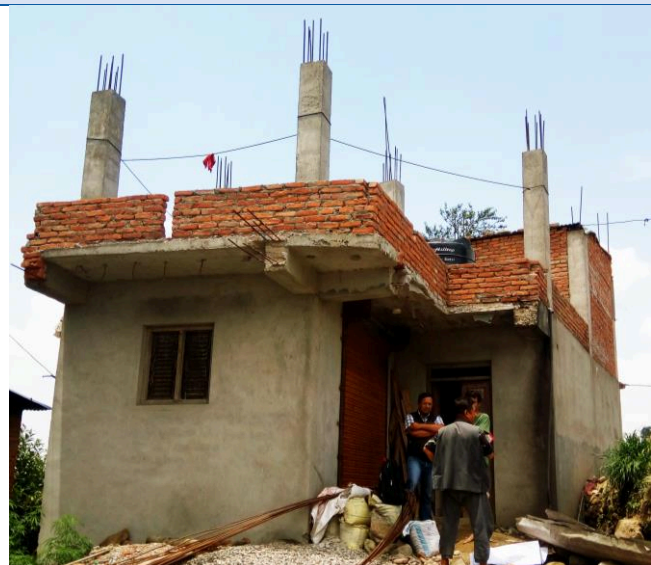
Changunarayan Municipality, Khawa Village, Ward no. 9, One storey RC frame structure of Mr. Raghunath Dulal. The inspection for the 2<sup>nd</sup> and 3<sup>rd</sup> tranche was conducted during the visit. The house was compliance and the file will be forwarded to the DLPIU for further process.

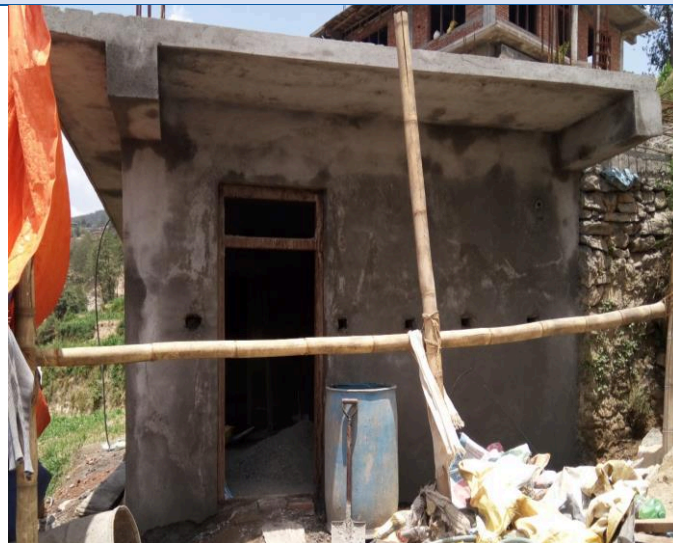
Changunarayan Municipality, Khawa Village, Ward no. 9, one storey RCC frame structure. Mr. Madhav Prasad Dulal has applied for the building permit in the municipality. Till date he has received 1<sup>st</sup> tranche.

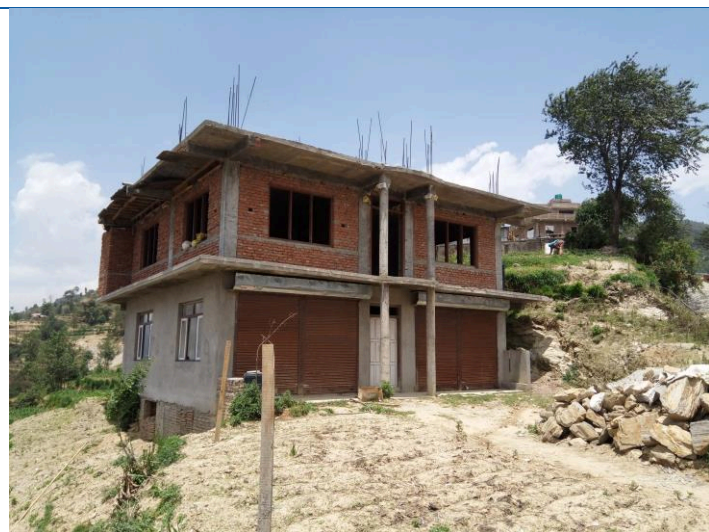
Changunarayan Municipality, Khawa village, Ward no. 9, RCC pillar system house. The house owner has received 1<sup>st</sup> tranche and remaining tranche has not been claimed. M & E Consultant suggested for need of structural analysis and also the correction measures in order to become eligible for remaining tranche.

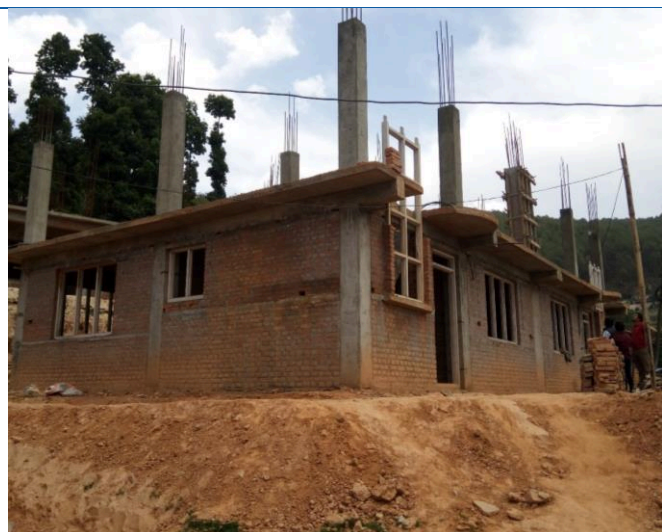
Changunarayan Municipality, Halal Gaun, Ward no. 9, one storey RCC frame structure house. Two houses belonging to brothers Mr. Arjun Thapa and Mr. Bhimsen Thapa are constructed jointly. The beneficiaries have requested for the inspection of 2<sup>nd</sup> and 3<sup>rd</sup> tranche together. M & E Consultant suggested for structural analysis of structure in order to become eligible for 2<sup>nd</sup> and 3<sup>rd</sup> tranche.

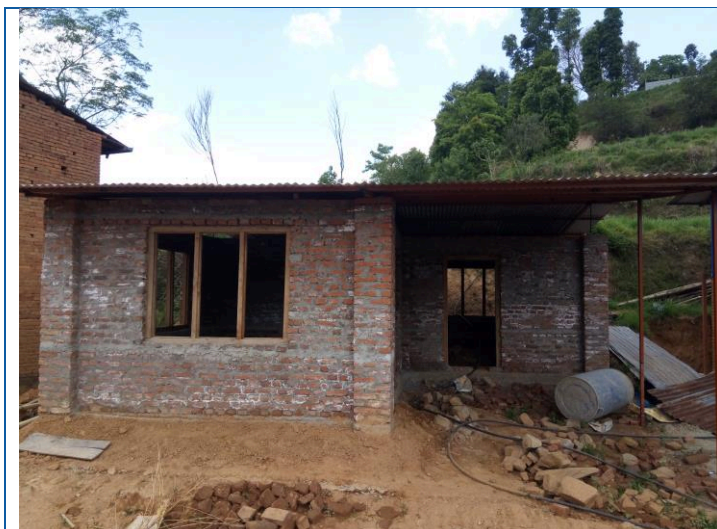
Changunarayan Municipality, Halal Gaun, Ward no. 9, load bearing structure with CGI roof. House belonged to a single woman Ms. Radha Khatri Thapa. The house was found to be non-compliance as the connection between the wall and roof, vertical reinforcement and bands were missing. After applying the correction measures inspection for the tranche can be conducted.

| <b>Objective(s)</b> | <ul style="list-style-type: none"> <li>To observe the reconstruction status of the beneficiaries</li> <li>Discuss on the reconstruction update and issues with the local representatives and seek solutions where able possible.</li> <li>To interact with DSE and DLPIU engineers about issues/challenges of the visit area.</li> <li>To provide inputs to the beneficiaries in regards of housing reconstruction and for grant receipt process.</li> </ul> | | |
|---|---|---|---|
| Vertical reinforcement is missing in most of the houses under construction. | Beneficiaries need to contact engineers for technical assistance in order to apply correction measures so that proper measures can be applied. Similarly, the concerned technical personnel should provide on-site technical support and guidance to the beneficiaries so that the houses could meet minimum requirements from the early phase of reconstruction. | Beneficiaries, local bodies, DLPIU engineers. | As soon as possible or before Ashad 2075 end. |

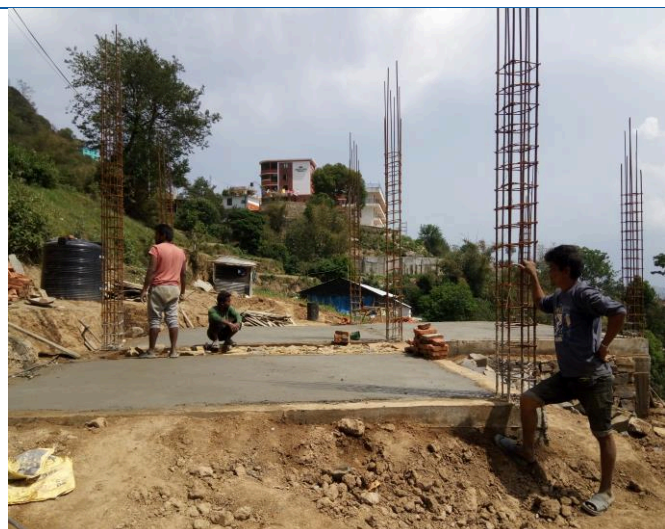
Changunarayan Municipality, Halal Gaun, Ward no. 9, DPC work of RC structure is ongoing. The beneficiary have received the first tranche.
