# District Report

## Ramechhap

28 September - 11 October 2018

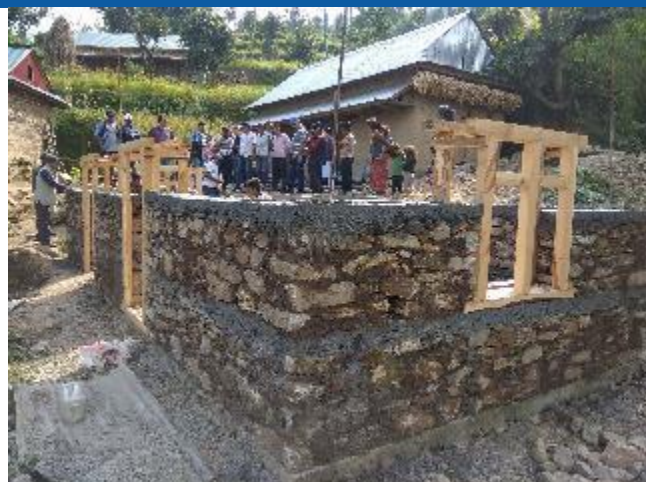
The house under construction in daduwa of doramba rural municipality being monitored by the joint monitoring team led by DLPIU Chief Mr. Parikshit Kadariya. The monitoring team suggested some minor corrections to the house being constructed. The house has been constructed under technical assistance of EFSR II of Helvetas. The house is constructed using stone in mud mortar with RC Bands. The house has been constructed upto intermediate level. The house owner has received second tranche of reconstruction grant.

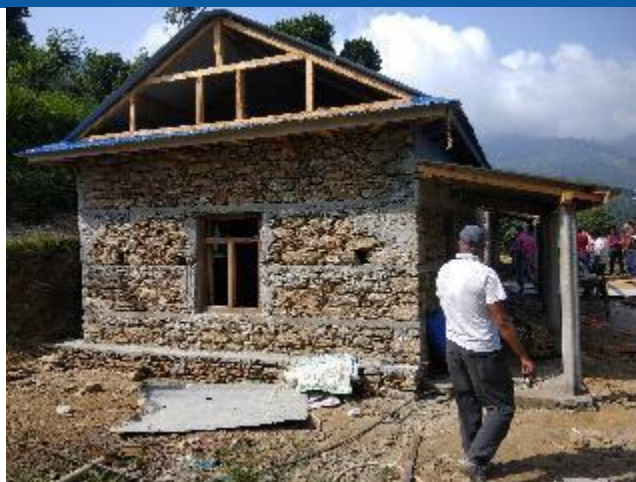
The house under construction in Fulasi of manthali municipality. The house has been constructed under EFSR II of Helvetas with SW Nepal providing Social Technical Assistance. The house is constructed using stone in mud mortar with RC Bands. The house has been almost completed only gable wall remaining and the doors and windows to install. The house owner has received second tranche of reconstruction grant and has been forwarded for third tranche.

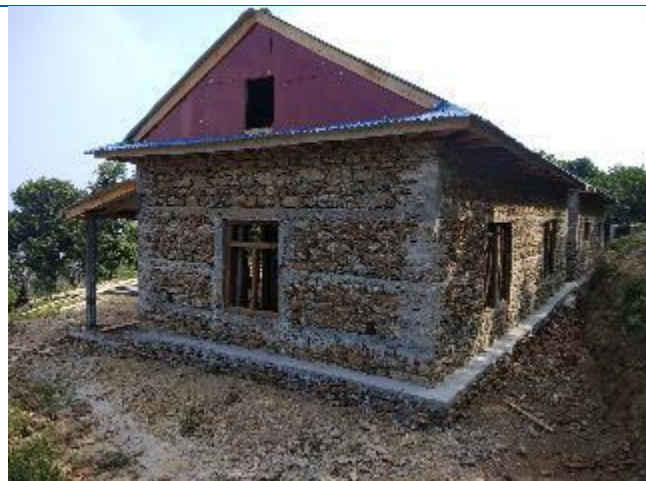
The house under construction in Fulasi of Manthali municipality. The house has been constructed under EFSR II of Helvetas with SW Nepal providing Social Technical Assistance. The house is constructed using stone in mud mortar with RC Bands. The house has been almost completed only the doors and windows to install. The house owner has received second tranche of reconstruction grant and has been forwarded for third tranche.

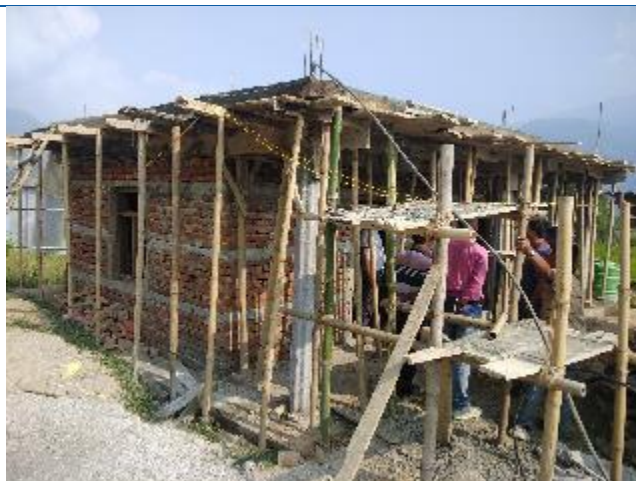
The house under construction in Fulasi of Manthali municipality. The house has been constructed under EFSR II of Helvetas with SW Nepal providing Social Technical Assistance. The house is constructed using brick in cement mortar with RC Bands. The rigid roof has been provided to the house. The house owner has received second tranche of reconstruction grant and has been forwarded for third tranche.

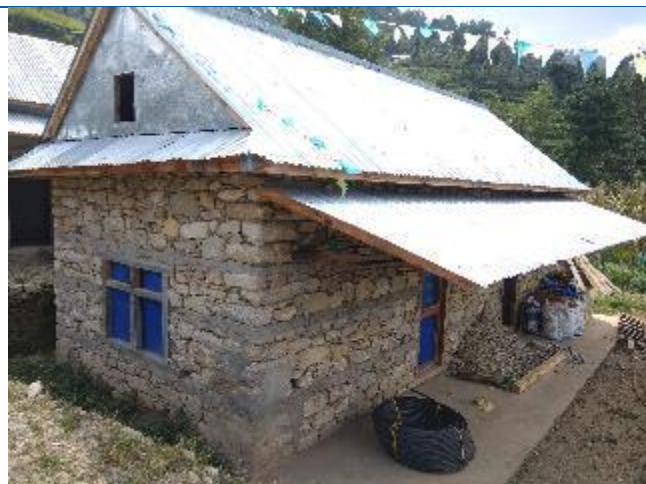
The house under construction in Daduwa of Doramba Rural municipality. The house has been constructed under EFSR II of Helvetas with SW Nepal providing Social Technical Assistance. The house is constructed using stone in mud mortar with RC Bands. The flexible roof has been provided to the house. The house owner has received second tranche of reconstruction grant and has been forwarded for third tranche.

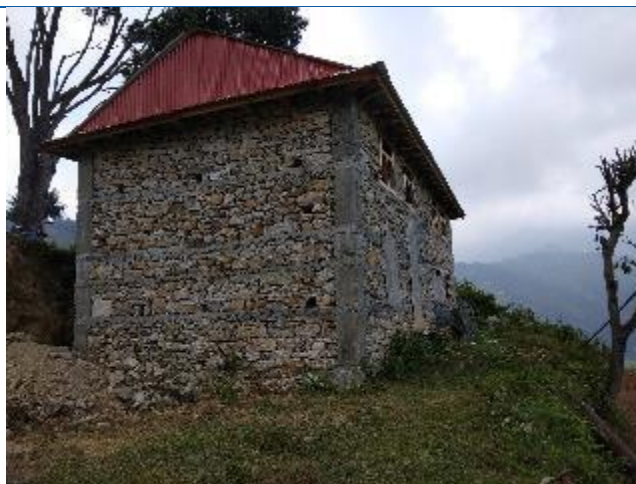
The house under construction in Daduwa of Doramba Rural municipality. The house is constructed using Stone in mud mortar with RC Bands. The flexible roof has been provided to the house. The columns have been provided in the four corners of the house. The house owner has received second tranche of reconstruction grant and has been forwarded to DSE as noncompliance issue.
