# Monthly District Report

## Kathmandu Valley

15 March – 11 April 2019

## Field Visit /Joint Field Monitoring Visit Reports

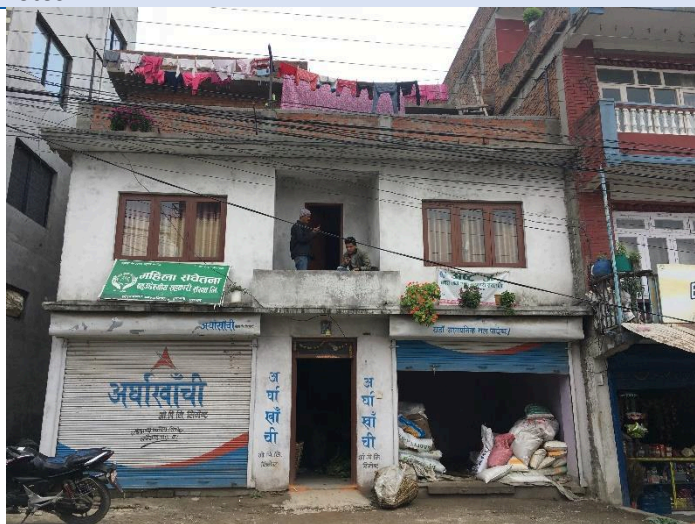
| Challenges / Issues Identified | Action Required | Responsible | Timeframe |
|---|---|---|---|
| Municipality has been approving the design and giving building permit to RC structure with 9"X12" pillar size for 3 storey and more which is found to be unsafe during the structural analysis. | As per MRT the 12"X12" column so Technical staffs of Municipality should not promote such construction practice and disapprove such houses. | Municipality, DLPIU- Building, CLPIU- Building | As soon as possible |

Beneficiary name: Jiban Prasad Pradhan, Duwakot, ward no 2, Changunarayan Municipality, Bhaktapur. 2 and half storey 10 roomed Reinforced Cement Concrete Framed Building (RCC) structure with 9"X12" column. The structure was found to be unsafe by the structural analysis conducted by the DSE. At present the file cannot be forward for the tranche.

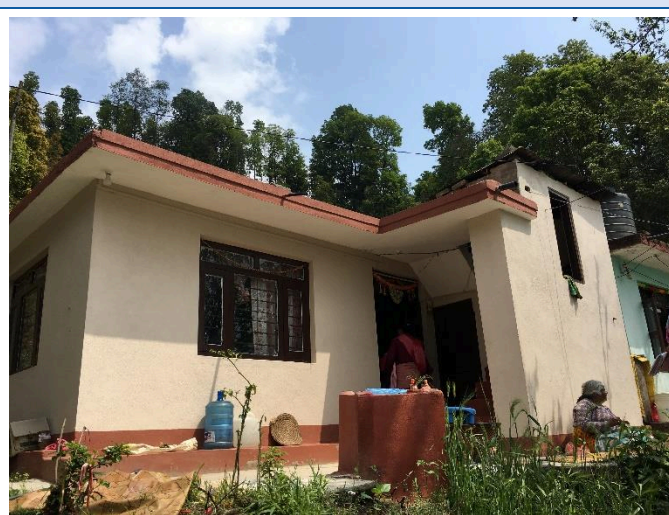
Beneficiary name: Pabitra Poudel, Ward no 4, Changunarayan Municipality. 1 storey, 4 roomed Load Bearing Brick and Cement Mortar Masonry structure. The house was listed as non-compliance as the beam, bands and vertical reinforcement were missing in the house. Correction measures such as addition of bands, reinforcements were suggested to the beneficiary. The house was constructed immediately after the earthquake.

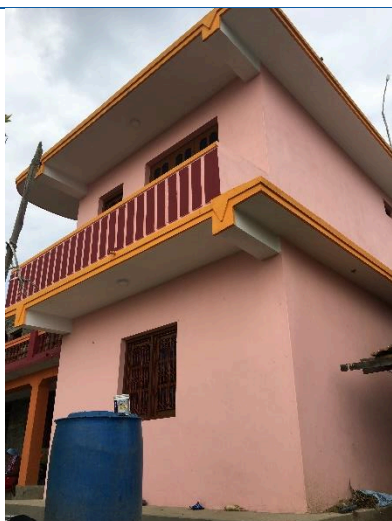
Beneficiary name: Shyam Krishna Nepal, Bageshwori, ward no 7, Changunarayan Municipality. 2 storey , 8 roomed structure. The beneficiary claims the structure to be confined masonry with the use of 9"X9" column. The house is not as per the build drawing. The detail of the house couldn't be observed as the house was completed and painted. DLPIU- Bhaktapur will be discussing on the issue and possible measures will be suggested soon.

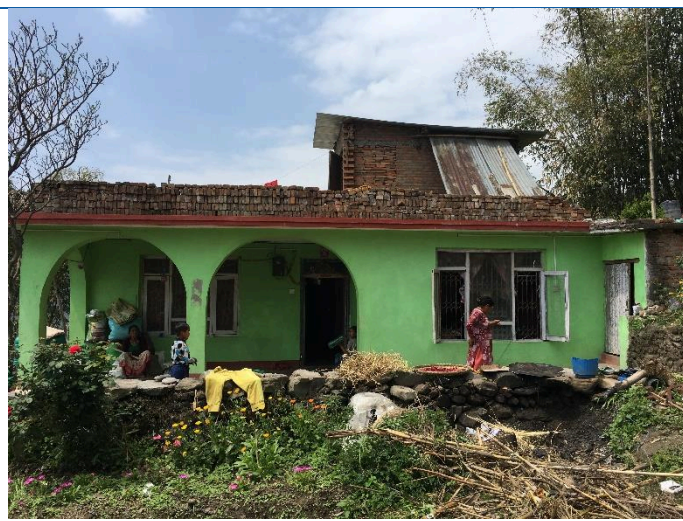
Beneficiary name: Bhairab Bahadur Thapa, ward no. 4, 1 storey Load Bearing Brick and Cement Mortar Masonry structure. The house was constructed immediately after the earthquake and the earthquake resistant elements such as beam, and bands are missing. The beneficiary also expressed interest in adding another storey to the house. Monitoring team suggested the beneficiary not to do so as the structure will be at risk.

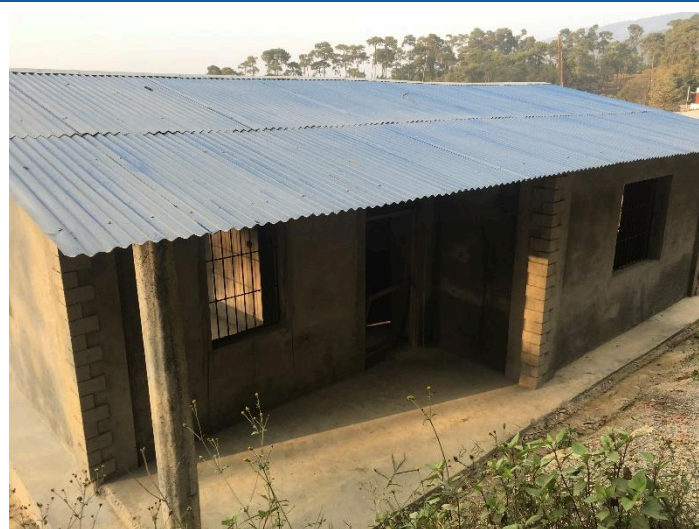
Beneficiary name: Mohan Khadka, Ward no 10, Khadka Gaun, Suryabinayak Municipality. 1 storey load bearing BMC structure with CGI roof. The beneficiary has requested for 2<sup>nd</sup> and 3<sup>rd</sup> tranche together at the time of inspection.

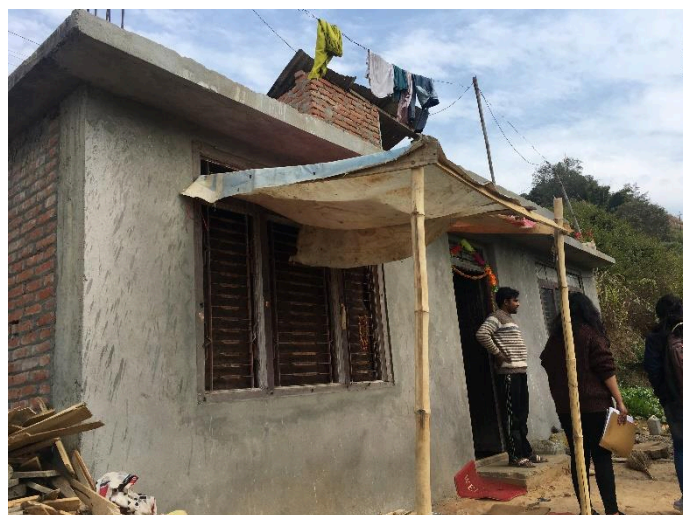
Beneficiary name: Suman Pariyar, Ward no. 10, Khadka Gaun, Suryabinayak Municipality. 1 storey RC structure has beam missing during inspection. Beneficiary has received 1<sup>st</sup> tranche.
