# District Report

## Ramechhap

4 - 17 January 2019

### Visit 1

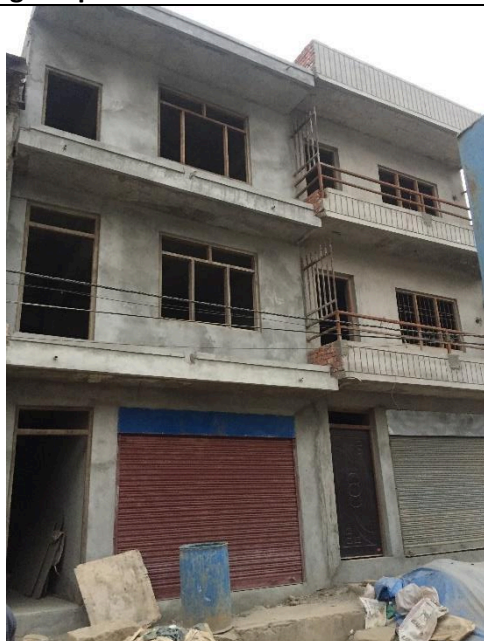
RCC house reconstruction at Ramechhap Municipality ward-3, Sanghutar.

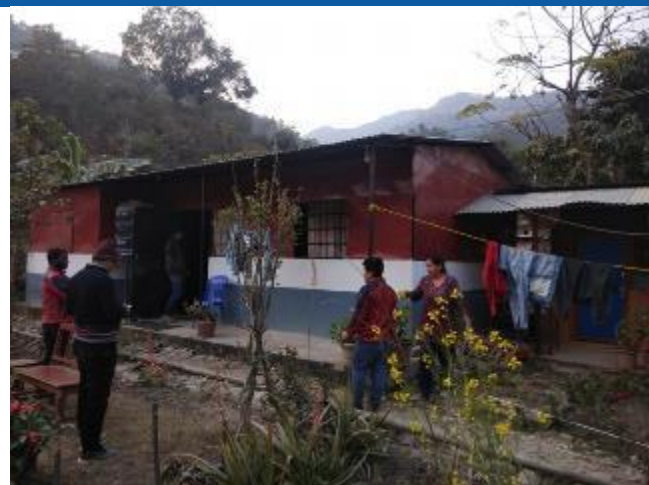
The house of Madan Bhaukaji constructed in Sanghutar, Ramechhap Municipality-3. The house has been constructed using walls made from bamboo which is concreted from outside upto 4 feet height and the remaining wall is constructed with CGI Sheet. The hollow steel post has been erected from the foundation level. The DPC has been provided in the house. The house was constructed in Bhadra 2072 before arrival of technical persons.

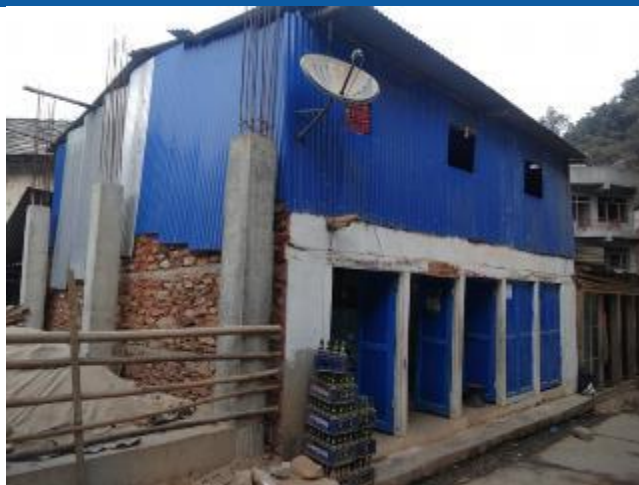
The house of Chatra Bahadur Pradhan constructed in Sanghutar, Ramechhap Municipality-3. The house has been constructed with load bearing structure in ground floor. The ground floor has been constructed by using brick in cement mortar. The RC bands has been provided in the house. The house is provided with Excess openings. The first floor is constructed by using timber and CGI Sheet. There is no proper connection between two floors. The house is considered as hybrid Structure. The house owner has received first tranche of reconstruction grant.

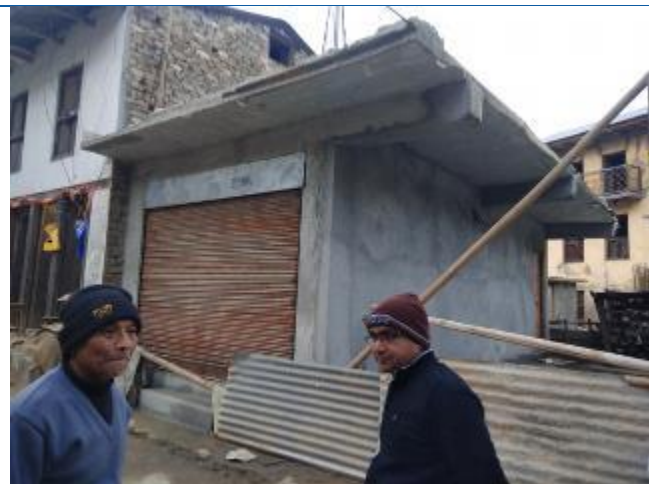
The house of Diwat Kumar Shrestha constructed in Sanghutar, Ramechhap Municipality-3. The house is constructed on a single bay. The SAP analysis is done for the house to proof the earthquake resilience structure. The house constructed is RCC structure. The house owner has received all three tranches of reconstruction grant.

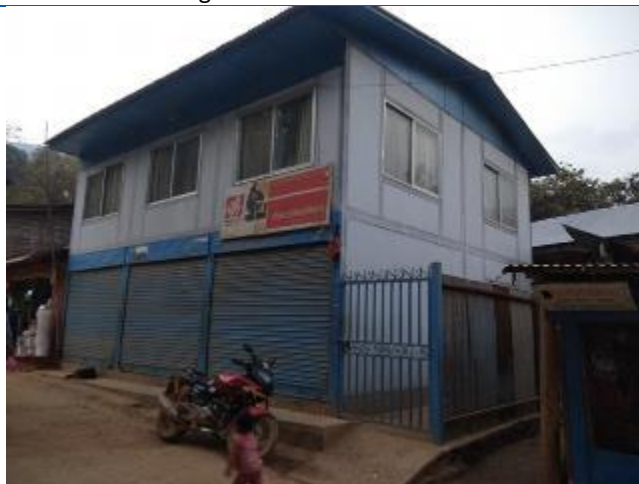
The house of Narayan Das Shrestha constructed in Sanghutar, Ramechhap Municipality-3. The house is constructed using prefab. The house is considered as semi-permanent structure. The house owner has received first tranche of reconstruction grant. The house is registered as non-compliant case.

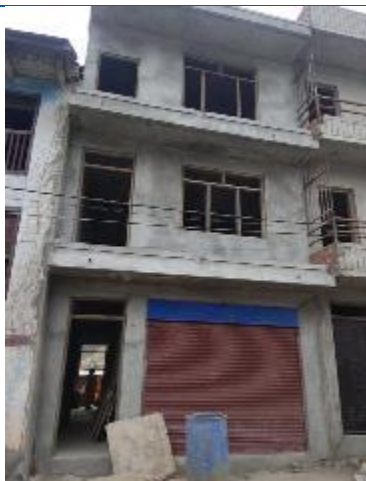
The house of Sanjeev Shrestha constructed in Sanghutar, Ramechhap Municipality-03. The house is a RC Frame structure. It has been provided with 4-16 dia and 4-12 dia bars in column. The size of column is found to be 12"x12". The house is constructed using double tie beam. The house owner has received second tranche and has been forwarded for third tranche of reconstruction grant.

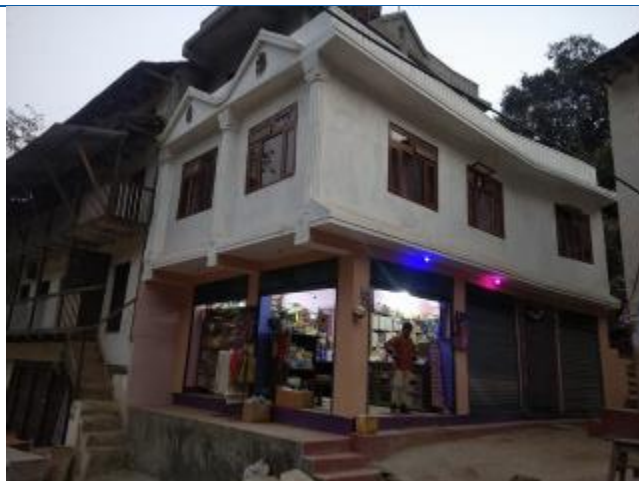
The house of Raj Babu Bhaukaji constructed in Sanghutar, Ramechhap Municipality-03. The house is a RC Frame structure. It has been provided with 4-16 dia and 4-12 dia bars in column. The size of column is found to be 12"x12". The house is constructed using double tie beam. The house owner has received second tranche and has been forwarded for third tranche of reconstruction grant.

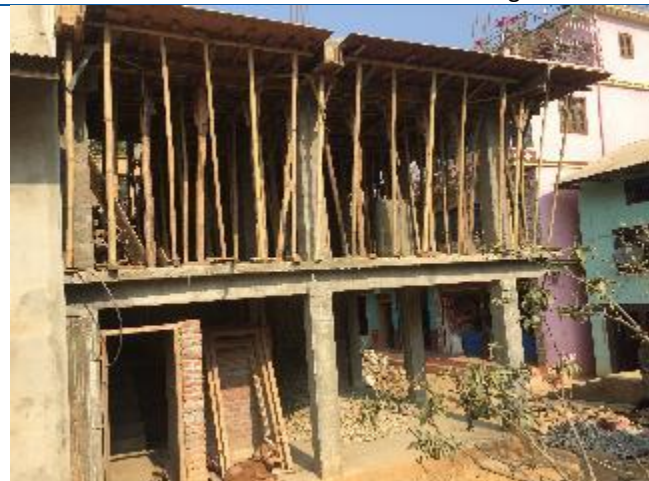
The house being constructed in Sanghutar, Ramechhap Municipality is being claimed by the house of two brothers Tula Bahadur Magar and Prem Bahadur Magar. Both brothers are in the reconstruction beneficiaries list. The two brothers claim that they donot have any land in other place. The case has been forwarded to GMall for further decision.
