# District Report

## Sindhuli

25 May - 7 June 2018

### Field Visit Reports

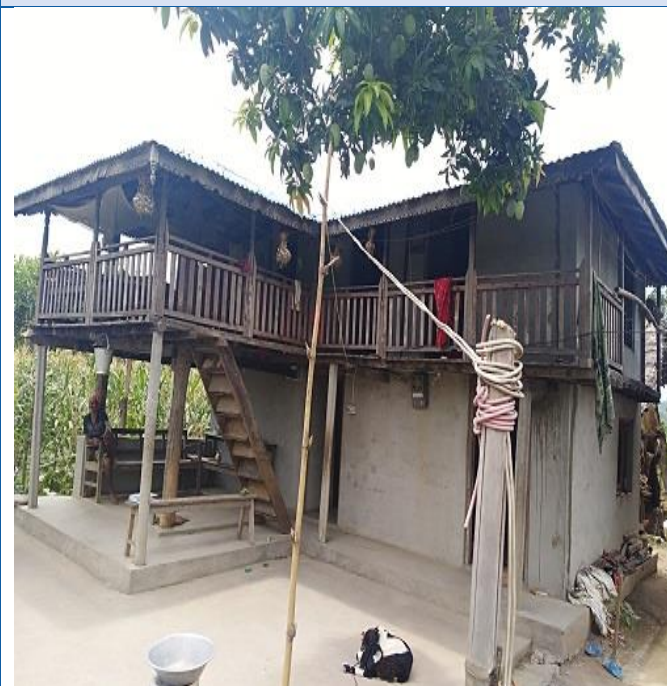
Timber framed structure house located in Dudhauli ward no – 09 of Dudhauli Urban Municipality, Sindhuli district. This house was built recently after the Gorkha Earthquake, it is L-shaped so, we provided some correction measures to the house owner during visit. House owner is waiting for government 3<sup>rd</sup> tranche.

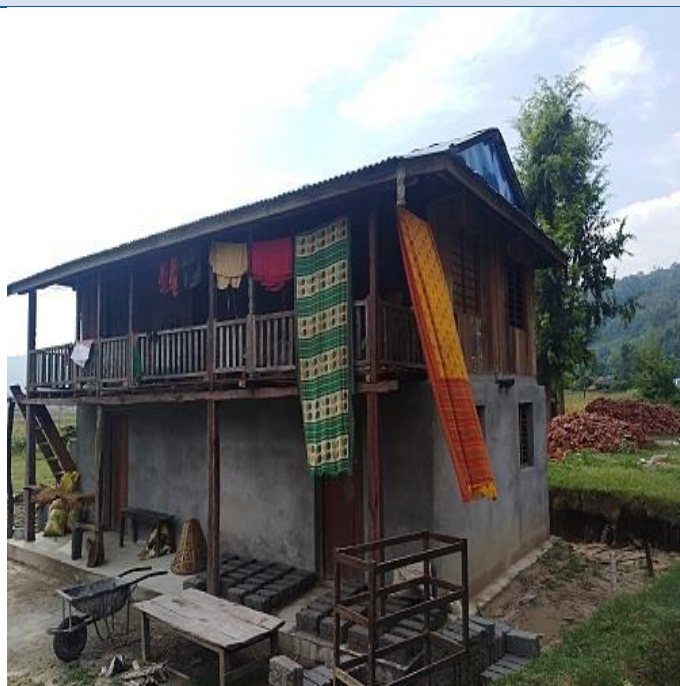
Timber framed structure house located in Bhimasthan Ward no – 03 of Tinpatan Rural Municipality, Sindhuli district. This house was built recently after the Gorkha Earthquake, before the deployment of DLPIU Engineers. Few corrections are required to make compliance so that house owner would get government 3<sup>rd</sup> tranche.

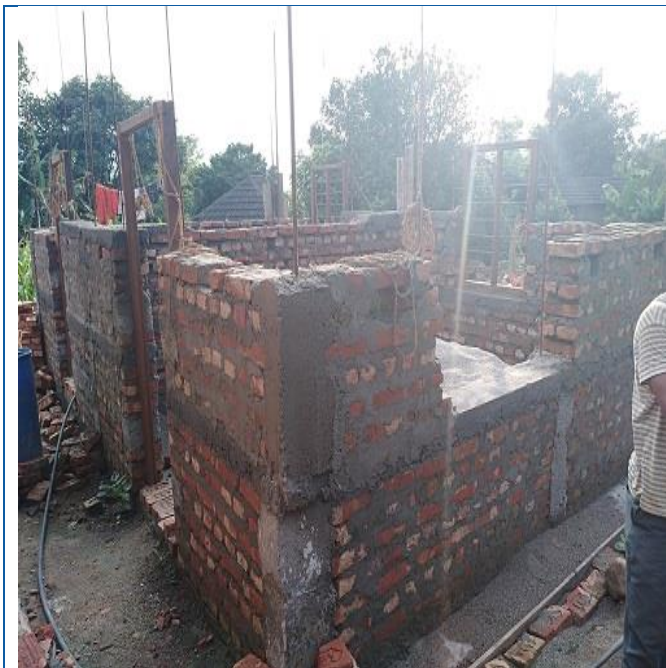
Brick Masonry building located in Bhimasthan ward no – 03 of Tinpatan Rural Municipality, Sindhuli district. This house is in the stage of under construction, it seems non-compliance because RCC column with single reinforce bar. The house owner has received government 2<sup>nd</sup> tranche.

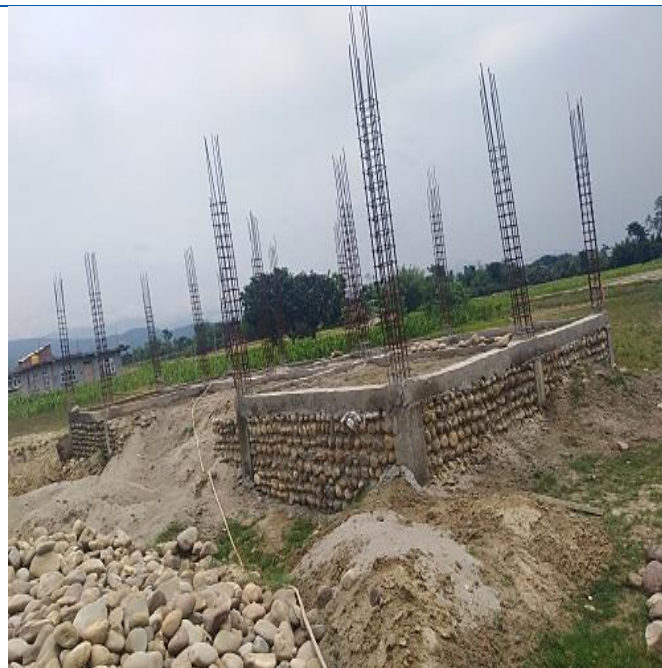
RCC building located in Dudhauli ward no – 09 of Dudhauli Urban Municipality, Sindhuli district. According to DLPIU Engineer, the house owner has started reconstruction without design and drawing approval from Municipality and the shape of building is C. The house owner has only received government 1<sup>st</sup> tranche.

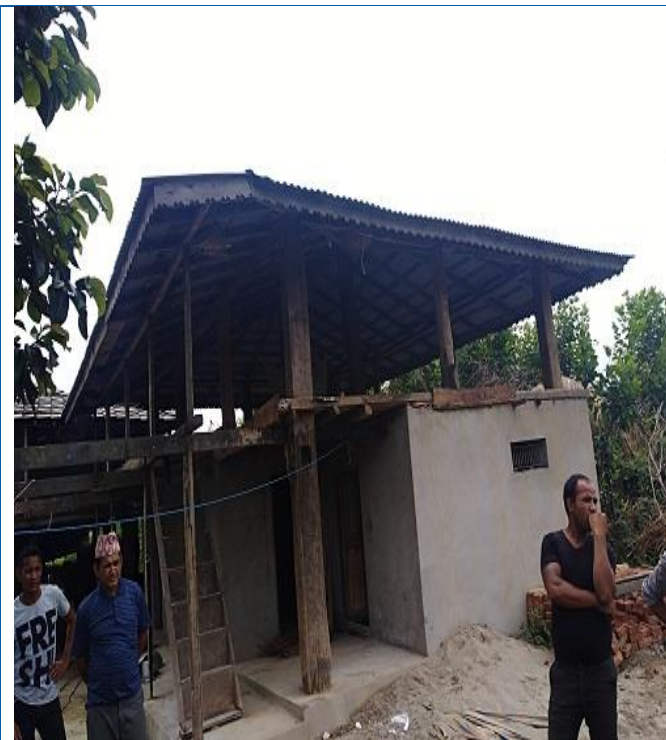
Timber framed structure house located in ward no – 07 of Dudhauri Municipality, Sindhuli district. The house is in the stage of under construction. We suggested house owner to extend the ground floor wall up to vertical timber post and in the first floor to use light construction material to make compliance. House owner has received government 2<sup>nd</sup> tranche and waiting for 3<sup>rd</sup> tranche.

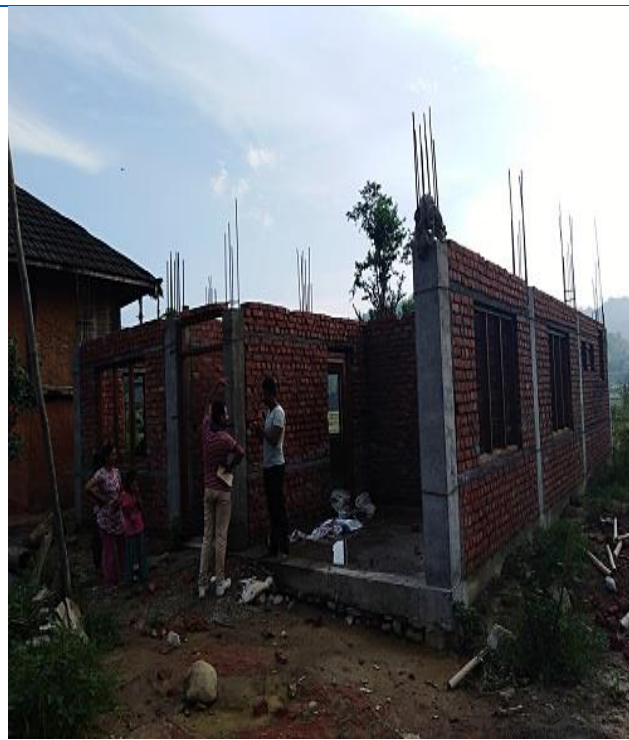
RCC framed structure building located in Bhimsthan ward no – 03 of Tinpatan Rural Municipality, Sindhuli district. The house was non-compliance so DSE providing technical support to beneficiary so that she/he can receive government 3<sup>rd</sup> tranche.
