## Monthly District Report

### Nuwakot, Rasuwa

9 May - 13 June 2019

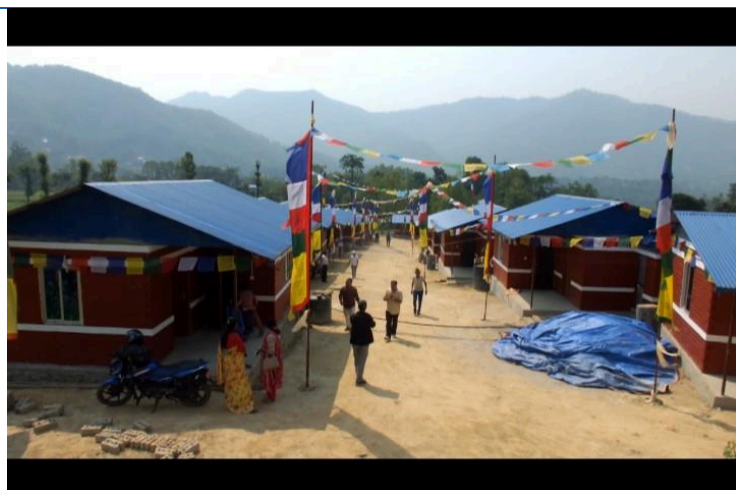
A view of Barthok, Ghaletole integrated settlement in Jafati, ward no. 9 of Bidur Municipality. Total 18 displaced HHs are relocated under the process of NRA and construction Supported by OXFAM/SSS. All the structures are built using with interlocking block and flexible roof.

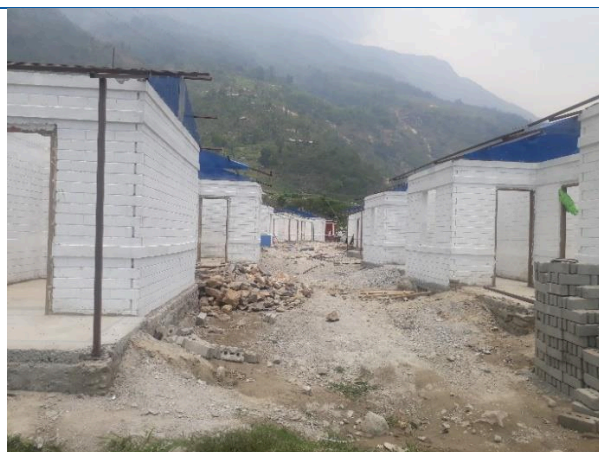
Ongoing construction of 16 houses of displaced beneficiaries in Mathillo Shantibazar integrated settlement in Kispang Gaupalika under NRA relocation process and supported by OXFAM/SSS

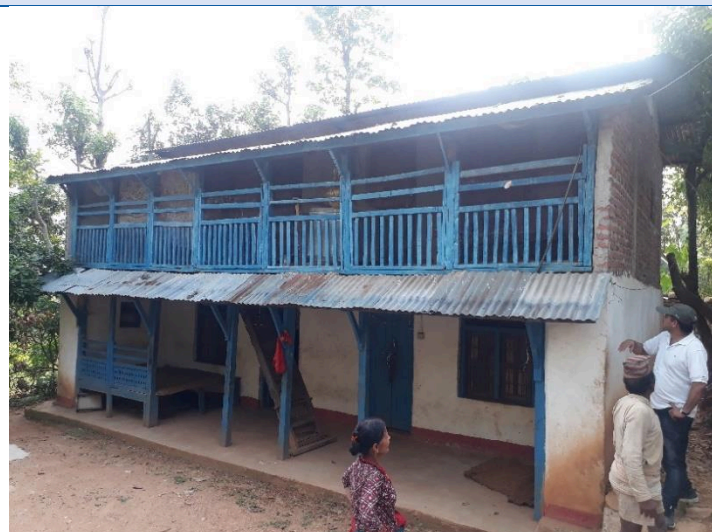
Beneficiary name: Chhabilal Adhikari, KhadgaBhanjyang, ward no 3, Bidur Municipality, Nuwakot. 2 storey 3 roomed Reinforced Cement Concrete Framed Building (RCC) structure with 9"X12" column. The structure was found to be unsafe by the structural analysis. So, it is on process to forward in the list of the non-compliance houses which

were constructed immediately after EQ and before publication of the NRA guideline and deployment of the technical staffs.

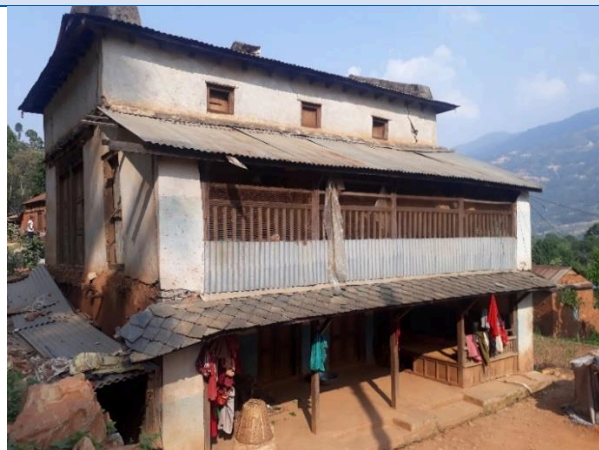
Beneficiary name: Shalikram Ghimire, Khadga Bhanjyang, Ward no 3, Bidur Municipality. A damaged 3 storey SMM house is still used for kitchen and storage though beneficiary have reconstructed a house and have received all the tranches of housing

grant. Such damaged structures are still in use and have not been demolished in the fields.

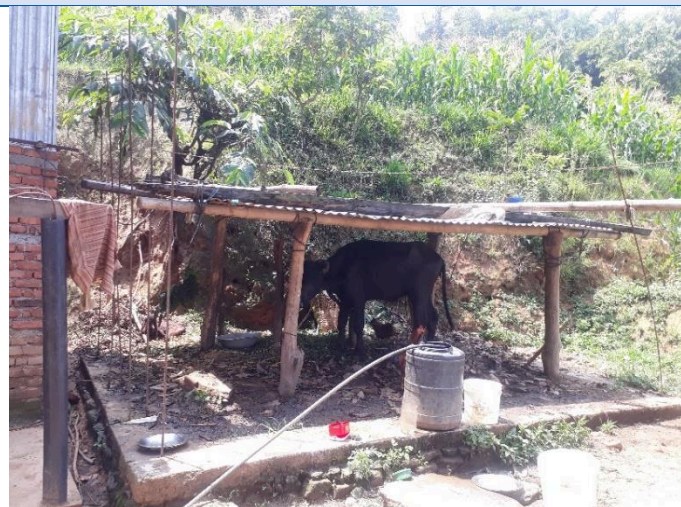
Beneficiary name: Santa Bahadur Tamang, Bahundada, ward no 8, Belkotgadhi Municipality, Nuwakot. A 69 years old beneficiaries reconstructed his house up to DPC level a year ago and received second tranche. The structure up to DPC level is being used for animal shed. Since his wife died after EQ, he is living with family of son. His son is also a beneficiary and he reconstructed a hybrid 2 storey house and received 3 lakhs already. (His intention to build further could not find out since his absence in the field)

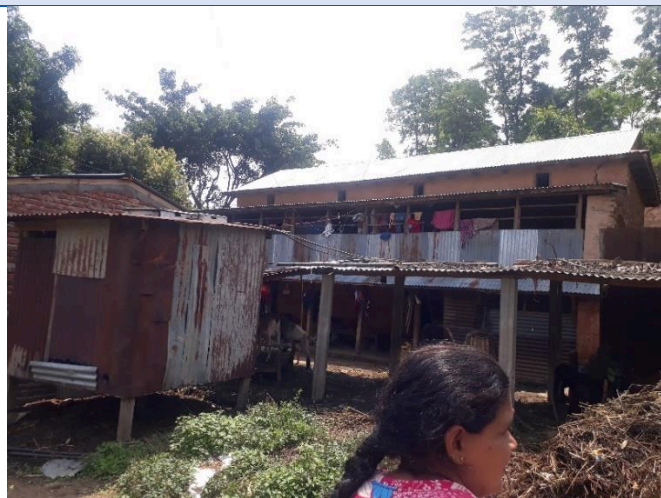
Beneficiary name: Delnath Dahal, Jiling Bahundada Ward no 8, Belkotgadhi Municipality. A family of 9 members living in EQ damaged SMM house which construction was completion phase in EQ happened. They reconstructed a BMC one roomed house opposite to the damaged house and the one roomed house is on use for grand-parent to sleep.

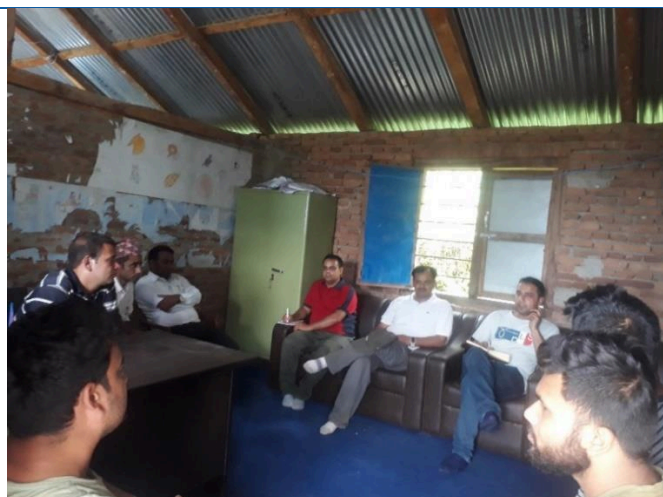
Meeting in ward no. 9, BelkotGadhi Municipality. Discussion over reconstruction issues and challenges with ward chairperson, ward secretary and ward engineers. The team of all 11 participants had observed some houses in the field nearby after the meeting.

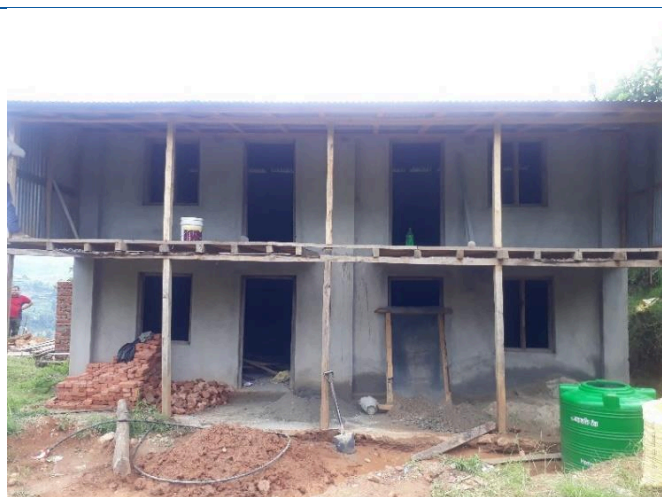
Beneficiary name: Arjun Prasad Gajurel, Gairaghar ward no. 9, BelkotGadhi Municipality. Load Bearing BMC received 2<sup>nd</sup> Tranche. The structure of 9"X12" wall has exceeded 6" attic height and listed as non-compliance.

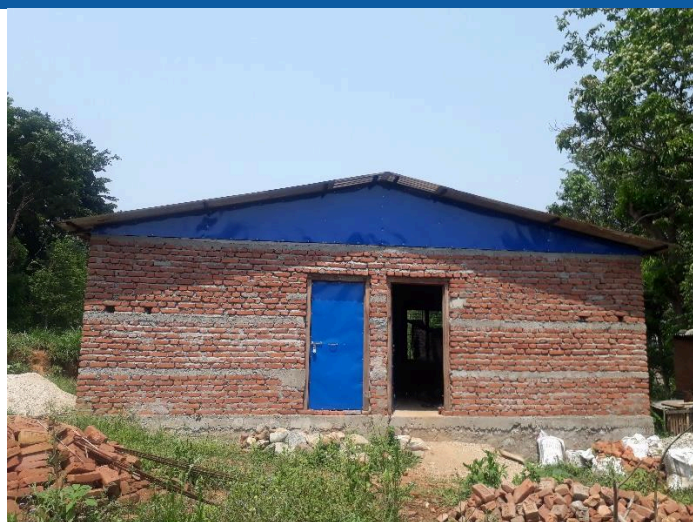
Beneficiary name: Bhim Bahadur Majhi, Ward no 3, MajhiGaun, Bidur Municipality. 1 storey, 2 roomed load bearing BMC structure with flexible roof. The beneficiary has already received all tranches. A family having 5 members sleep in this house and the EQ damaged house is being used for kitchen.

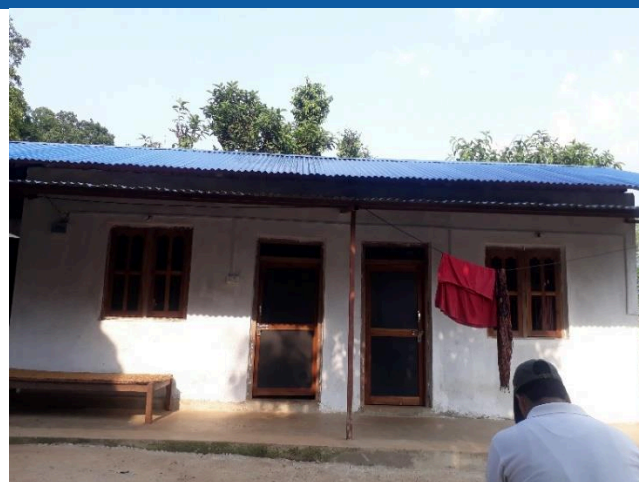
Beneficiary name: ChakraPani Adhikari, Ward no. 3, KhadgaBhanjyang, Bidur Municipality. 1 storey, 2 roomed Loadbearing structure.

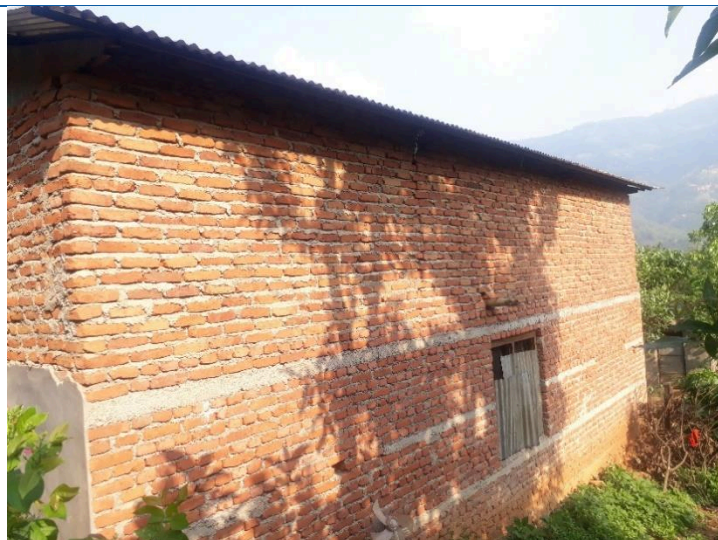
Beneficiary name: Gyan Bahadur Rai, KhadgaBhanjyang ward no. 3, Bidur Municipality. 2 storey Load Bearing Brick and Cement Mortar Masonry structure (BMC). The house was listed as non-compliance as it has missing the earthquake resistant elements such as roof band and exceeded attic height.

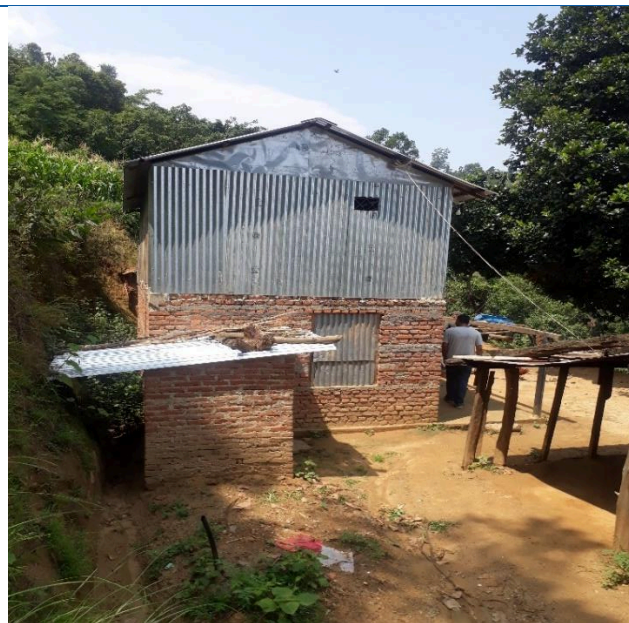
Beneficiary Name: Sanukanchha Tamang, KhadgaBhanjyang ward no. 3, Bidur Municipality. 2 storey hybrid structure received third tranche.
