## District Report

### Dhading

23 Nov - 6 Dec 2018

## Field Visit Report

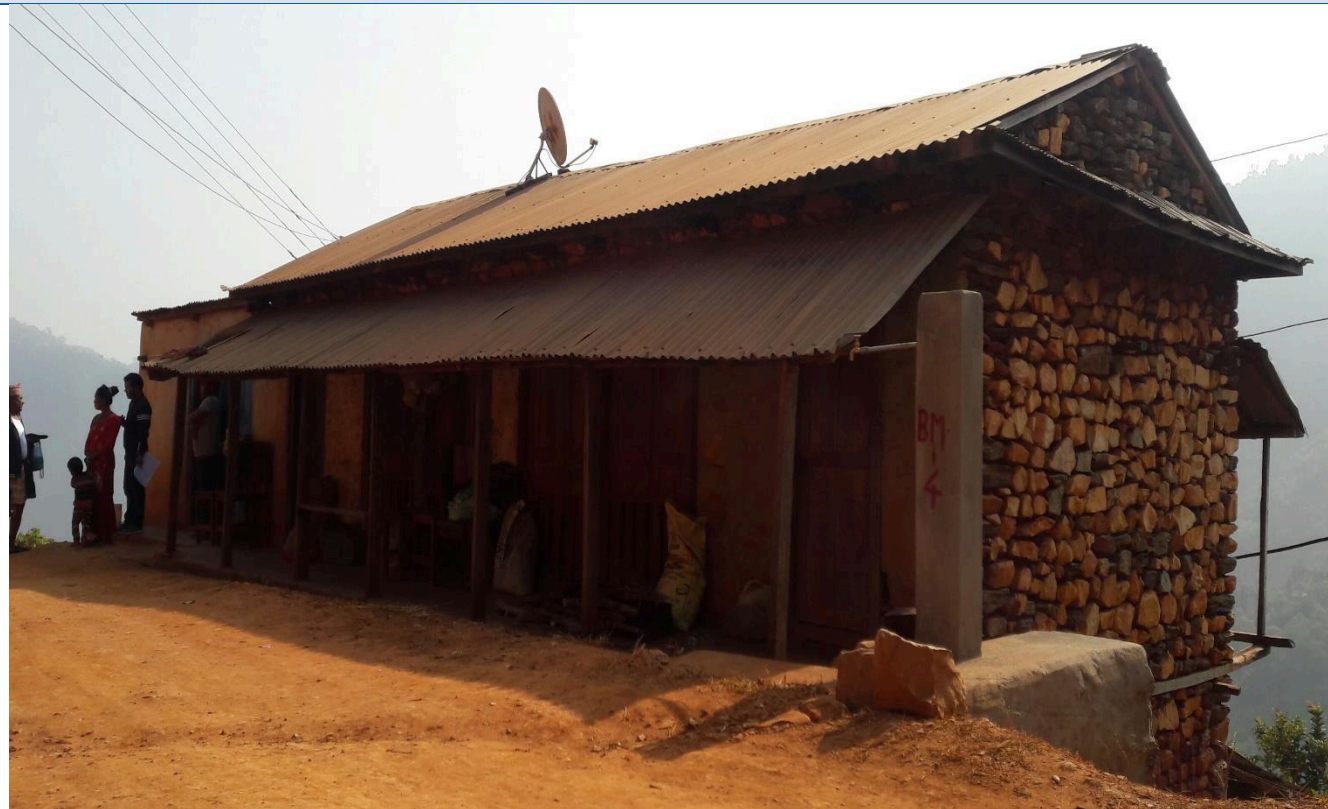
Rajendra Puri is a beneficiary whose PA no is (30-39-8-0-84). This is the house damaged in earthquake 2072 which has not been demolished yet. He has not started reconstruction while he has been listed for second tranche due to the technical error in MIS. He uses to stay more in ktm and less in this vdc. He has already taken first and second tranche of government grant without constructing new house so he has two option either he should return the money or he should reconstruct his new house.

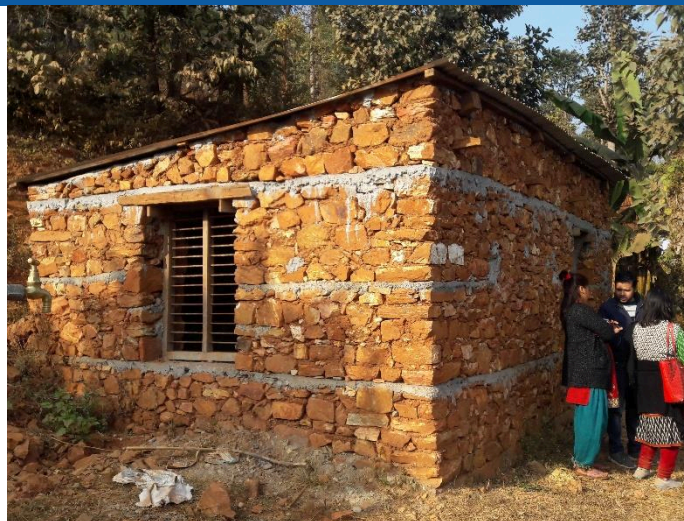
Name: - Thug Bahadur Pata Magar  
Location: - Salang 04, Siddhalekh Rural Municipality  
He has received all three tranches of government grant  
It is a one-storey stone masonry in mud mortar building with all necessary vertical and horizontal bands. The construction of house is completed.

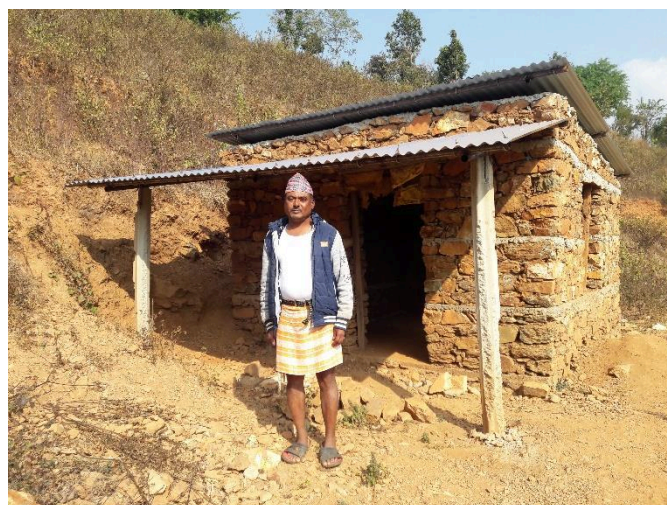
Name: - Laxman Sahi  
Location: - Salang 04, Siddhalekh Rural Municipality  
He has received second tranche of government grant  
It is a one-storey stone masonry in mud mortar building with all necessary vertical and horizontal bands. The construction of house is completed.

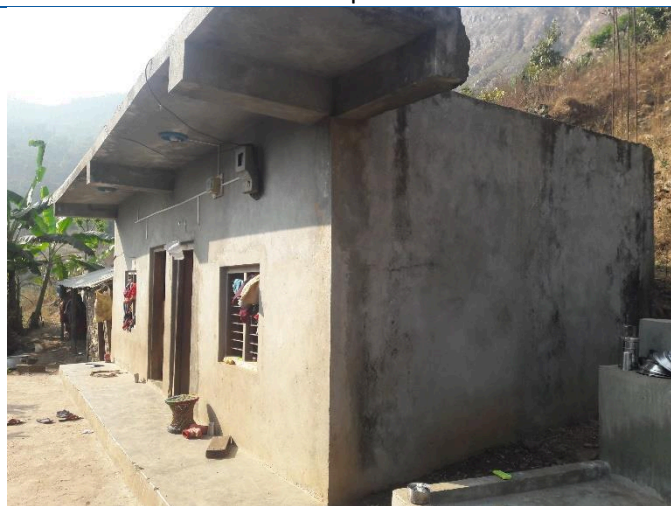
Name: - Bishnu Maya Puri  
Location: - Salang 04, Siddhalekh Rural Municipality  
He has received second tranches of government grant  
It is a one-storey RCC framed structure building with brick masonry in cement mortar as infill wall. The construction of house is completed. The house owner uses 10 mm rebar – 4 nos, (9" x 9") size at column. DLPIU Engineer forwarded this file to District support engineer and as a result via analysis this house fails.

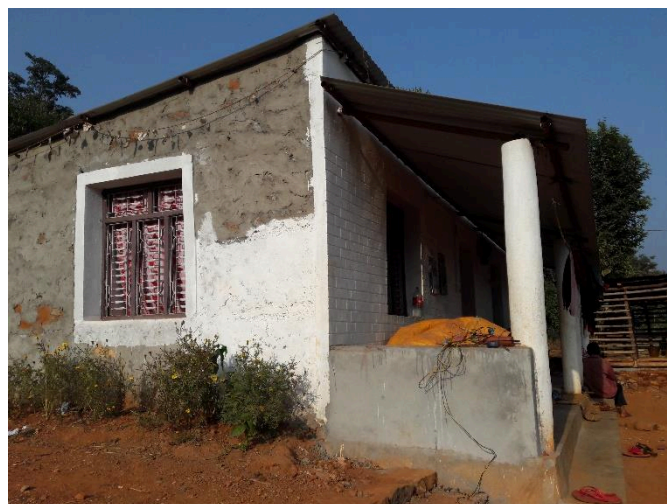
Name: - Chameli Magar  
Location: - Salang 04, Siddhalekh Rural Municipality  
He has received all three tranches of government grant  
It is a one-storey stone masonry in cement mortar building with all necessary vertical and horizontal bands. The construction of house is completed.
