# District Report

## Ramechhap

22 June - 5 July 2018

## Housing Typology Report

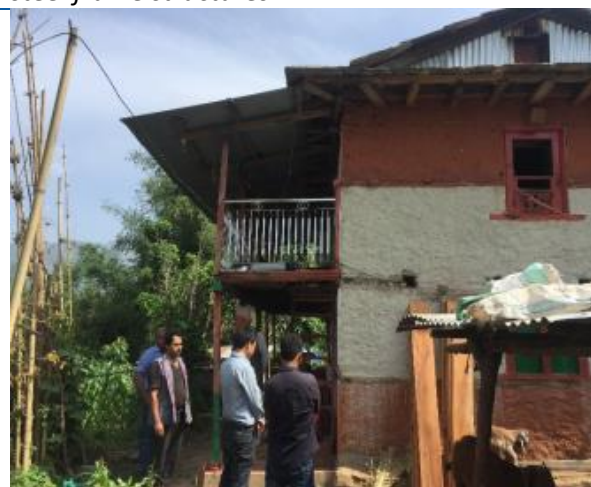
*DLPIU Engineer and HRRP team monitoring the Non-compliant house at Bethani of Gakulganga Rural Municipality.*

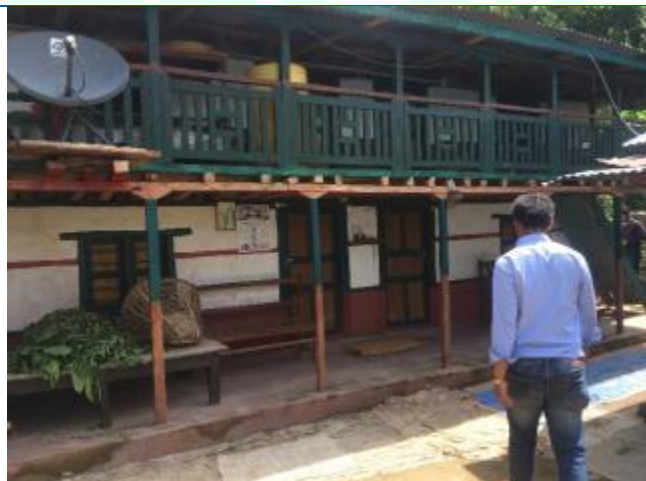
*NRA/DLPIU Engineer inspection a house at ward-8, Bethani Gokulganga Rural municipality.*

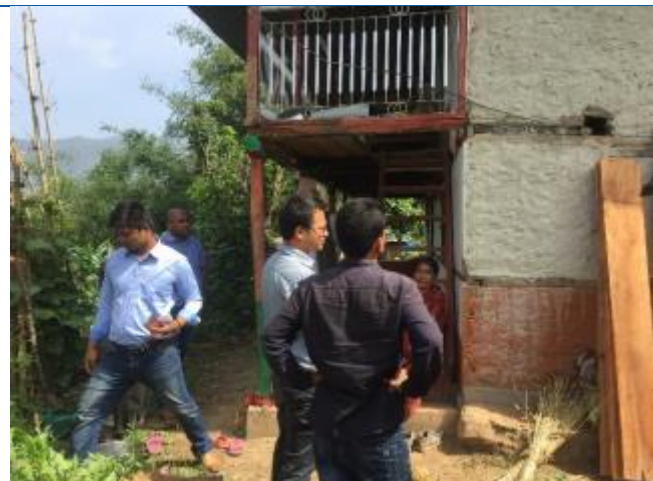
*DSE Mr. Nimesh Maharjan is discussion with house owner at Bethani Ward-8 while monitoring visit.*

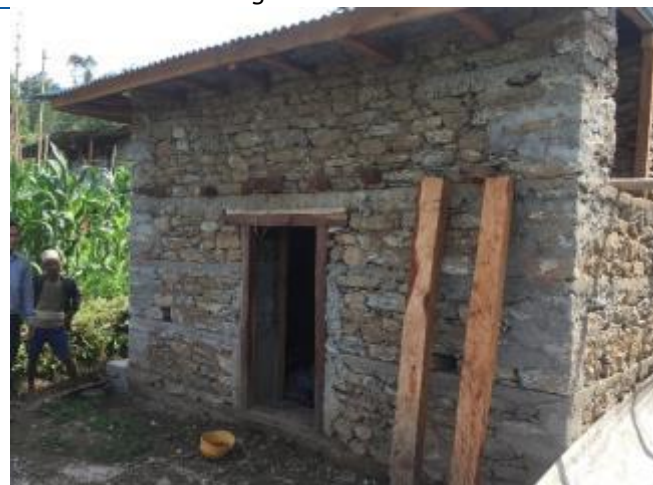
*One room house at Bethani Gokulganga Rural Municipality*

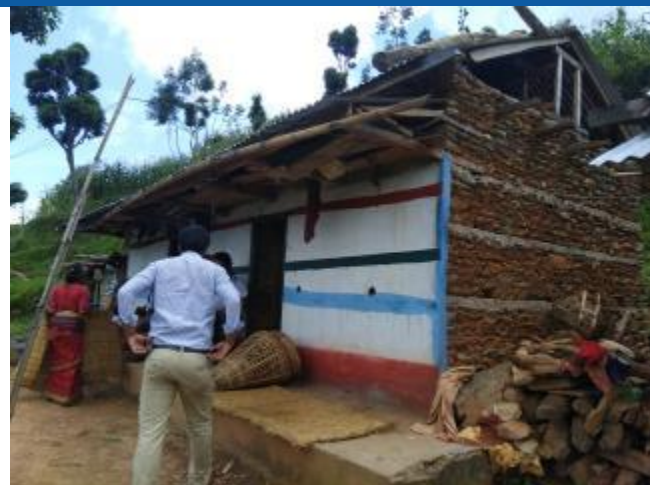
The house of Sakkal Bahadur Sarki constructed in Gothgaun, Ramechhap-1. The house has been constructed using stone in mud mortar and RCC Bands have been provided. The gable wall was constructed using heavy materials without gable band. After the consultation of the NRA Engineer, the heavy gable wall has been removed and will be replaced by light structures. The house owner has received second tranche of reconstruction grant

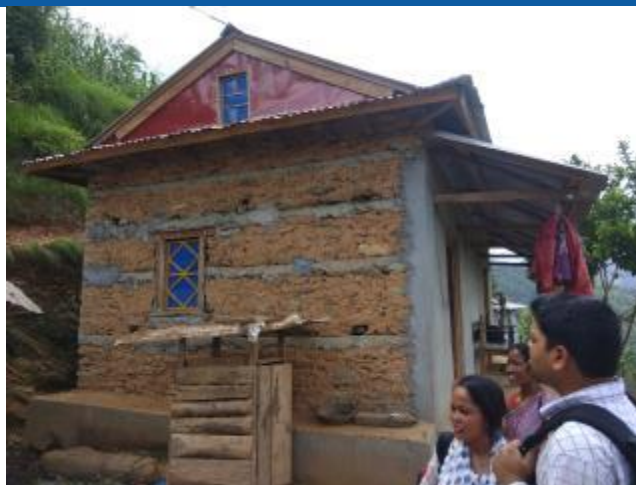
The house of Nar Bahadur Sarki constructed in Gothgaun, Ramechhap-1. The house has been constructed using stone in mud mortar and RCC Bands have been provided. The gable wall was constructed using heavy materials without gable band. After the consultation of the NRA Engineer, the heavy gable wall has been removed and has been replaced by light structures. The house owner has received second tranche of reconstruction grant and has been forwarded for the third tranche.

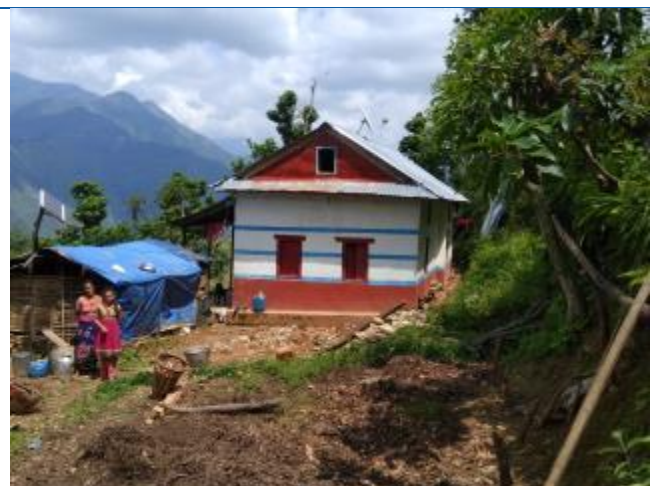
The house of Menuka Sarki constructed in Gothgaun, Ramechhap-1. The house has been constructed using stone in mud mortar and RCC Bands have been provided. The gable wall was constructed using heavy materials without gable band. After the consultation of the NRA Engineer, the heavy gable wall has been removed and has been replaced by light structures. The house owner has received second tranche of reconstruction grant and has been forwarded for third tranche. The external buttress wall has been provided in the house along with the inter partition wall.

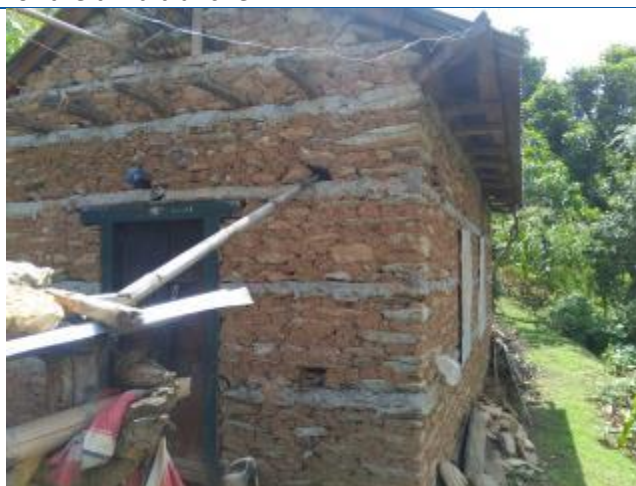
The house of Sukamaya Sarki constructed in Gothgaun, Ramechhap-1. The house has been constructed using stone in mud mortar and RCC Bands have been provided. The gable has been constructed using heavy materials without gable band. After the consultation of the NRA Engineer, the house owner has agreed to replace the heavy gable wall by light structures. The house owner has received second tranche of reconstruction grant.

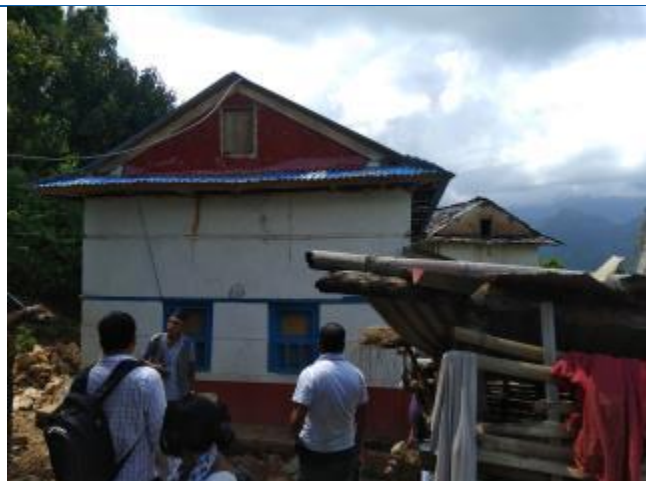
The house of Kalu Sarki constructed in Gothgaun, Ramechhap-1. The house has been constructed using stone in mud mortar and RCC Bands have been provided. The gable wall was constructed using heavy materials without gable band. After the consultation of the NRA Engineer, the heavy gable wall has been removed and has been replaced by light structures. The house owner has received second tranche of reconstruction grant and has been forwarded for the third tranche.

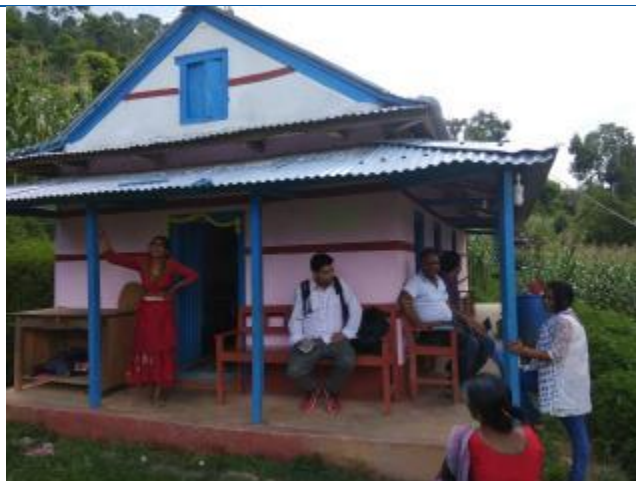
The house of Ros Bahadur Nepali constructed in Gothgaun, Ramechhap-1. The house has been constructed using stone in mud mortar and RCC Bands have been provided. The gable wall has been constructed using heavy materials without gable band. The house owner has received second tranche of reconstruction grant.

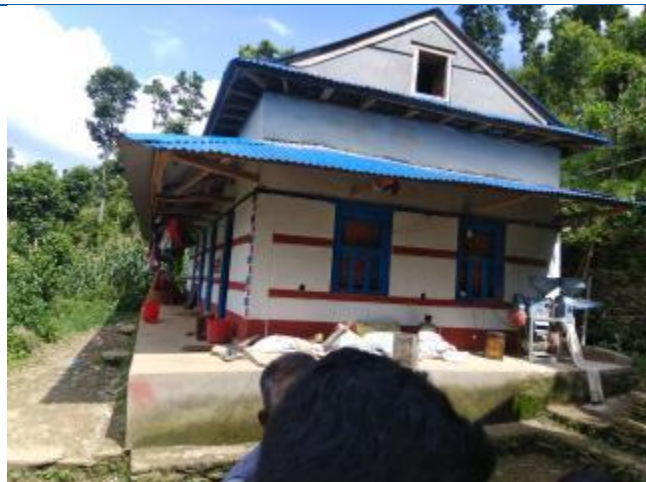
The house of Ghamanda Maya Budhathoki constructed in Gothgaun, Ramechhap-1. The house has been constructed using stone in mud mortar and RCC Bands and timber bands combinedly have been provided. The gable wall has been constructed using heavy materials without gable band. The attic height has exceeded three feet. The house owner has received second tranche of reconstruction grant

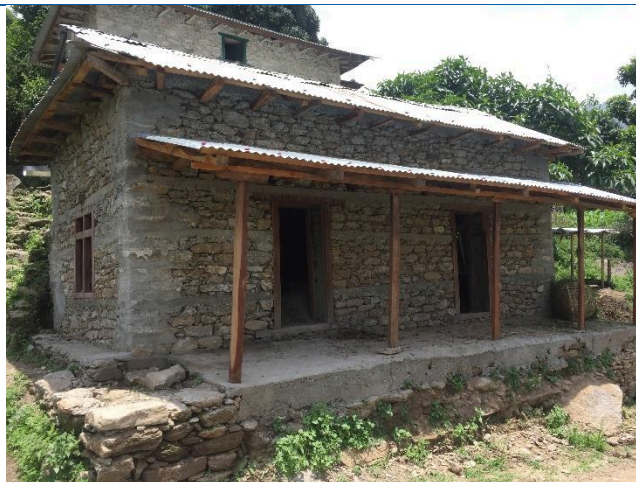
The house of Top Nath Ghimire constructed in Bethani, Gokulganga-8. The house has been constructed using stone in mud mortar and RCC Bands has been provided. The house is non-compliant because the plinth band has been missed. The house owner has received second tranche of reconstruction.
