# District Report

## Okhaldhunga

8-19 July 2018

## Housing Typology Report

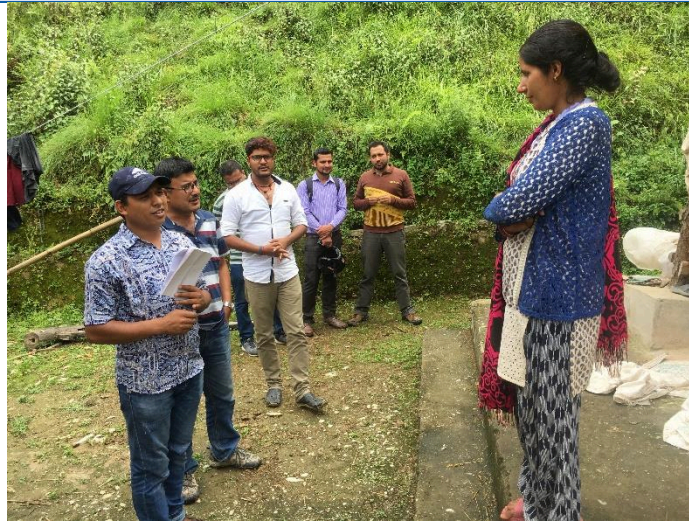
| | | | | | | | | | | | | |
| Ward 3, siddhicharan municipality, Okhaldhunga:<br>Bijaya muni Bajracharya DE GMALI and visiting team discussion with the beneficiaries regarding the noncompliance issues of her house. | | Ward 3, siddhicharan municipality, Okhaldhunga:<br>Bijaya muni Bajracharya DE GMALI and visiting team during unformal meeting with ward president Mr. Rahar Man Rai | | | | | | | | | | | | | |

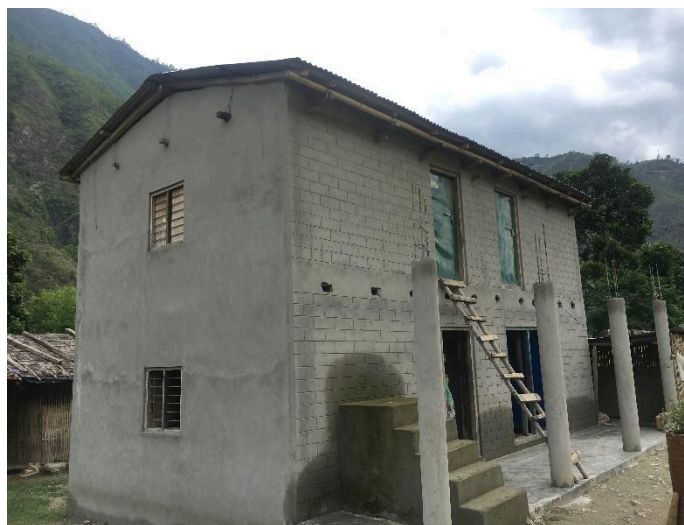
**Ward 7, Maney Bhanjhang Rural municipality, Okhaldhunga:** Hari Maya Dhamala is the house owner. The two stories structure has been constructed in Stone masonry in cement mortar providing with the concrete horizontal band and flexible roof. The house owner has received only first tranche because of being noncompliance issues. The structure consists of 7 RCC pillars of size 10\*10 feet.

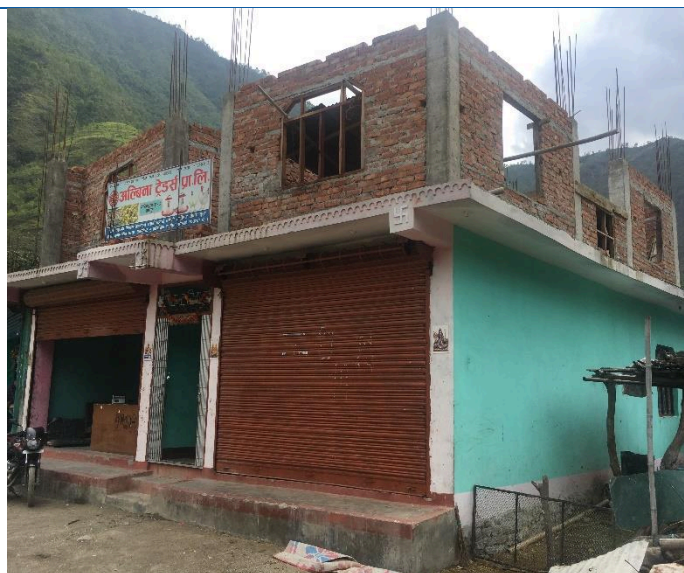
**Ward 7, Maney Bhanjhang Rural municipality, Okhaldhunga:** Padma Kumari Gautam is the house owner. The house has received only first tranche. The RCC frame structure is noncompliance and has problem on footing and Grid of the Column. The RCC structure has been constructed in eccentric footing and improper grid of the column.

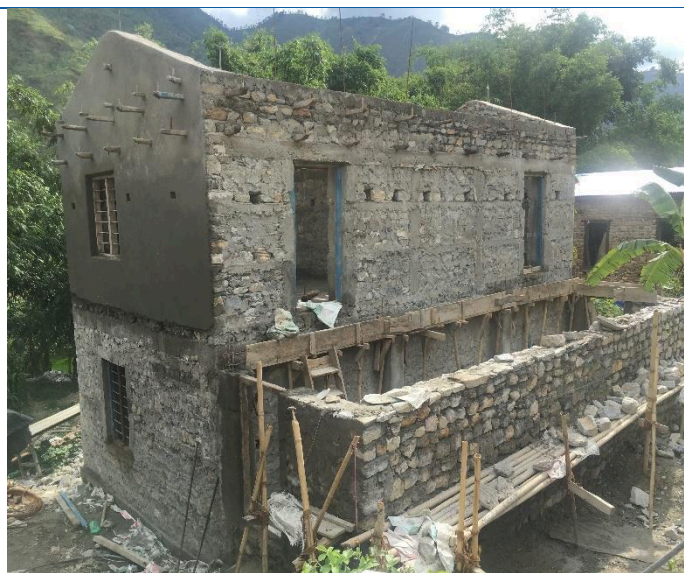
**Ward 7, Maney Bhanjhang municipality, Okhaldhunga:** Karuna Nithi Gautam is the house owner. He has received second tranche and approved the file for third tranche. Two stories structure has been constructed in stone in cement mortar and concrete horizontal bands.

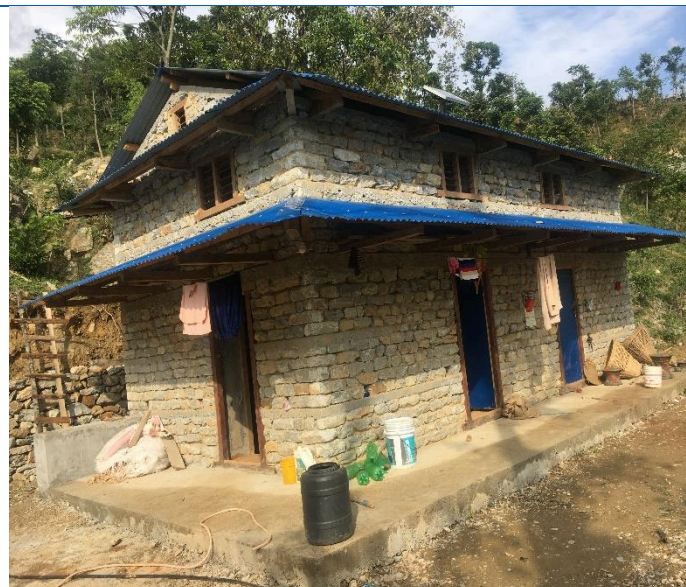
**Ward 6, Maney Bhanjhang Rural municipality, Okhaldhunga:** Chiranjivha Rai is the house owner. The house has been constructed in Stone masonry in mud mortar, providing with the concrete horizontal band and flexible roof. The house owner has received second tranche and approved the file for third tranche.

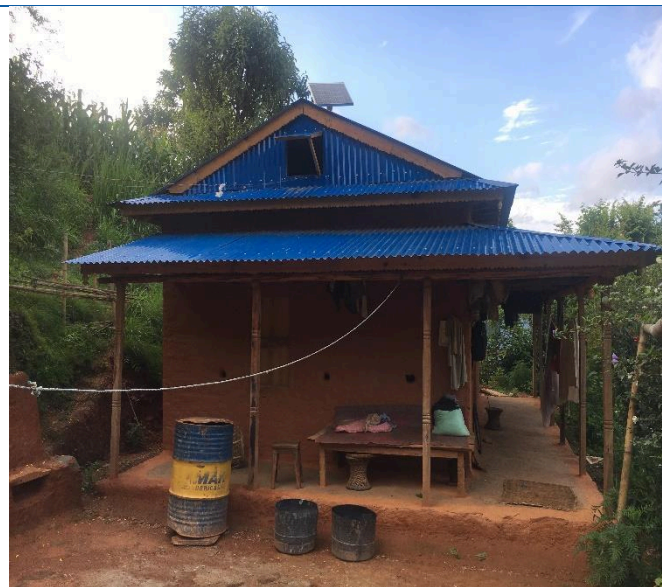
**Ward 8, Maney Bhanjhang municipality, Okhaldhunga:** Lila Nath Timalisina is the house owner, He has received second tranche and forwarded the file for third tranche. The house has constructed in stone in mud providing concrete horizontal bands and flexible roof

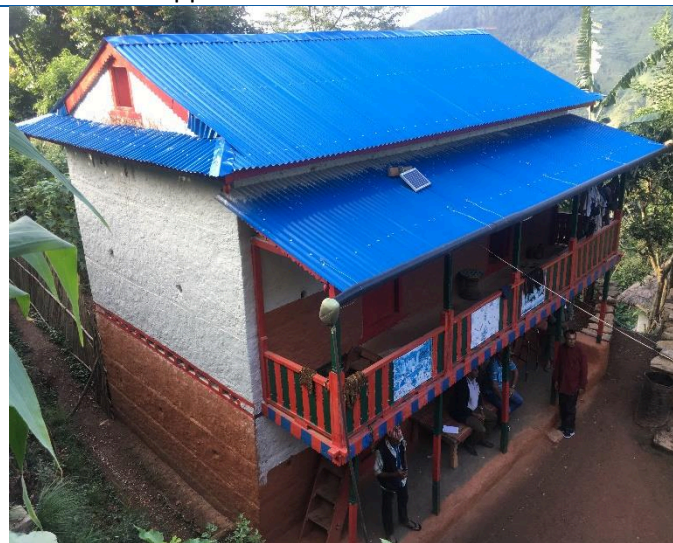
**Ward 8, Mana Bhanjang Rural municipality, Okhaldhunga:** Tanka Natha Bastola is the house owner. The two plus attic structure has been constructed in Stone masonry in Mud mortar providing with the wooden horizontal band and flexible roof. The house owner has received Second tranche and rejected for third tranche because of having two stories in mud mortar.

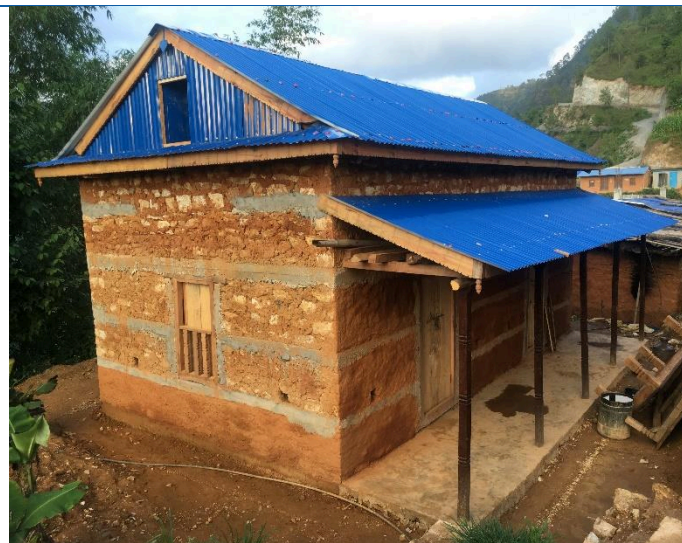
**Ward 8, Maney Bhanjhang municipality, Okhaldhunga:** Bimala Magar is the house owner. she has received second tranche and forwarded the file for third tranche. The house has constructed in stone in mud, providing concrete horizontal bands and flexible roof
