## District Report

### Kathmandu Valley

12 April – 9 May 2019

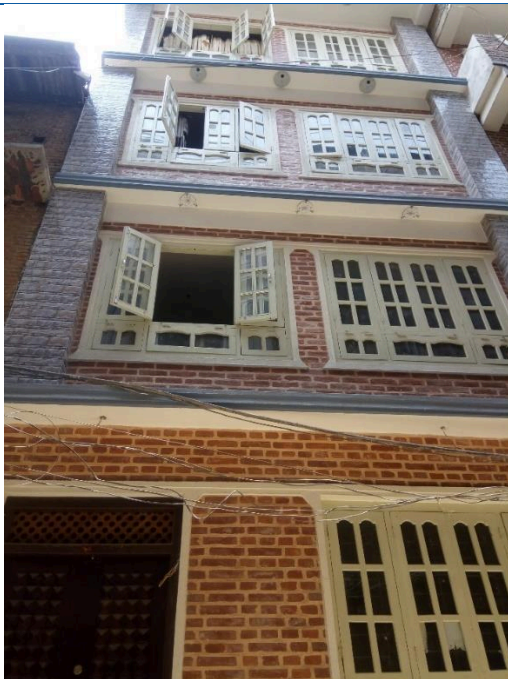
Beneficiary name: Mrs. Krishna Kumari Maharjan, Lukhushi Ward no 17, Lalitpur Metropolitan City. RCC structure with 5.5 stories has 6 rooms in total. The house is complaint and has received all three tranches from government.

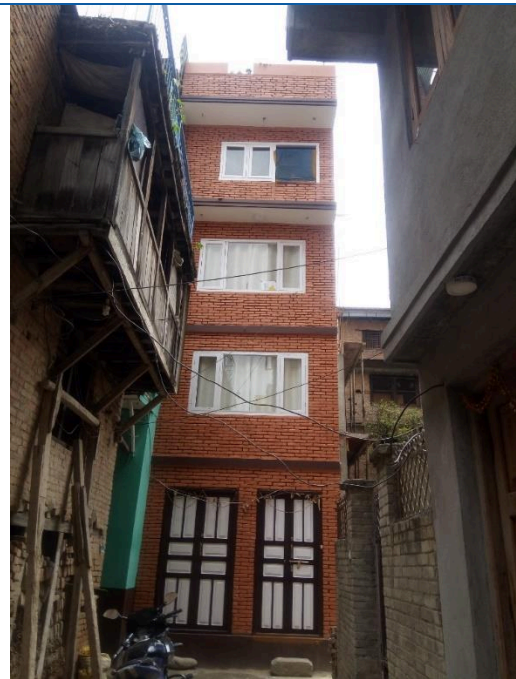
Beneficiary name: Mr. Rajbhai Maharjan, Ward no. 7, Sakho Tole, Pilachhen, Lalitpur Metropolitan City. RCC structure with 4.5 stories and 6 number of rooms. The house is complaint and has received all three tranche from government.

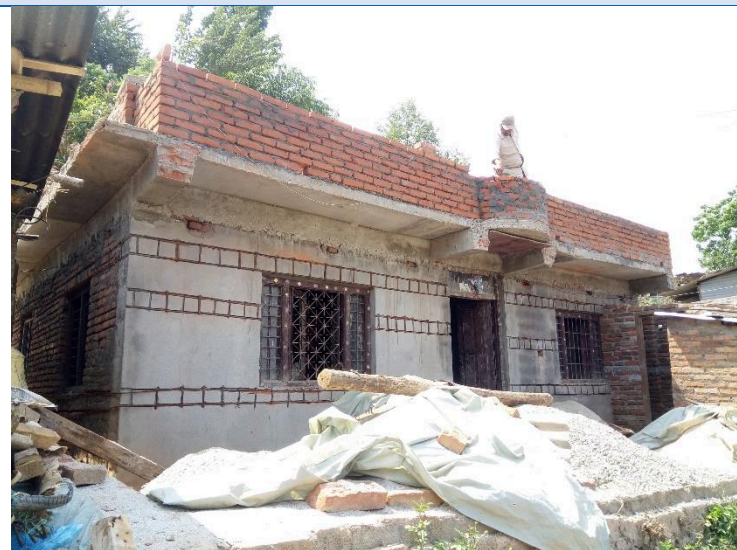
Beneficiary name: Mr. Rajan Baniya, Ward no. 9, Etaeti Tole, Champi, Godawari Municipality. 1 storey, 4 roomed load bearing BMC house is currently going through correction phase whereby keeping sil, lintel and corner stitch bands. Previously, beneficiary had only 2 rooms constructed during time of earthquake. After agreement done with government, 2 rooms were added by the beneficiary. The house was considered non-compliant during inspection therefore in suggestion from engineers correction of the house is in process from past 1.5 months. Upto now Rs 10 lakh has been spend including correction process too. Beneficiary is expected to spend upto 12 lakh with all the remaining works. Water shortage is a huge problem in this area. A small natural well (kuwa) is 20 minutes far, the water flow of which is very low from the tap. Nearly 6 hours is spend daily (morning and evening) to collect sufficient amount of water necessary for reconstruction purpose and for household purpose too. Beneficiary claims that reconstruction of his house has delayed due to shortage of water.

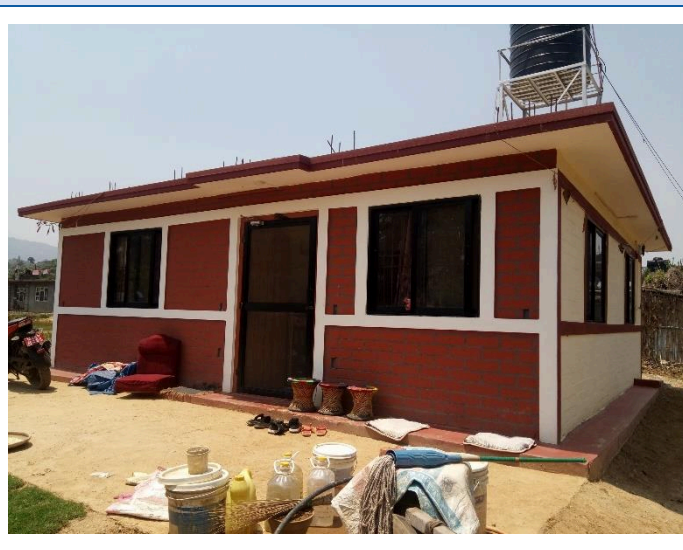
Beneficiary name: Mr. Krishna Kumar Bista, Ward no. 9, Champi, Godawari Municipality. 1 storey 4 roomed wall system house is made of interlocking bricks. The house has 23 feet length and 20 feet breadth with floor to floor height is 9 feet. Nearly 7 months was utilized to reconstruct this house. Further, around Rs 1500000 amount was spend by the beneficiary to reconstruct the house. The beneficiary has received upto 2<sup>nd</sup> tranche, however the house has been declared non-compliant. M & E Consultant insisted for some further discussion about this type of houses which could result in suggestion of applying correction methods for this house.

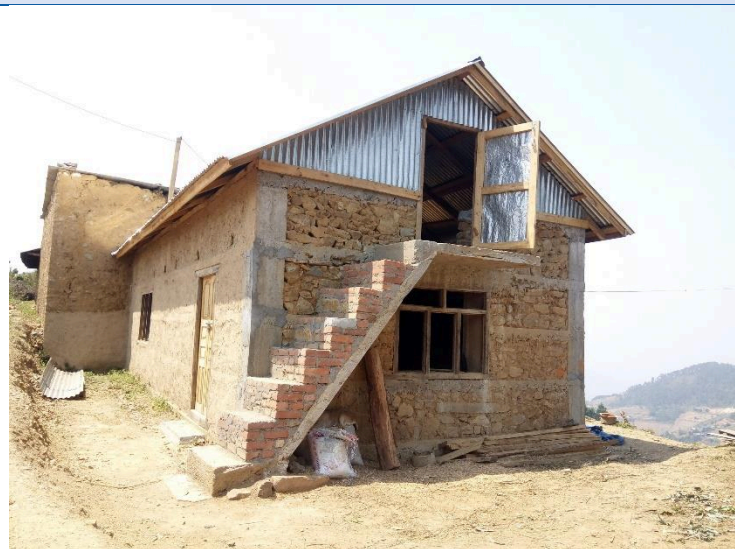
Beneficiary name: Mr. Ram Kumar Syangtan, Ward no. 7, Ghoda Kudne Chaur, Devichaur, Godawari Municipality. 1 storey with attic load bearing SMM house have received upto 2<sup>nd</sup> tranche. Nearly 3 months was utilized to reconstruct this house and the owner has spent upto Rs 5 lakh amount for entire reconstruction. The house was considered complaint by the Joint M & E visit.

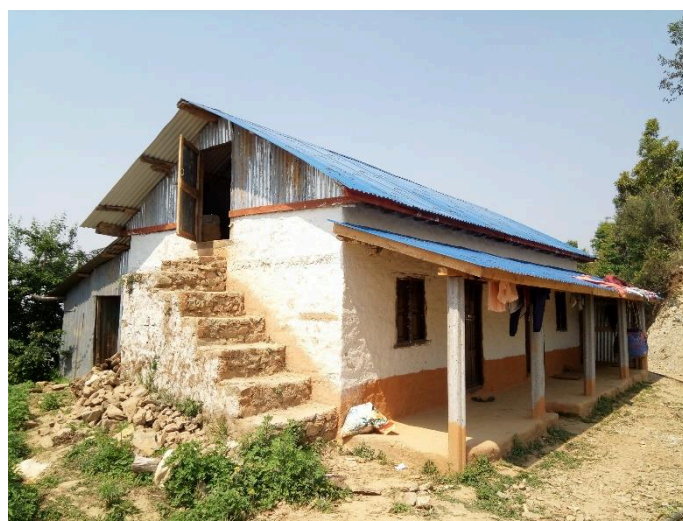
Beneficiary name: Mr. Sujan Thing, Ward no. 7, Ghoda Kudne Chaur, Devichaur, Godawari Municipality. 2 roomed, 1 storey with attic load bearing SMM house has 28 feet length and 15 feet breadth. The owner has received upto 2<sup>nd</sup> tranche. Nearly 3 months was utilized to reconstruct this house. The owner has taken Rs 2 lakh loan in 14% annual interest rate, from cooperative. The house was considered complaint by the Joint M & E visit.

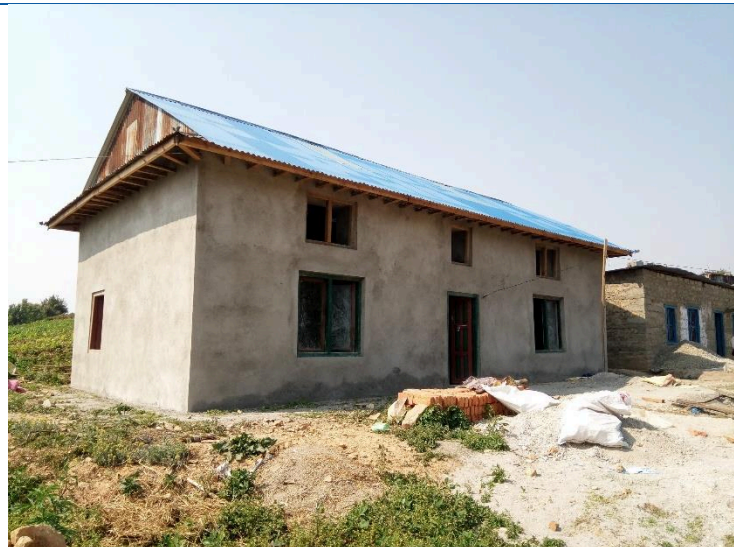
Beneficiary name: Mr. Prem Bahadur Thing, Ward no. 7, Deurali, Devichaur, Godawari Municipality. 2 roomed 1 storey with attic load bearing SMM house has 30 feet length and 15 feet breadth. The owner has received upto 2<sup>nd</sup> tranche. The owner taken Rs 2 lakh loan in 14% annual interest rate, from cooperative. The house was considered complaint by the Joint M & E visit.

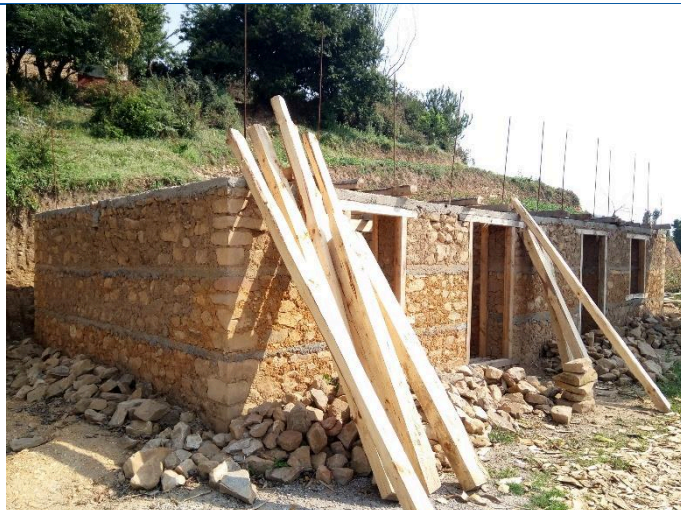
Beneficiary name: Mr. Indra Bahadur Syangtan, Ward no. 7, Deurali, Devichaur, Godawari Municipality. 2 roomed 1 storey with attic load bearing SMM house is under reconstruction phase from past 4 months. The owner has received 2<sup>nd</sup> tranche till now. Beneficiary cited the reason of wood shortage problem in reconstruction of the house. Currently, the beneficiary has accessed wood from the group cooperative. Further, beneficiary also revealed that water scarcity has also delayed in reconstruction the house. The owner currently resides in temporary shelter nearby.

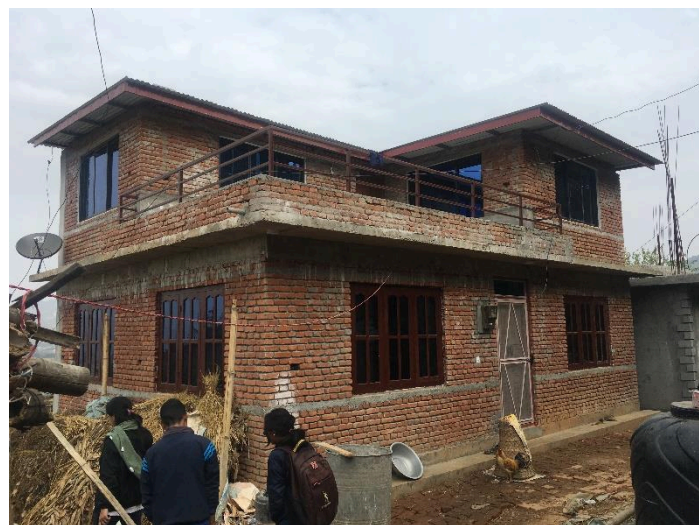
Beneficiary name: Tek Bahadur Ale Magar, Puwar Gaun, Ward no 10, Suryabinayak Municipality, BMC with 4 columns at back side- front view.

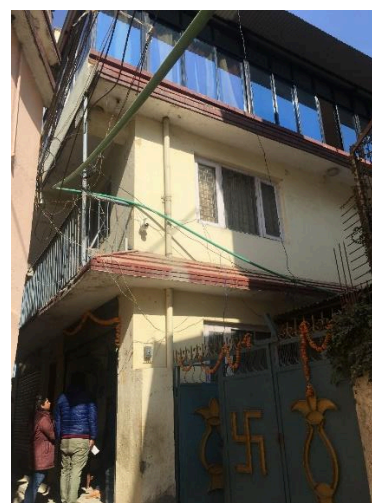
Beneficiary name: Parsi Shrestha, ward no 8, Gokarneshwor Municipality, the beneficiary has claimed to have retrofitted the house but adding RC frame to the load bearing brick in cement masonry.

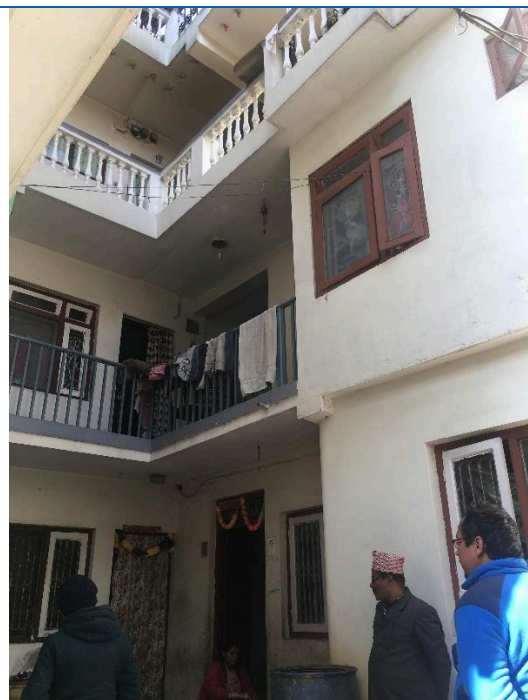
Beneficiary name: Sunita Shrestha and Ganesh Bahadur Shrestha, Ward no. 8, Gokarneshwor Municipality. Beneficiary has added I-beam in the house only in the ground floor.

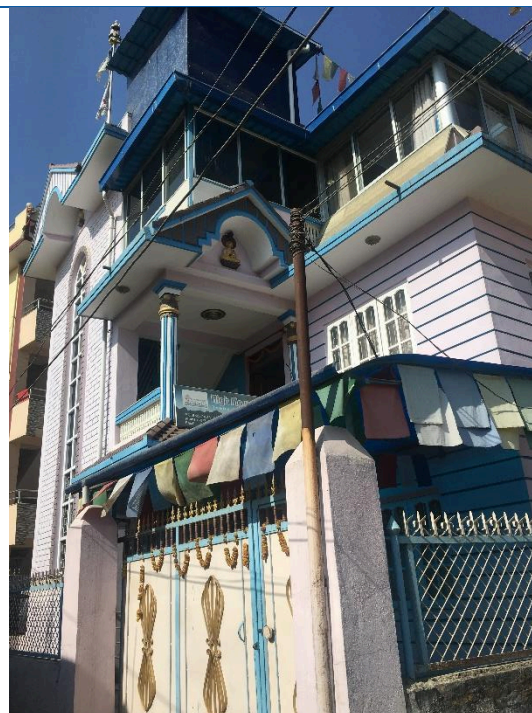
Beneficiary name: Santa Lama, ward no 8, Gokarneshwor Municipality. Retrofitting beneficiary, has done column jacketing of only the damaged pillar
