## Fortnightly District Report

### Kavrepalanchok

18 – 31 January 2019

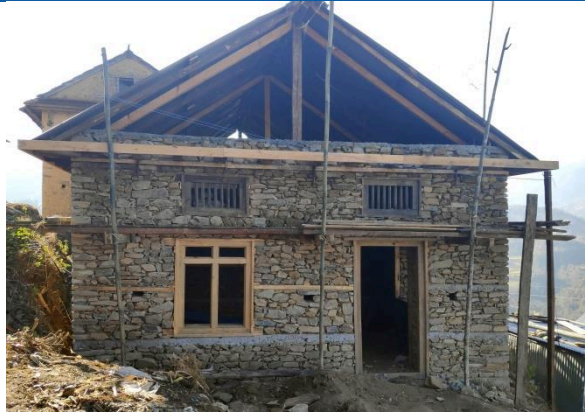
| Date | Location | Participants from HRRP and stakeholders |
|---|---|---|
| <div><div><p>A Retrofitting Demo House being constructed at the premises of Bethanchok Gaupalika office by UNOPS/Build Change. 10 masons are being trained during the construction. Photograph By: Reshma Shrestha</p></div><div><p>Hema Laxmi Lama, a single woman of Bethanchok-5 has reconstructed her house using skilled masons. She has received the second tranche of housing reconstruction grant. Photograph By: Reshma Shrestha</p></div></div> | | |

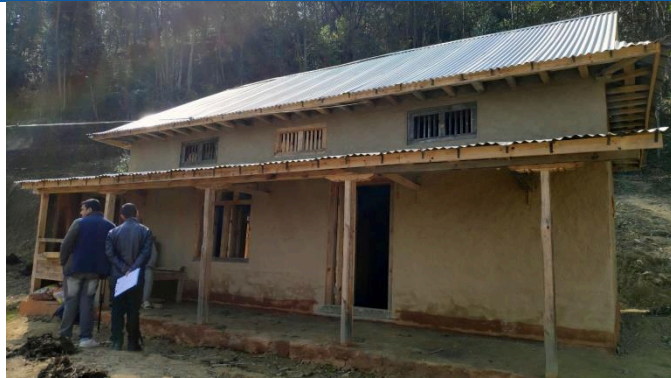
**Address:** Kavrepalanchok, Bethanchok-3

**Building Typology:** Stone in Mud

**Description:** Keshav Prasad Timalina constructed his house using skilled masons and continuous technical assistance from NRA engineers. He has received all three tranches of housing reconstruction grant.

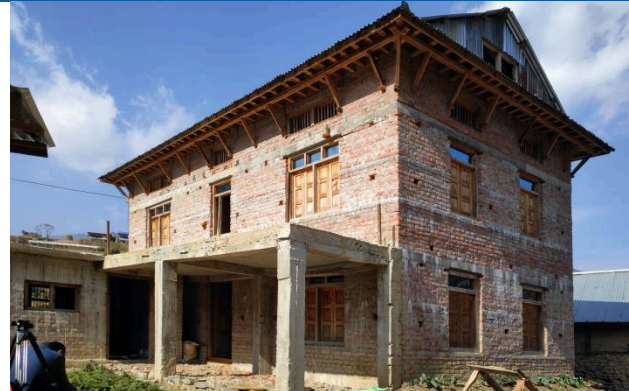
**Address:** Kavrepalanchok, Bethanchok-3

**Building Typology:** Brick in Cement

**Description:** Saraswati Timalina constructed her house similar to her pre earthquake house but she had to switch from stone in mud to brick in cement for similar space. She later added the front porch with a small gap to the main building as suggested by the engineers. The total cost was NPRs 20 lakhs and she has already received all three tranches of housing reconstruction grant.

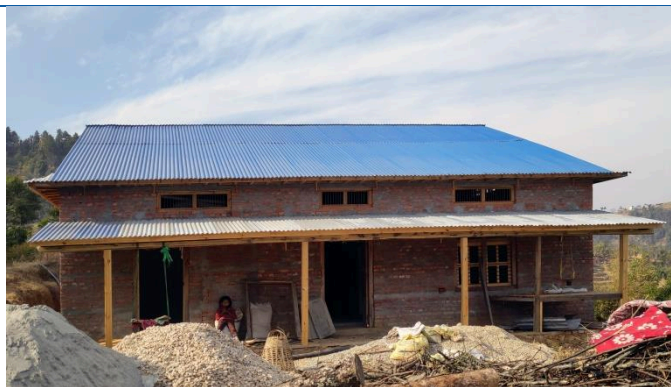
**Address:** Kavrepalanchok, Bethanchok-3

**Building Typology:** Brick in Cement

**Description:** Ram Kumari Sapkota has received all three tranches of housing reconstruction grant.

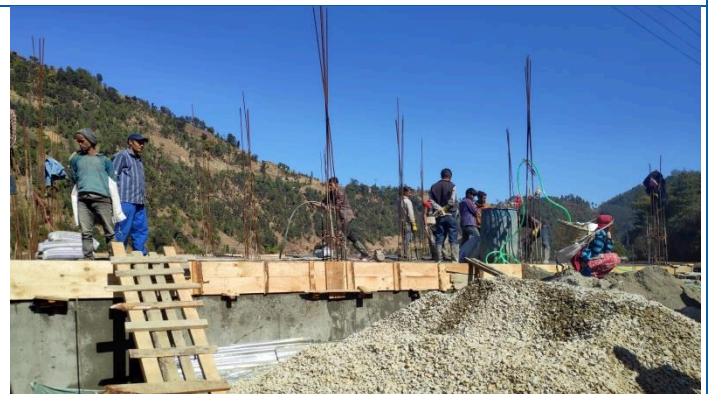
**Address:** Kavrepalanchok, Bethanchok-3

**Building Typology:** RCC

**Description:** Udhav Prasad Mainali recently returned from abroad to construct his house. He immediately had his designs made and approved from the palika to meet the deadline. He has received first tranche of housing reconstruction grant.

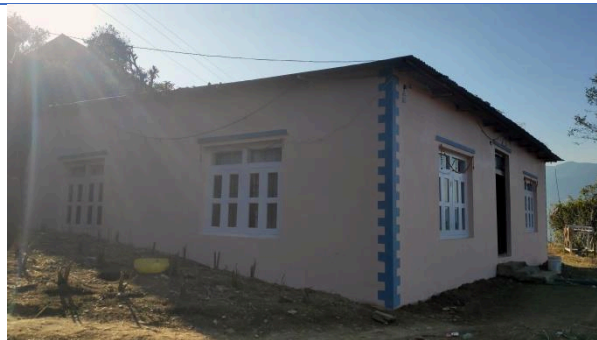
**Address:** Kavrepalanchok, Bethanchok-5

**Building Typology:** Stone in Cement

**Description:** This house of Akal Bahadur Tamang has no sill, lintel, roof and vertical bands.
