Gujarat Relief Engineering Advice Team (GREAT)  
**GREAT Publication: June 2001**

## **Repair and strengthening guide for earthquake damaged low-rise domestic buildings in Gujarat, India**

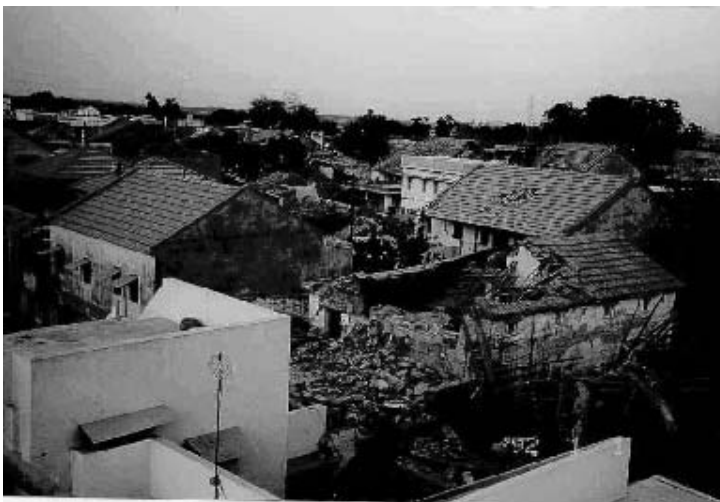
Even single storey buildings suffered severe damage and/or partial or complete collapse. Figure 3.1 and 3.2 shows some of the failure of these buildings.

*Figure 3.1- Collapse of random masonry building in Manukawa*

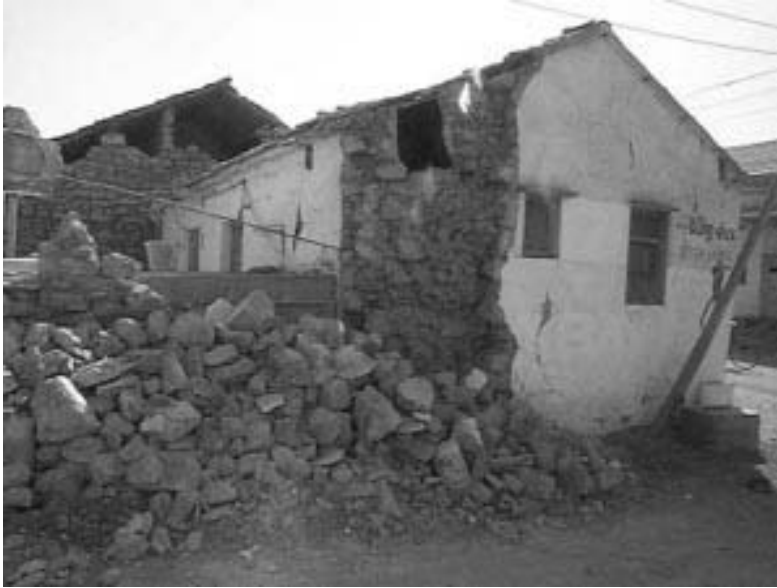
*Figure 3.2 – Partial collapse of gable wall for a single storey random masonry wall in Kera*

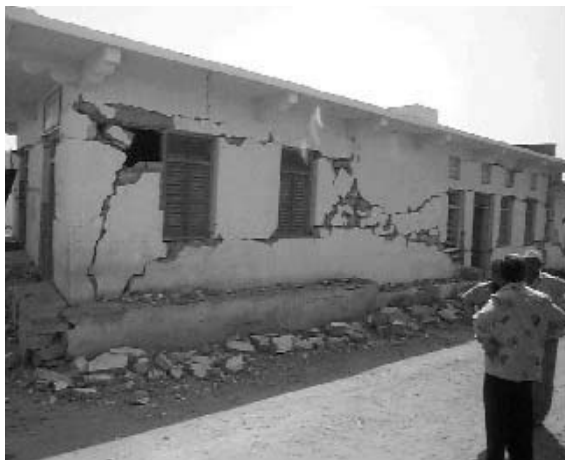
*Figure 3.3 – Heavily damaged single storey rubble masonry wall with concrete roof in Manukawa & Sukhpur.*

*Walls survived due to diaphragm action from roof. Cantilever beams embedded in walls also helped this. Note window openings are also not close to corners.*

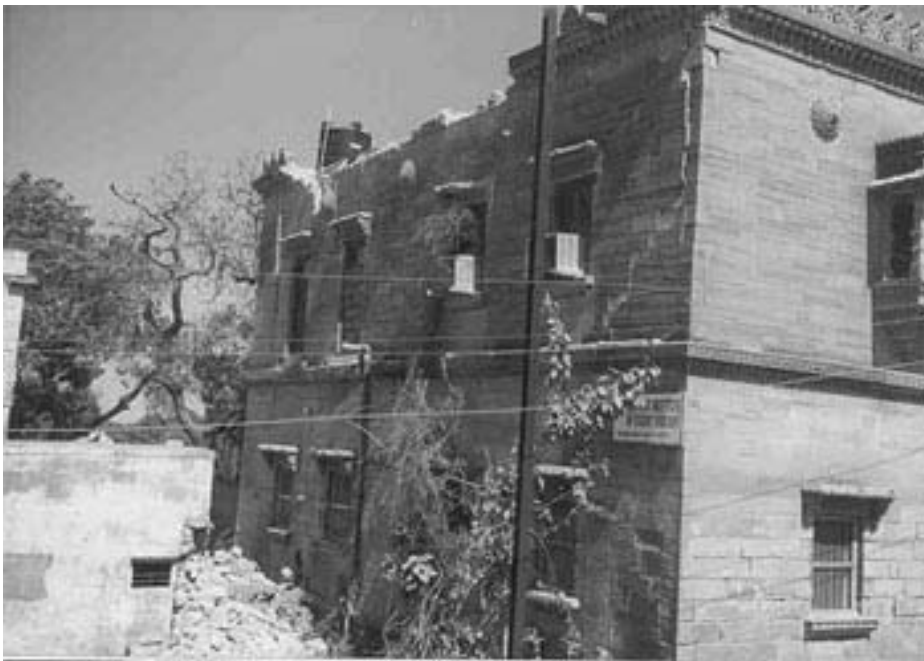
An old government building (predating 1900's) made with solid cut stone masonry walls is shown in Figure 3.4. This building received slight to moderate damage although it is in the centre of Bhuj and all around, rubble buildings have totally collapsed. The floors and roof are of timber and an adjacent similar building had cut-stone walls which were at least 0.5m thick. The upper storey wall is seen to be damaged at the edges by bending cracks caused by out-of-plane shear forces. Untied architectural stonework has also fallen off at roof level, as might be expected from severe shaking. The heavy wall units and regular stone blocks prevented collapse of these old buildings.

*Figure 3.4 Cut-stone building in Bhuj*

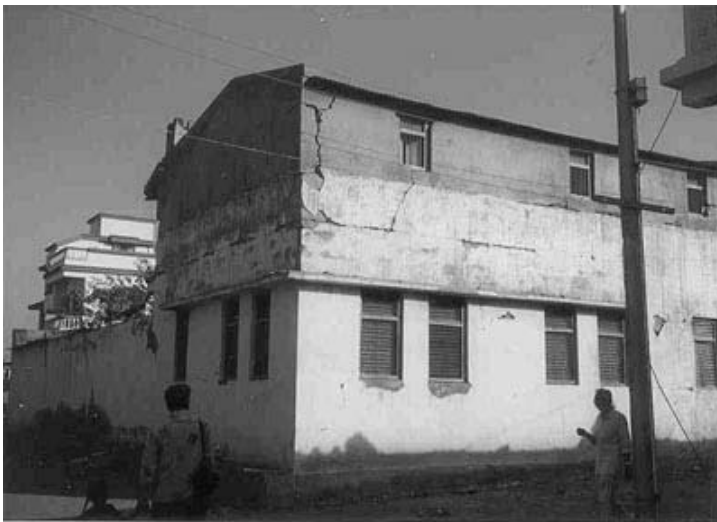
Figure 3.5 shows a two-storey modern cut-stone wall building near Bhuj, in town called Mirzapur. The building has cut-stone walls about 0.225 to 0.3m thick and has a 1<sup>st</sup> level concrete floor and a pitched timber roof. The window openings are not close to the edge and are also sensibly spaced. This is probably one of the main reasons why it survived with so little damage. Even so some vertical bending cracking has happened near to the corners, again due to out of plane shear forces.

Many buildings which did not collapse suffered from severe diagonal cracking at their corners, some with partial collapse at corners, primarily because of window openings being too close to the corner and because of lack of toothing between returns.

*Figure 3.5 Modern cut-stone masonry building in Mirzapur*

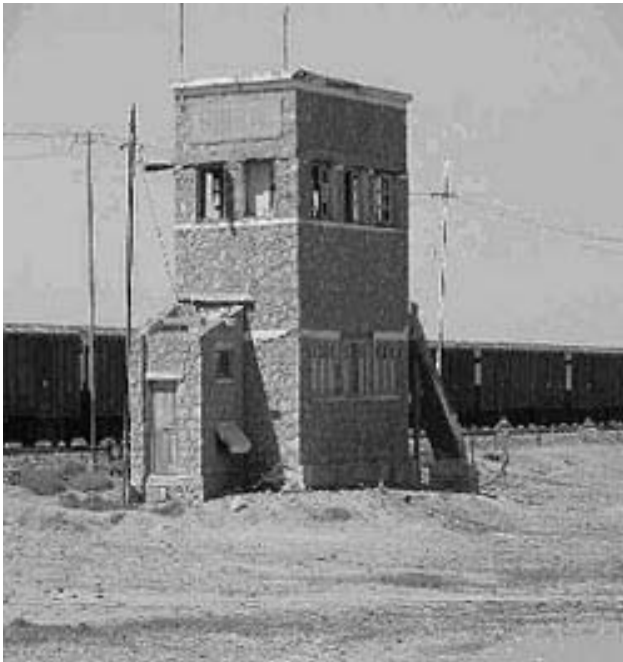
Seismic bands or ties greatly increase the strength of buildings in earthquakes. The railway lookout building in Figure 3.6 is made with random masonry, is well-constructed and is bonded with cement mortar and suffered very little damage. What sets this building apart from others that collapsed nearby, is that it has been designed with strong reinforced concrete seismic bands at lintel and cill level, which completely tie the four walls. There is also a flat concrete roof. The seismic shear force is resisted by the lintel and cill bands, and has clearly strengthened the building against repeated shaking from an earthquake which would make lesser buildings collapse.

*Figure 3.6:  
Strengthening of buildings  
by use of seismic bands*

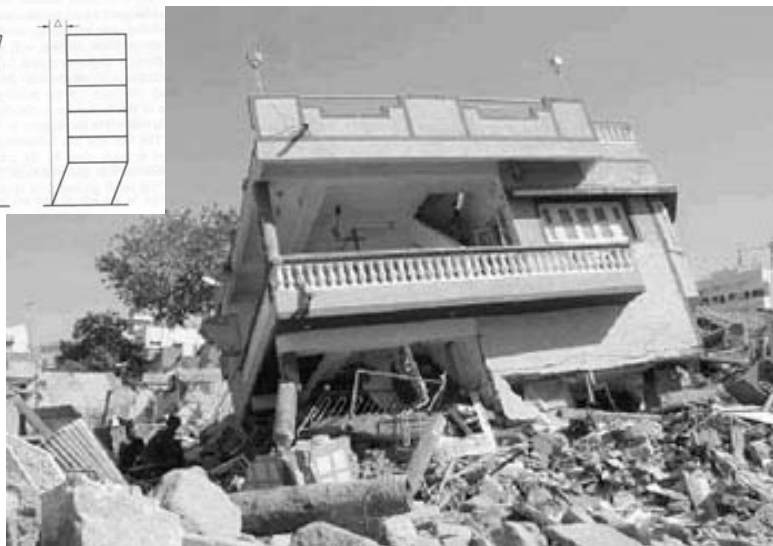
Some domestic reinforced concrete buildings had large internal openings or unsymmetrical masses at first or ground floor level. This caused severe structural damage and even collapse. Figure 3.7a shows a building, which collapsed because part of the floor area was converted to an opening for car parking. The building was subjected to torsion about its centre of rigidity and failed because of soft storey behaviour with large deformations and rotations concentrated at the top of the columns (Fig 3.7b).

Figure 3.7a – Typical soft storey and torsion collapse in Bhuj

*Fig 3.7b The inset shows large deformations were concentrated at column heads, which caused many soft storey failures, as per picture. Buildings if designed with uniform deflections as per left diagram of insert would have survived without collapse.*

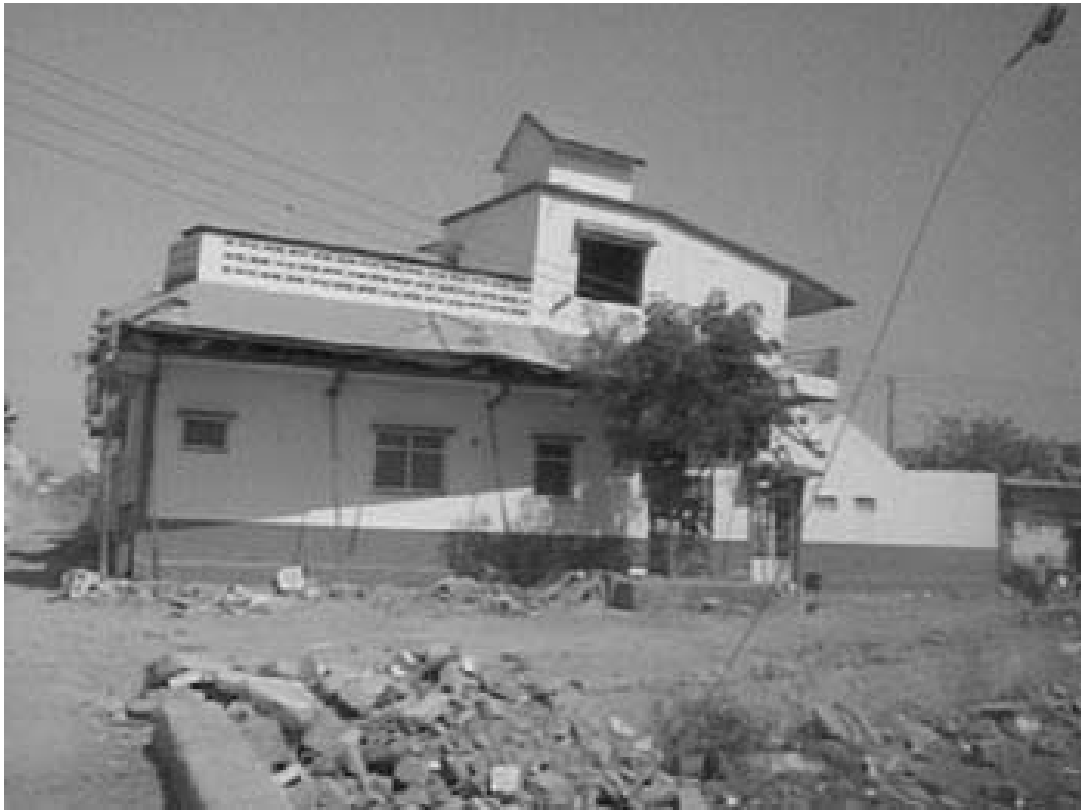
Figure 3.8 shows a building where the owner had a middle floor supported on columns with large internal open spaces, and hardly any masonry infill walls. Under seismic loading, large deformations occurred at the top and bottom of the columns and a soft storey collapse occurred, the upper floor storey falling onto the first storey. This shows that soft storey collapses do not always occur at ground floor.

*Figure 3.8 – Soft storey second floor collapse in Sukhpur*

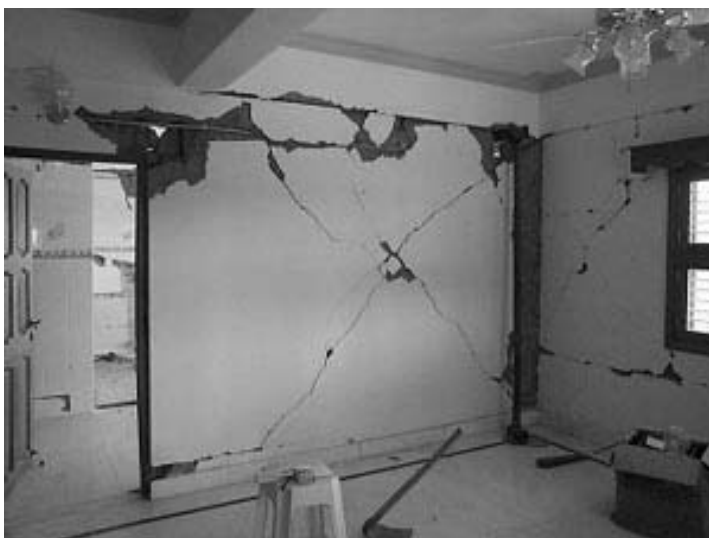
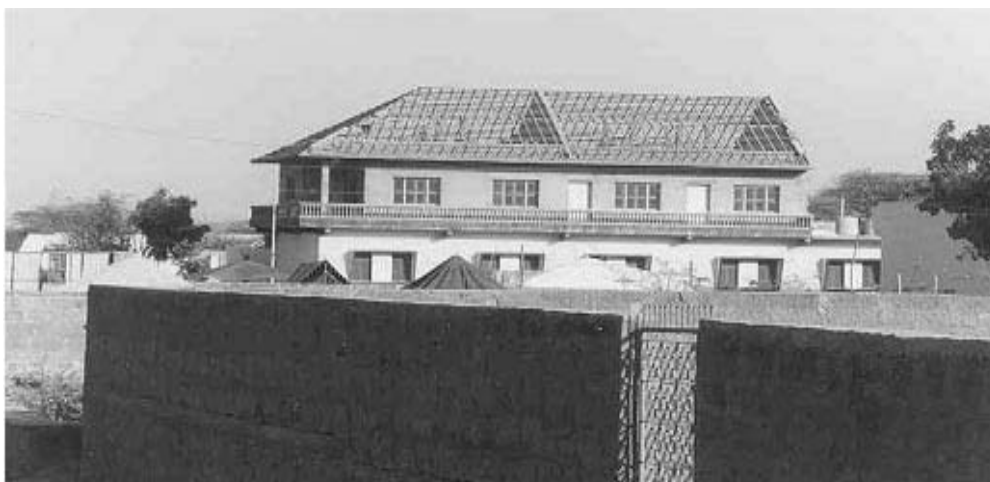
*Figure 3.10 Infill panels again prevented collapse of this structure although all the roof tiles fell off - Mirzapur.*

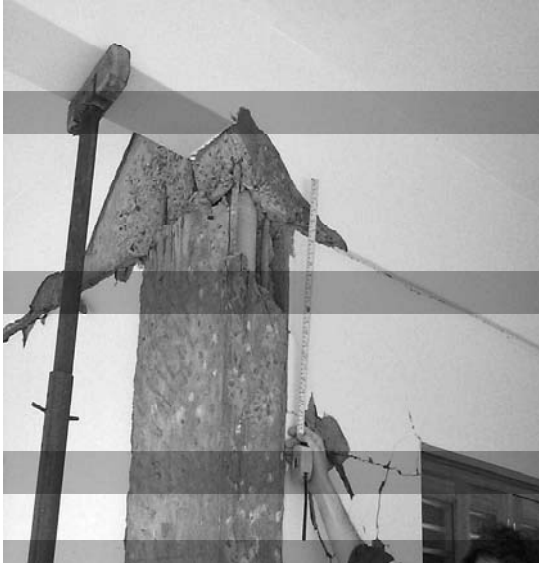
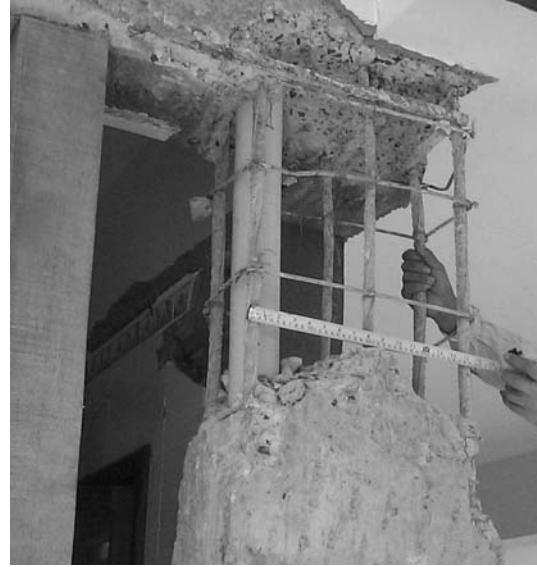
*Figure 3.12 A column that survived with minimal distortion as infill walls performed well and repairs being carried out to damaged column head showing minimal distortion to main bars (right)*

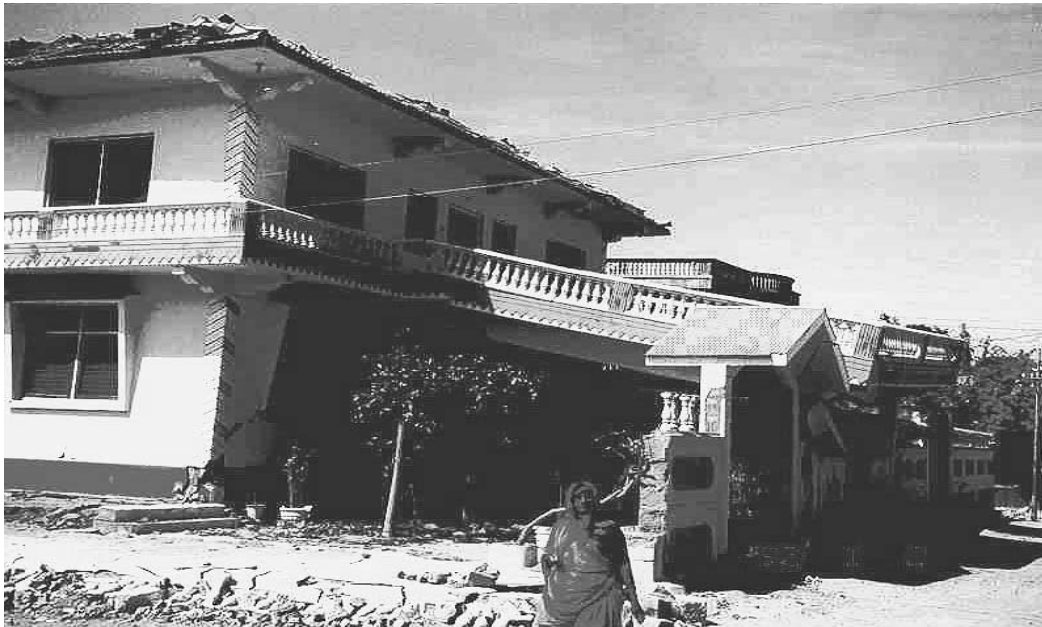
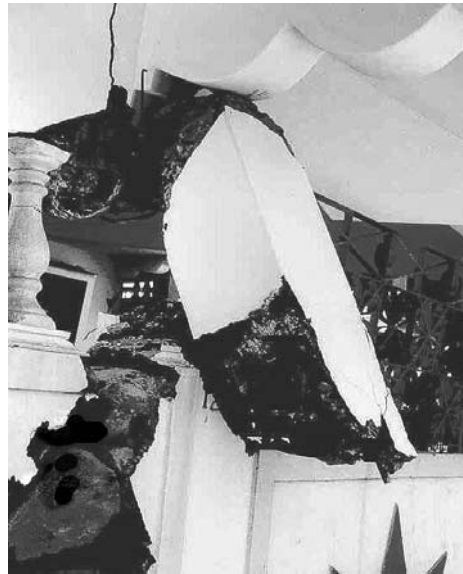
Several modern buildings had a single storey canopy with a flat roof supported by columns at one end and beams running into the main structural frame at the other end. These suffered varying degrees of damage depending on how slim the columns were, see Fig 3.14.

Beam Fracture

Snapped Column

*Fig 3.14 Collapse of a canopy structure due to column failure*

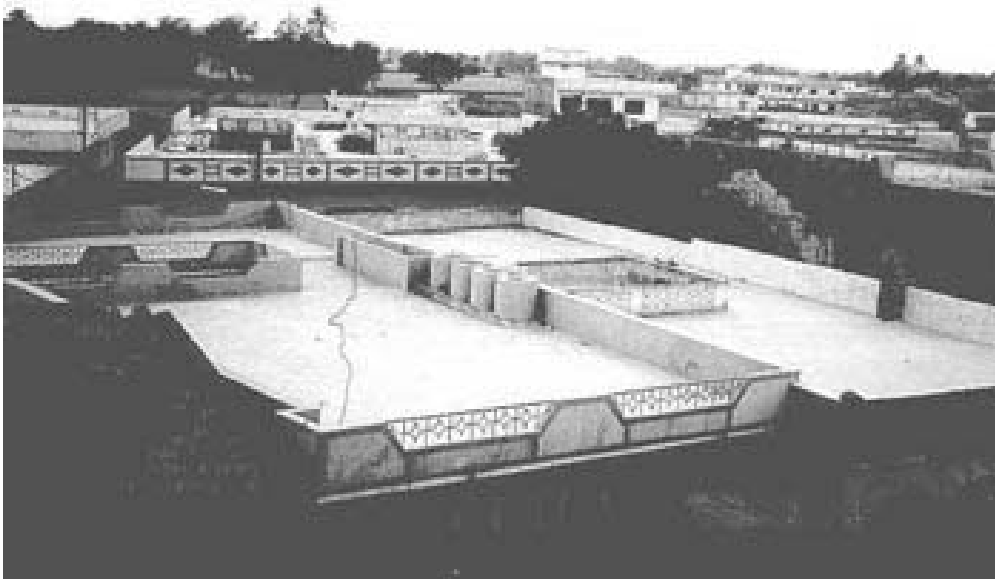
Smaller storage containers built on top of the roofs were either located directly on flat roofs or on short columns. These either slid along the roof breaking water pipes or sometimes toppled over when the short columns fractured. There was no evidence that the smaller header tanks were responsible for structural failure of 2 storey domestic houses.

*Figure 3.15 Flat roofs with small water storage containers - Madhapur*

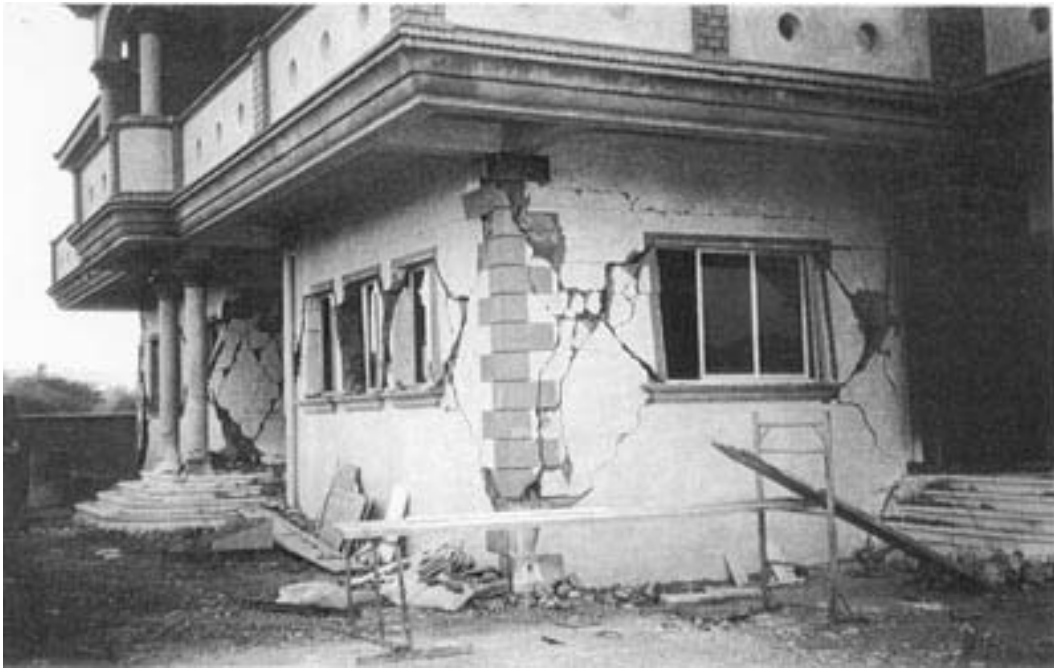
- d) **Short column failures.** Short column failure (diagonal cracking) can be seen to have occurred over the mid height of all the external concrete columns (these were 225mm square) and through the masonry columns. This is because when infill walls with wide openings are attached to columns, the portion of column that will deform under lateral seismic loading becomes very short compared to its normal height. Such short columns become much stiffer and attract much larger shear forces resulting in severe diagonal tension and cracking failure in the columns. This failure is plainly seen in Figs 3.19 and 3.20. The problem was magnified because plastic service conduits ran inside some of the corner columns and walls, reducing the column stiffness.

*Figure 3.20 Large window openings close to corners and short column failures*
