# Snapshots of field realities

Across districts Nuwarkot, Rasua and Dhading

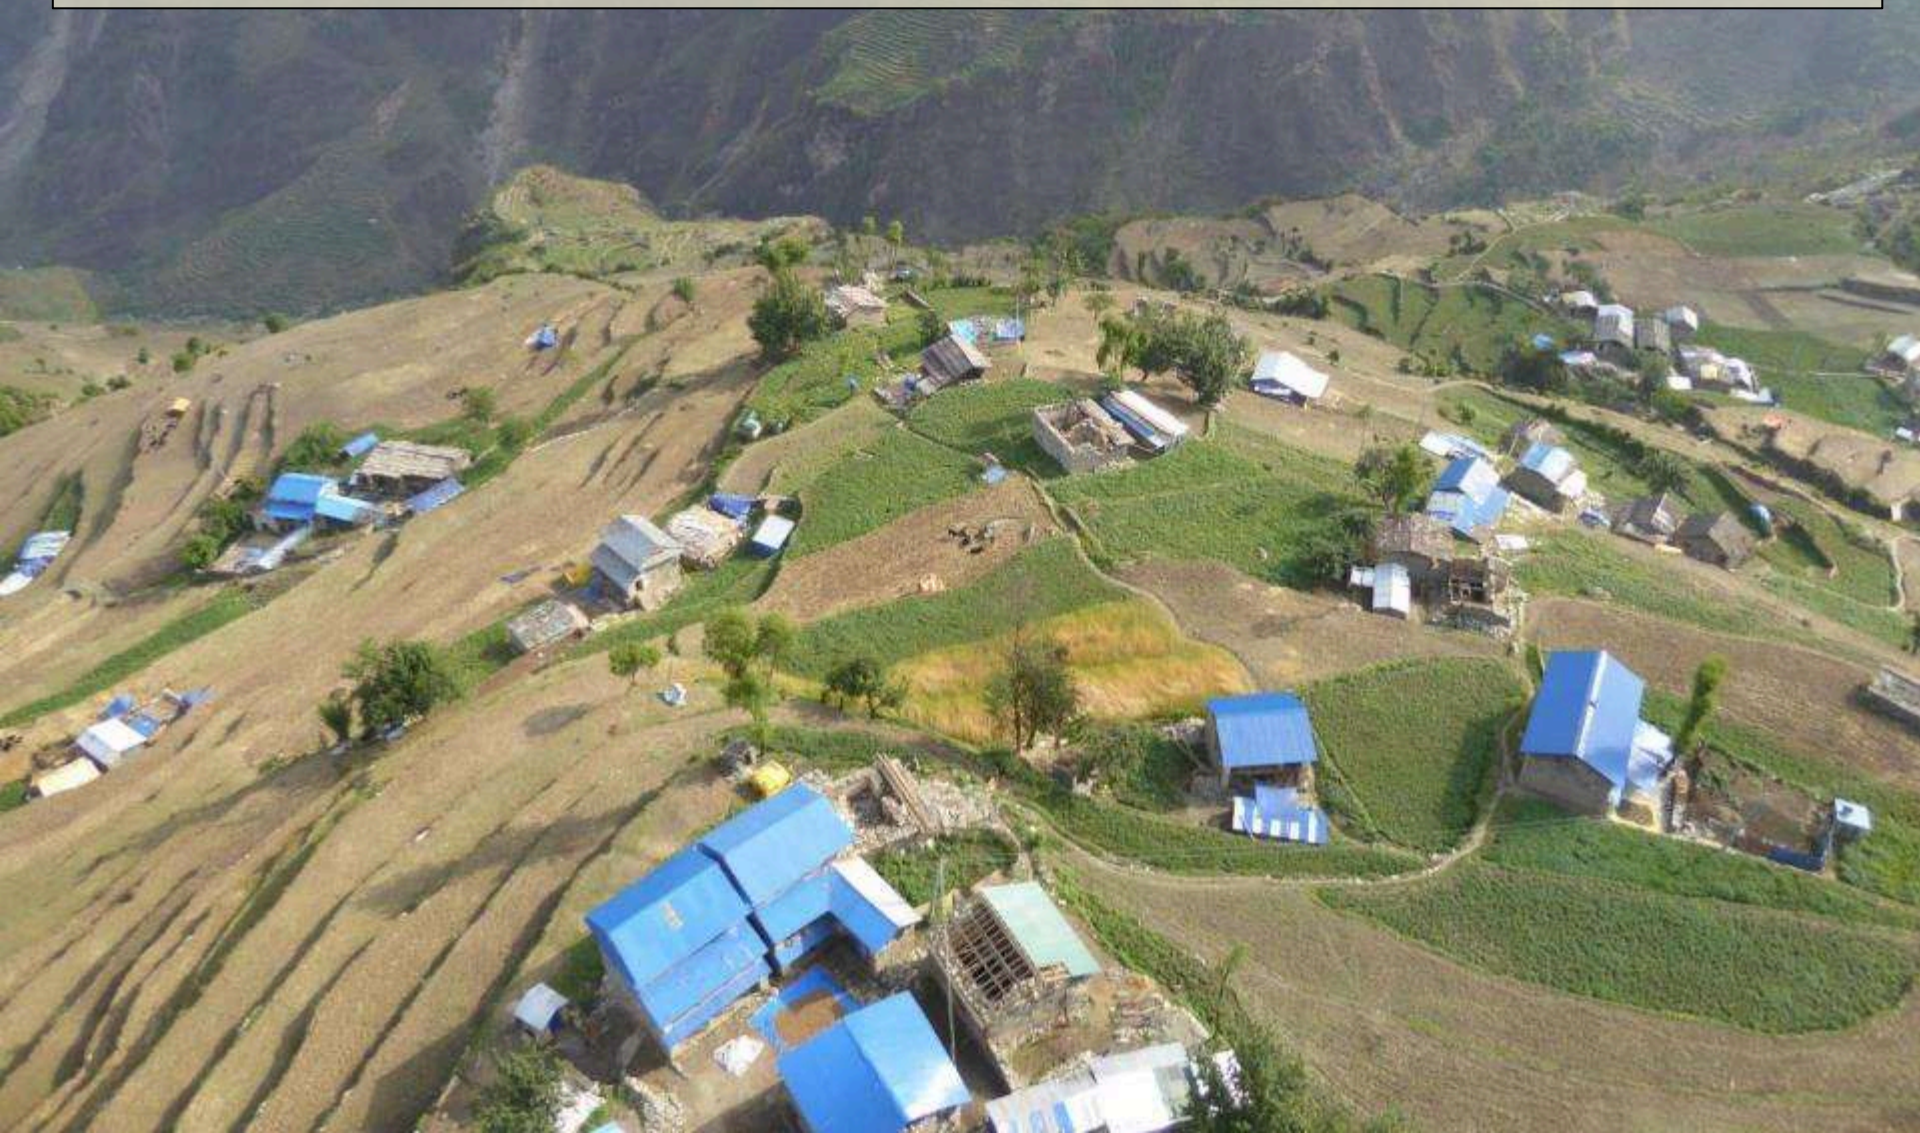
**Who owns the land?**

**Many cases of title deeds belonging to a religious entity or a representative.**

**Will need quick resolution through the grievance process.**

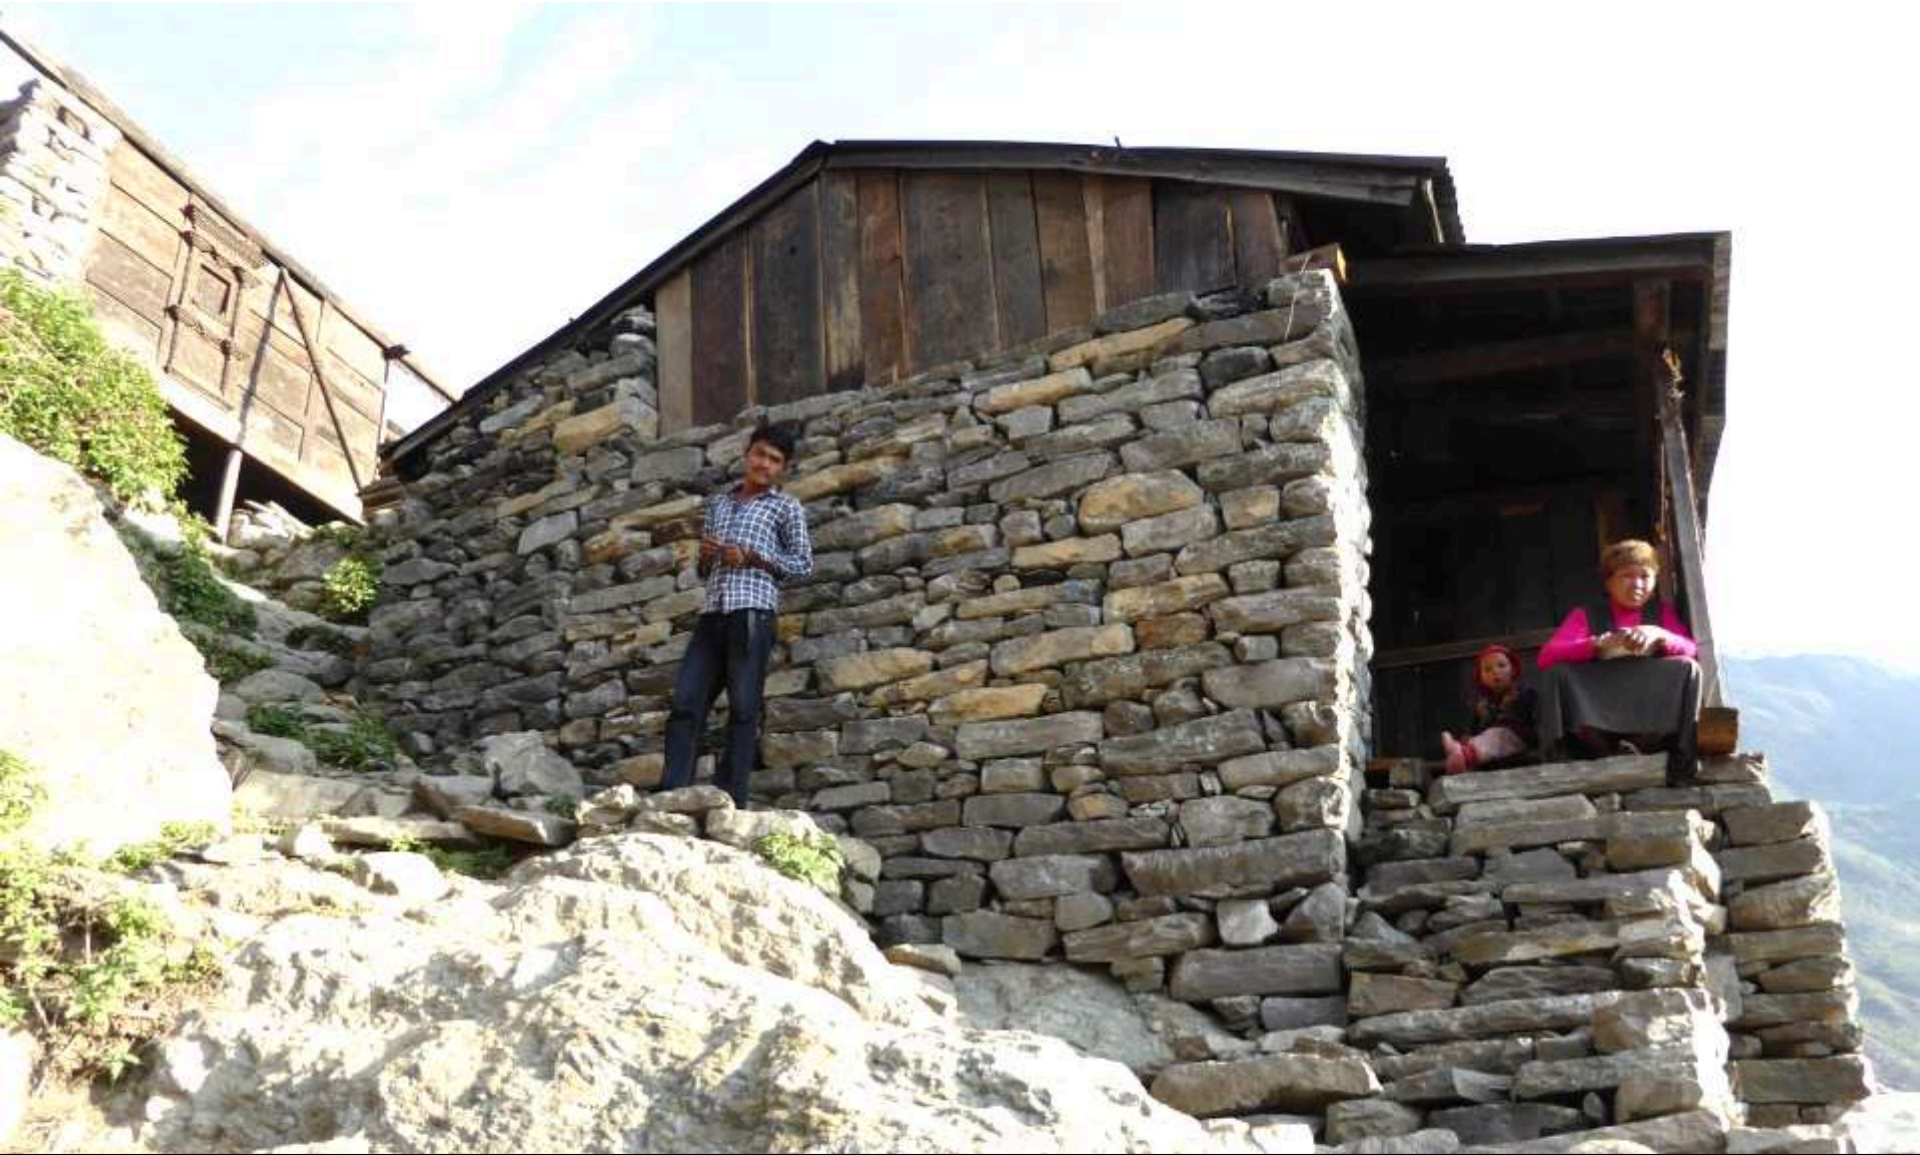
**Reconstructed home in Haku (Rasua). Highly vulnerable to future earthquakes or tremors. Speeding up deliver of training and guidance is critical in such areas.**

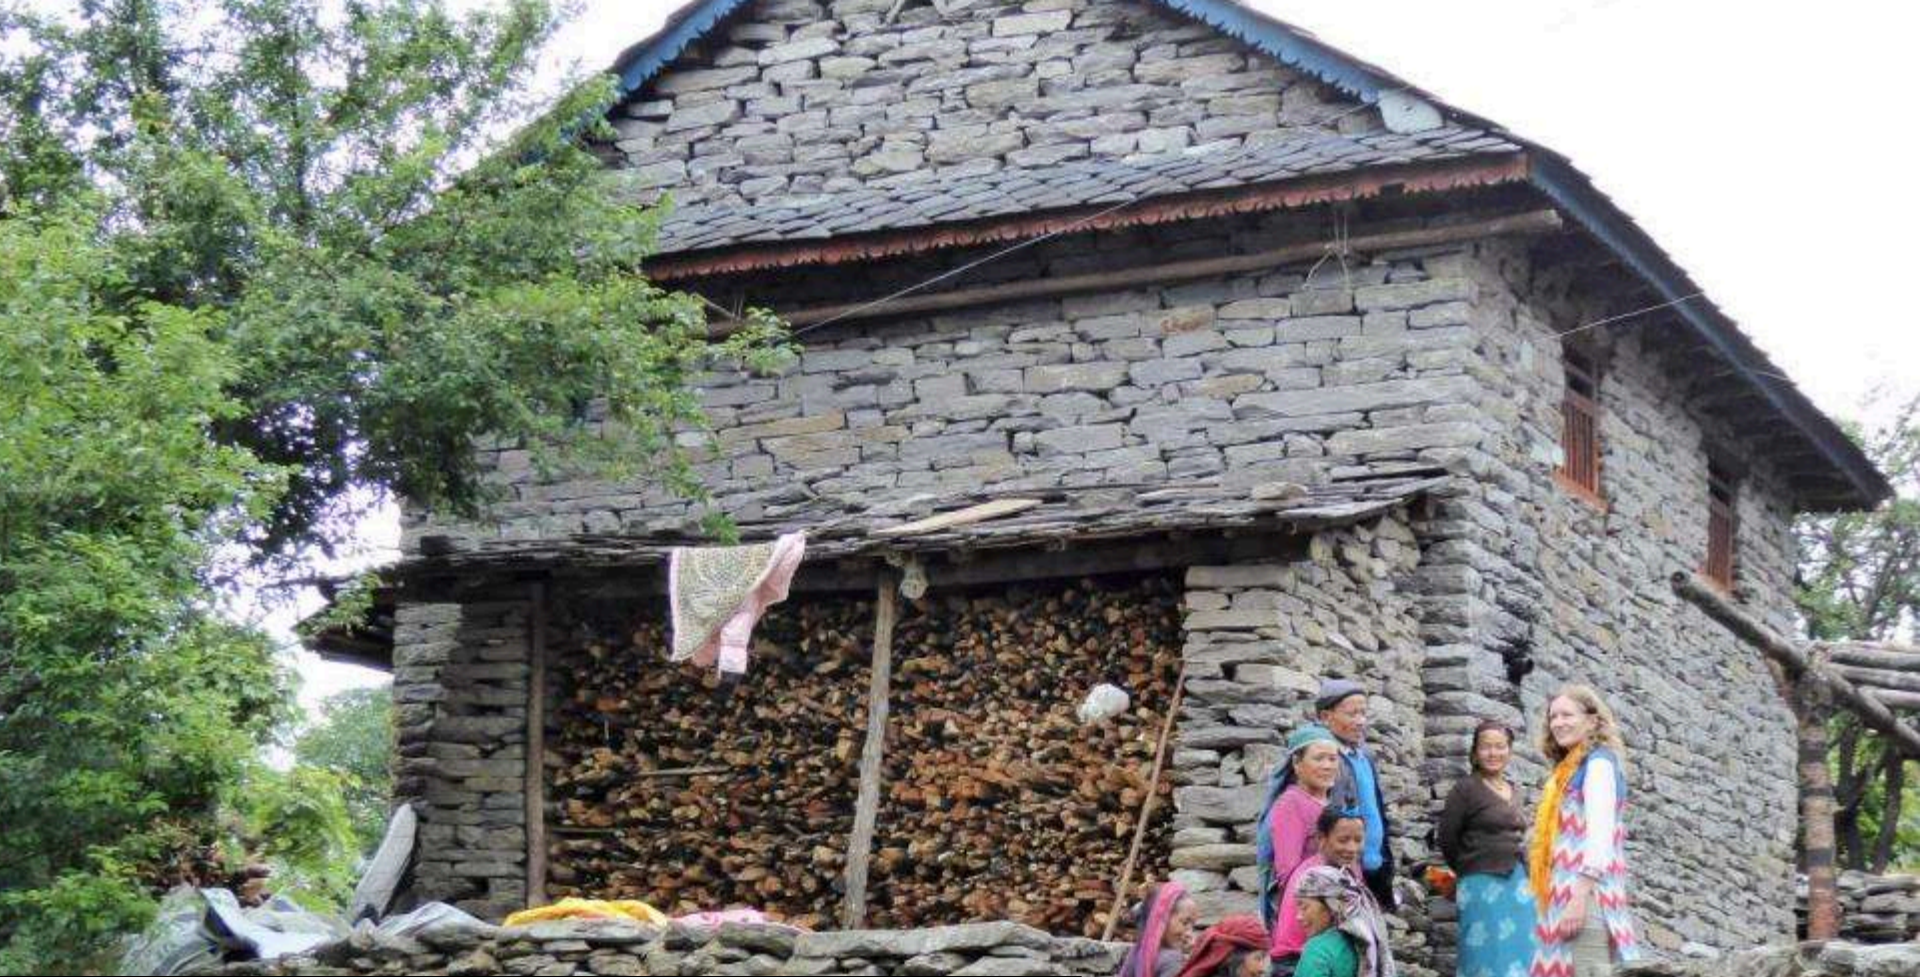
**Reconstructed house in Tippling, Dhading.  
Excellent stone work – but no reinforcement  
banding**

**People say “we couldn’t wait, wanted to  
rebuild before monsoon; weren’t sure if  
compensation was going to arrive”.**

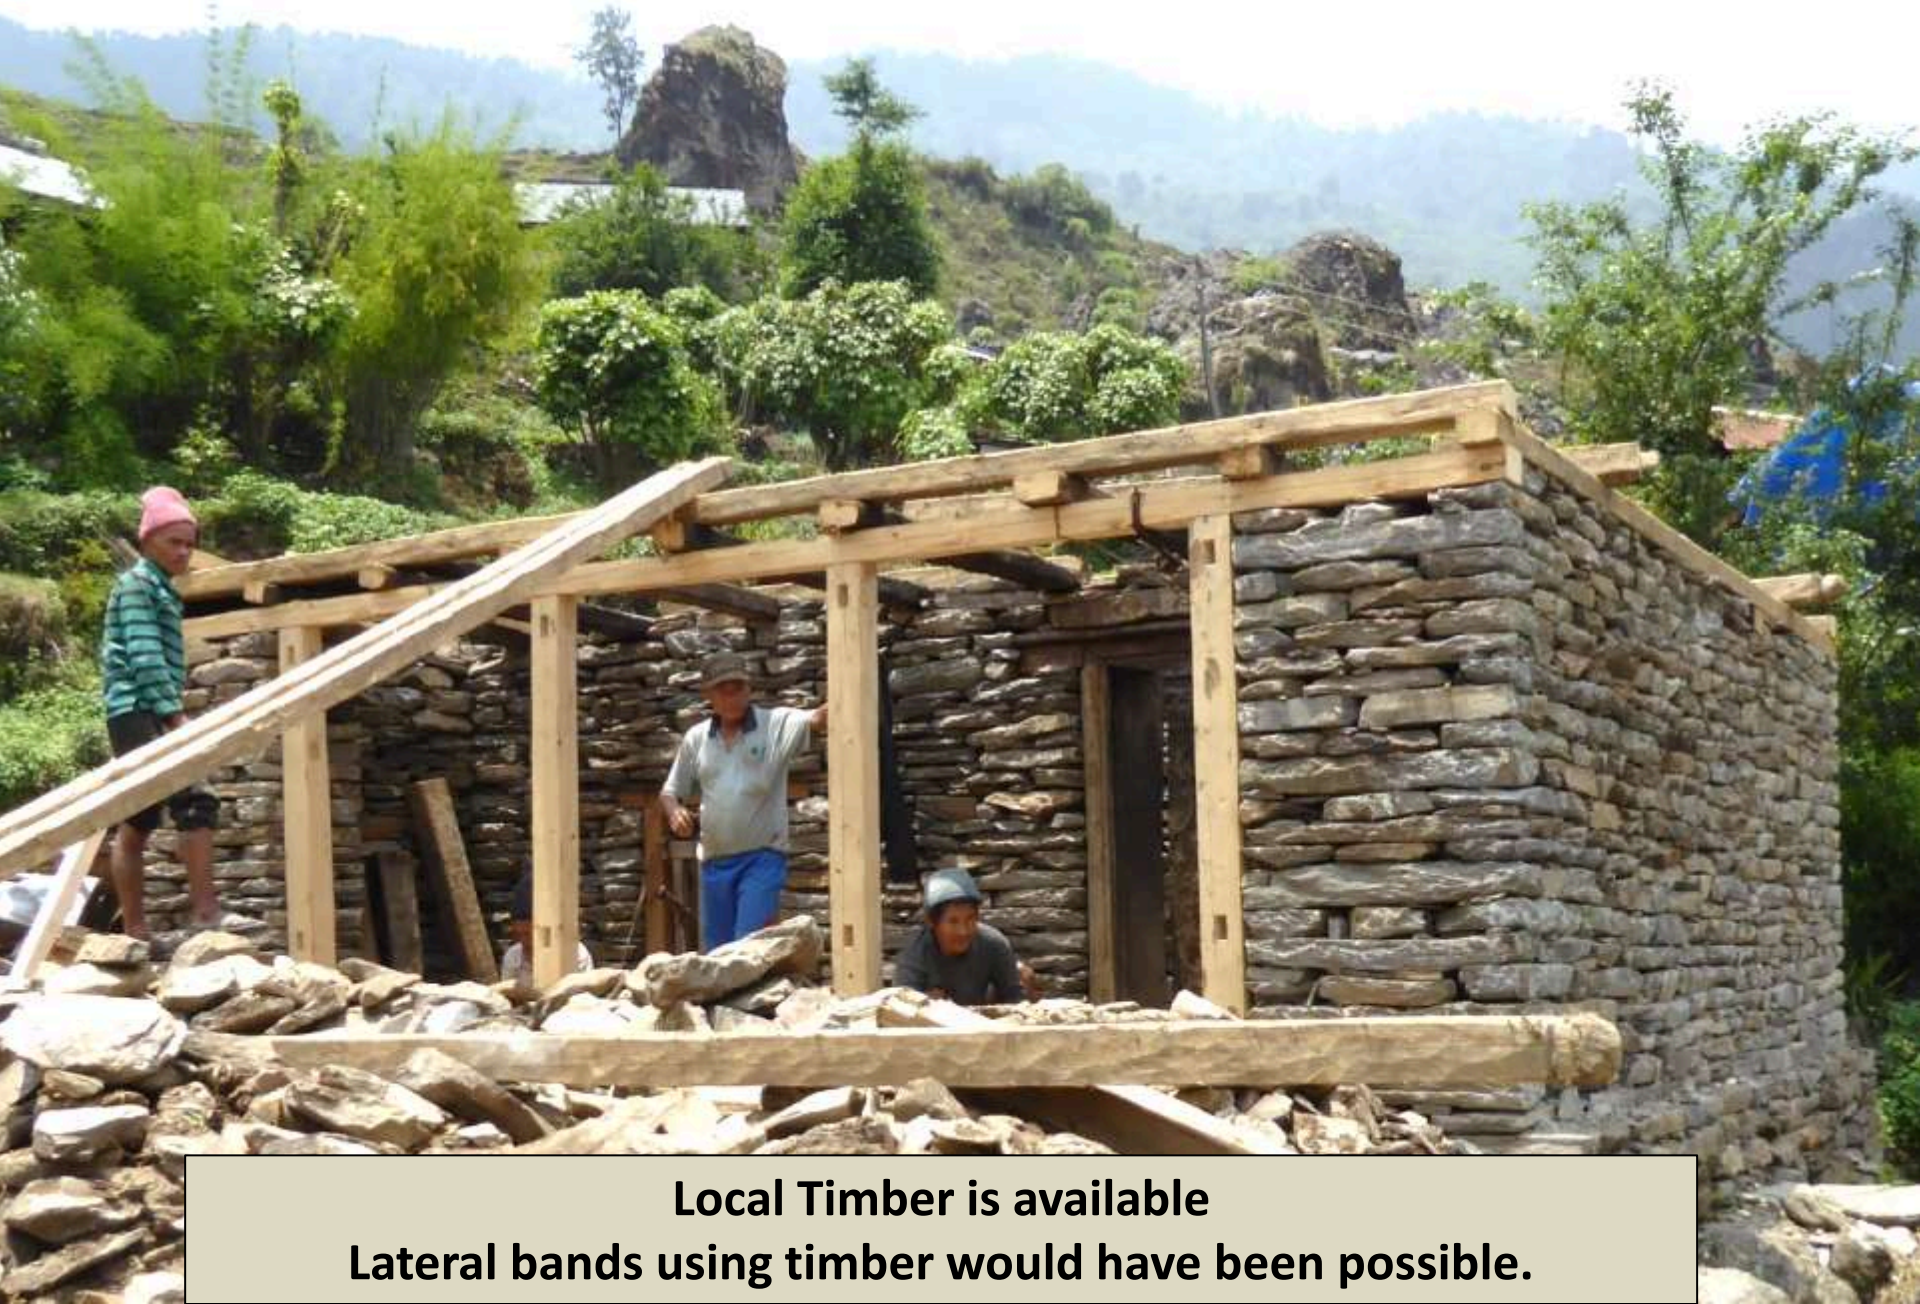
**Local Timber is available  
Lateral bands using timber would have been possible.**

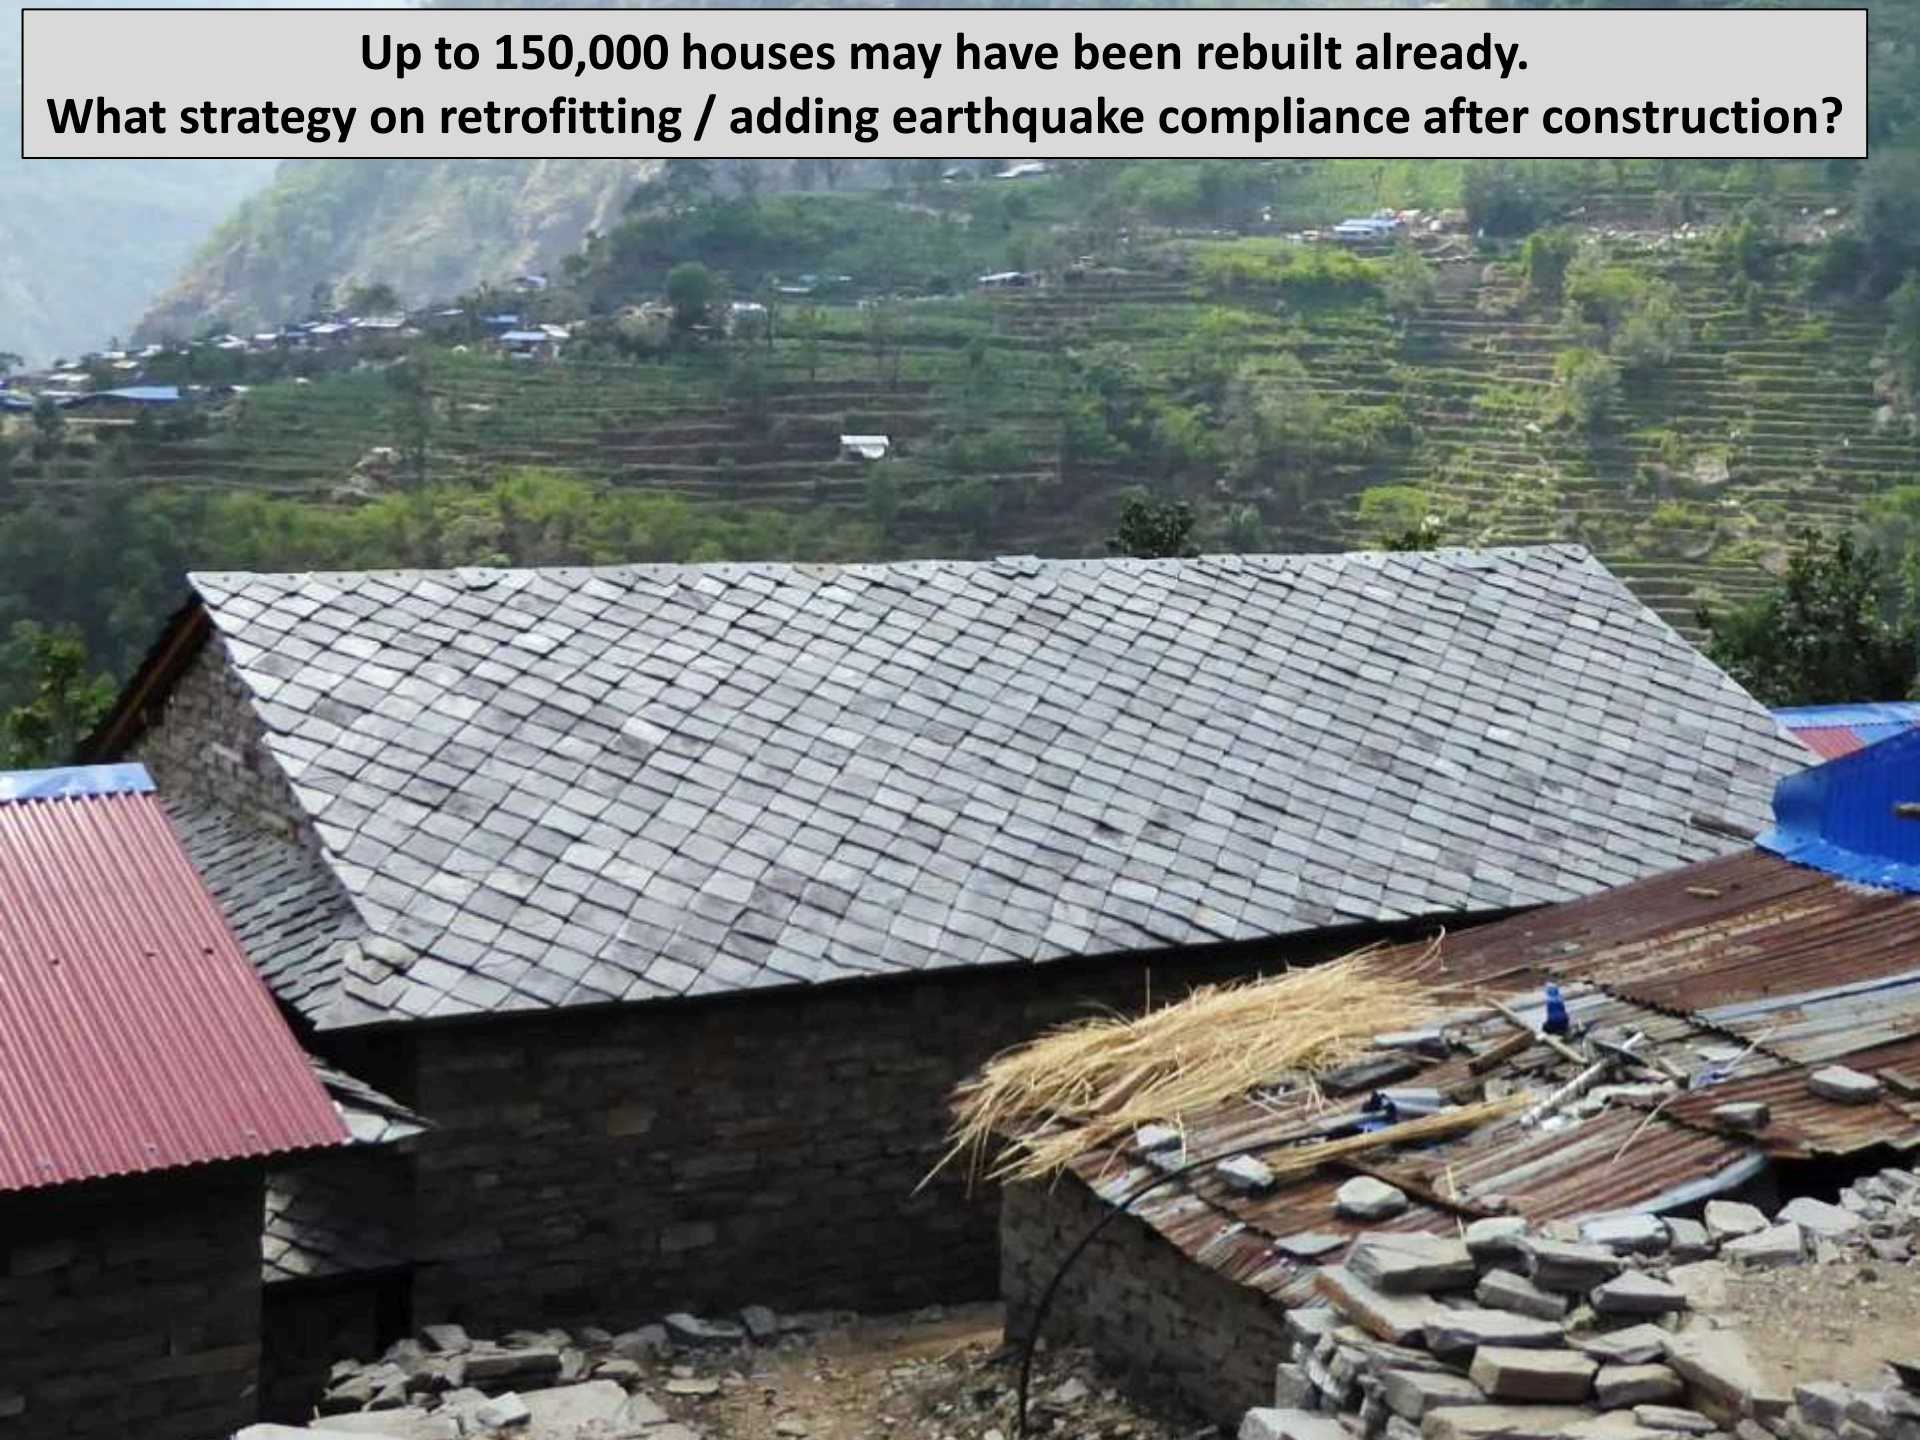
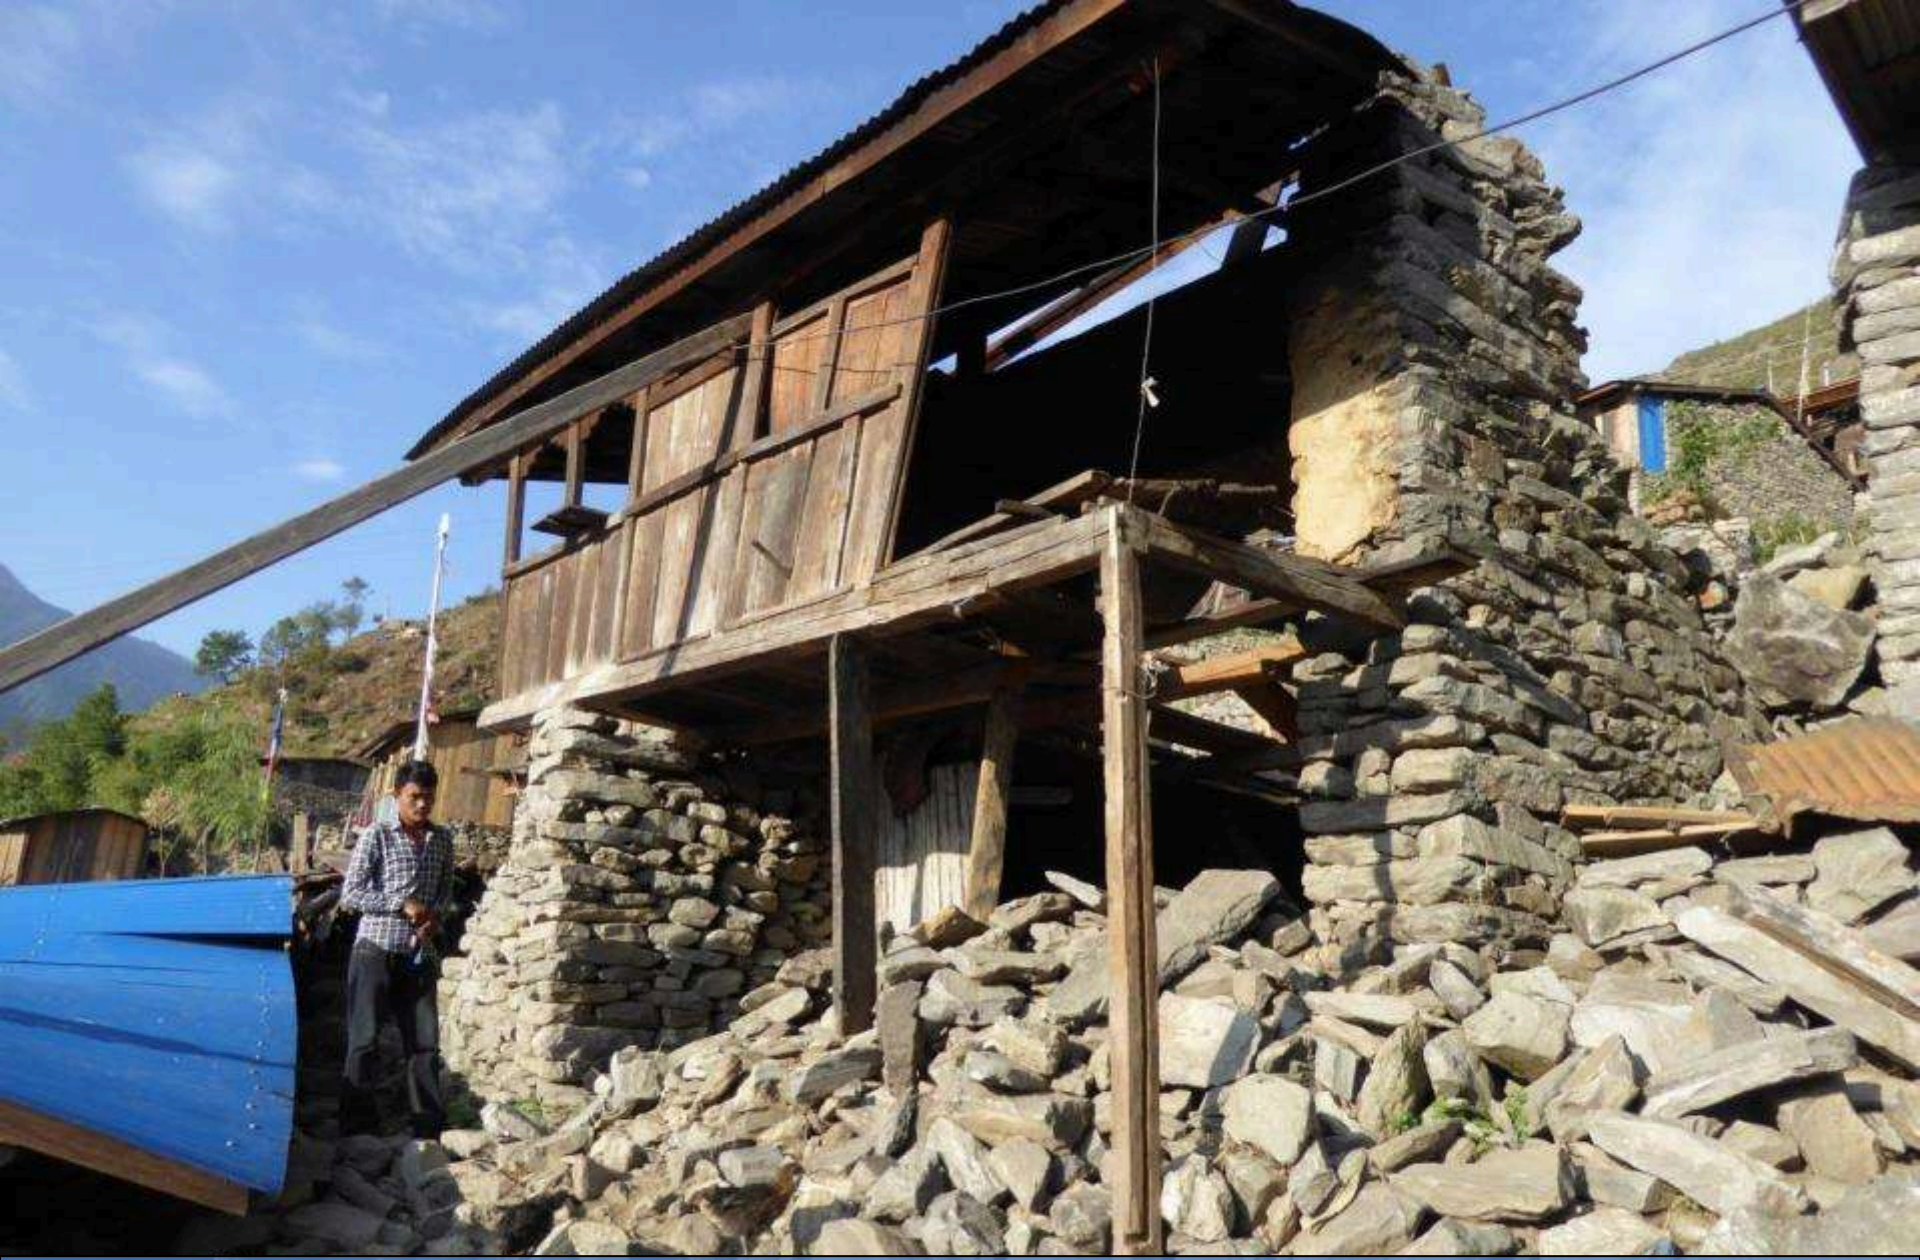
**Haku, Rasua District. People keen to reconstruct before monsoon..  
GOAL and OM Nepal recently approved to start training.**

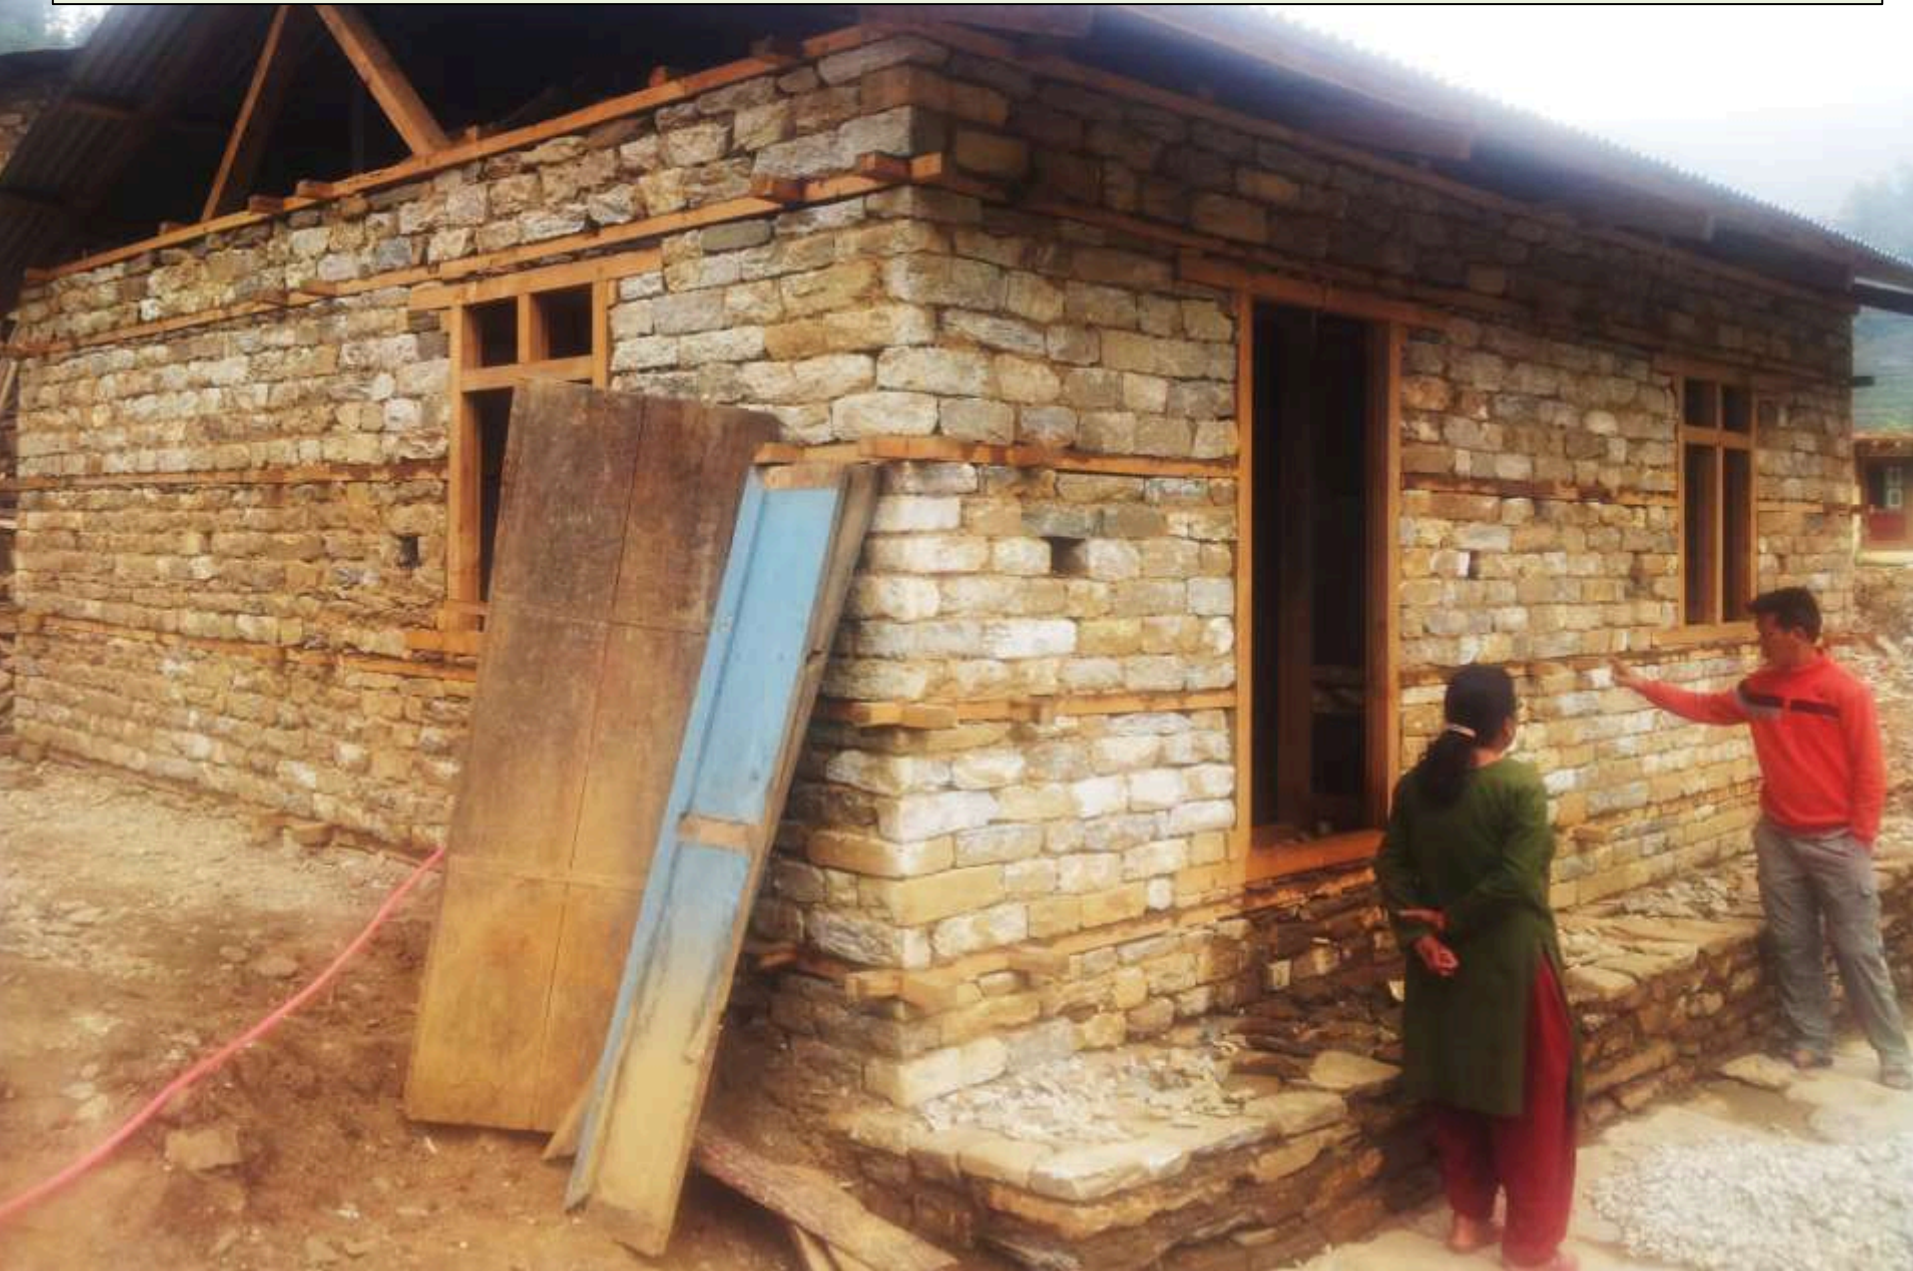
Model house built in training provided by HELVATAS – showing good use of wooden bands.

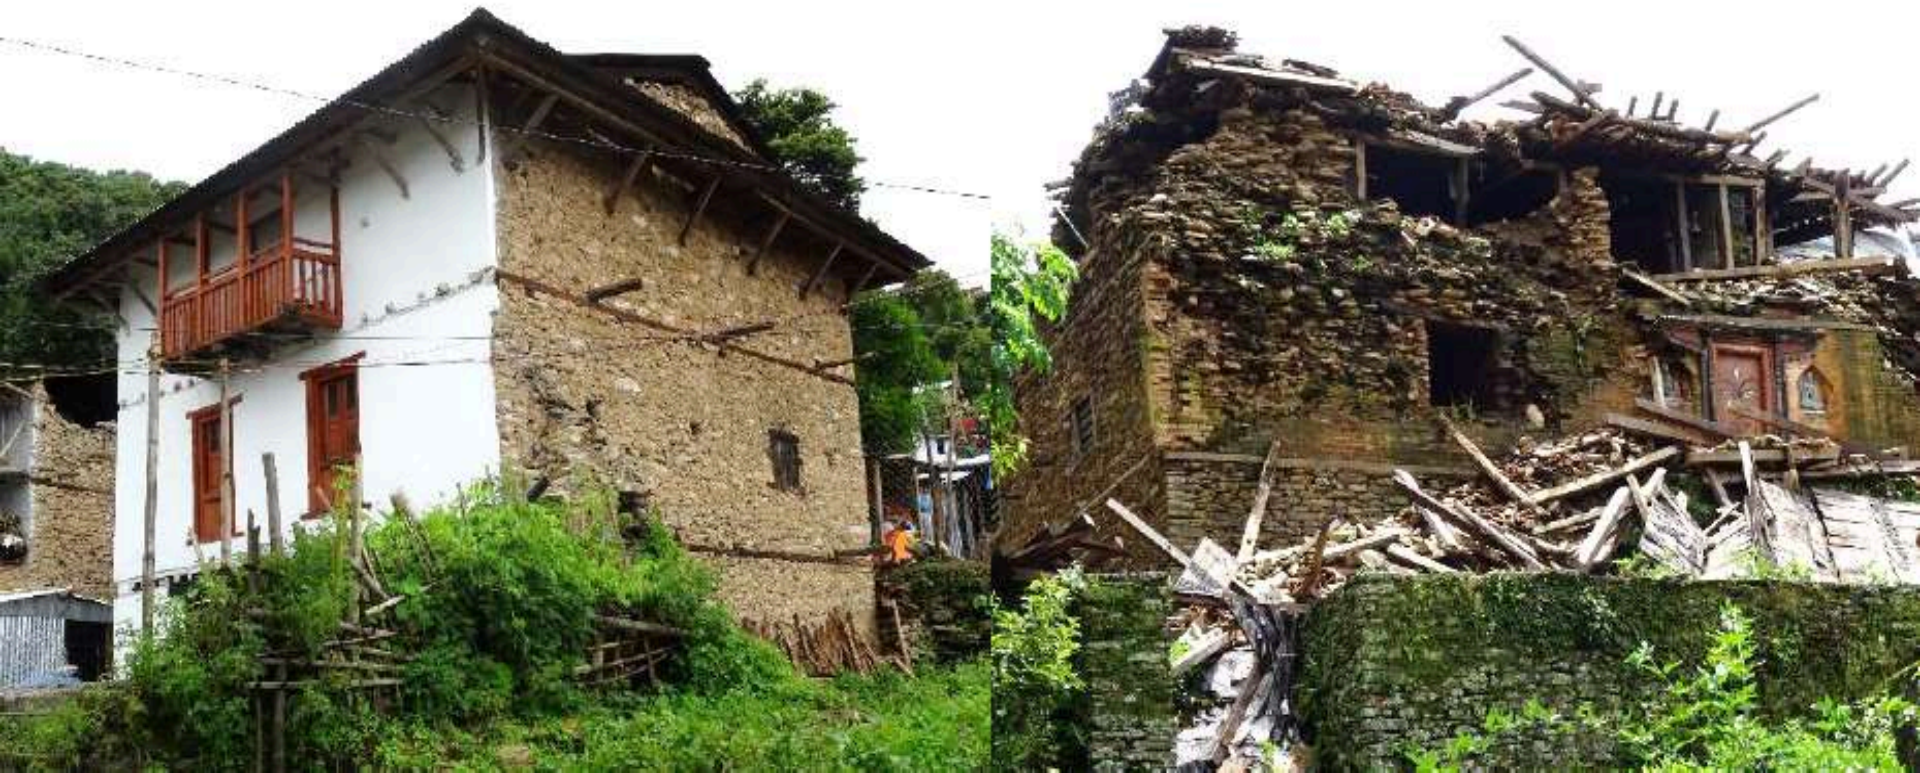
# Same village, Sindlepachok

## Not because of location, fate or luck...

**Not because of they were not steel & concrete**

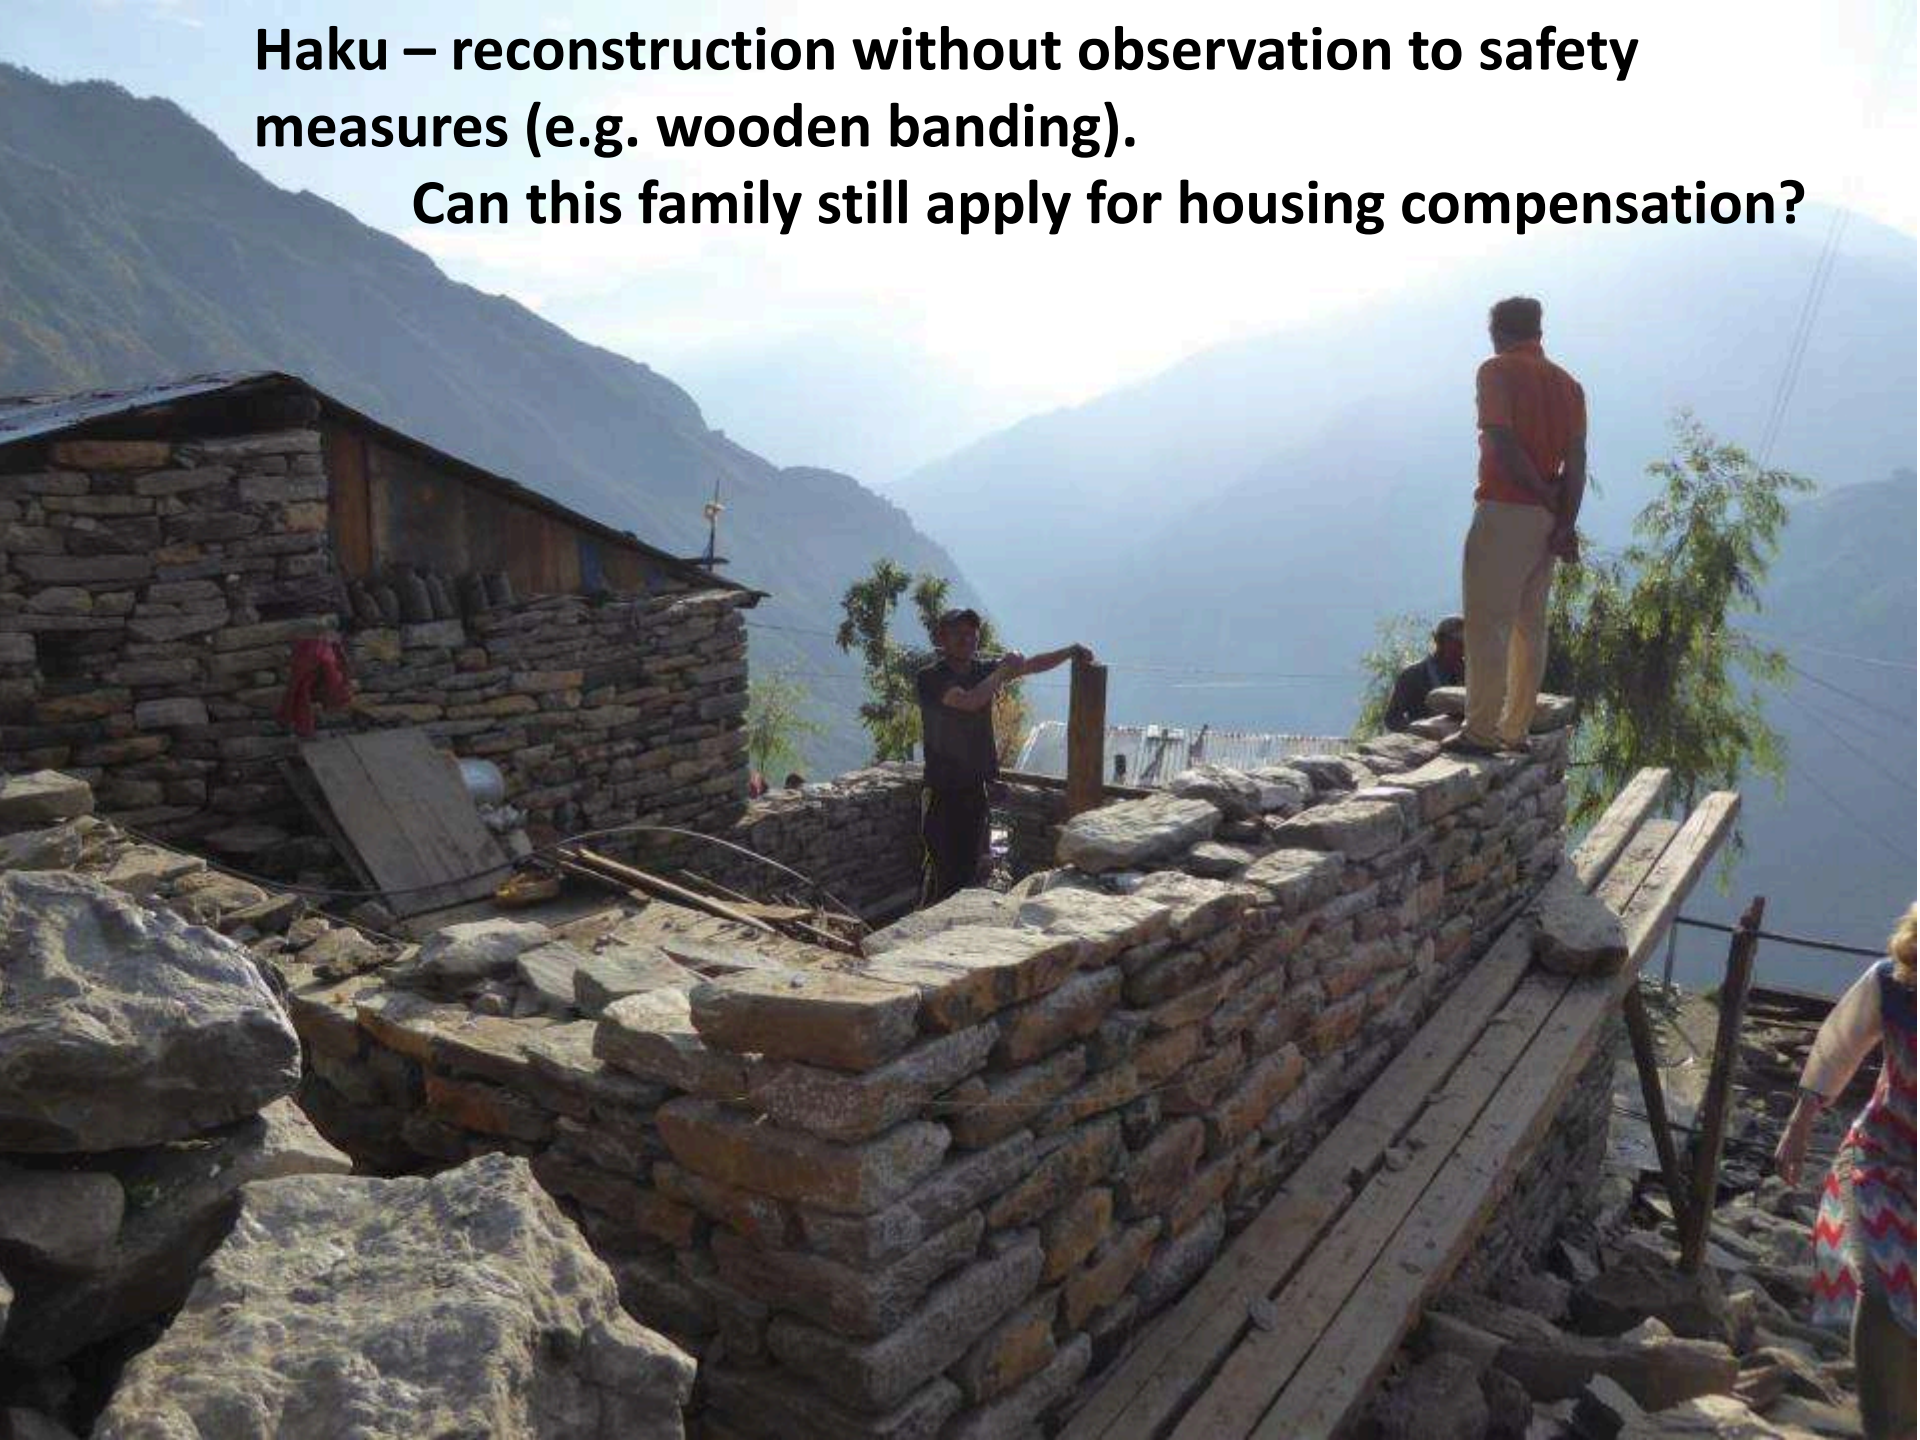
**Haku – reconstruction without observation to safety measures (e.g. wooden banding).**
