# Snapshots of field realities

Across districts Nuwarkot, Rasua and Dhading

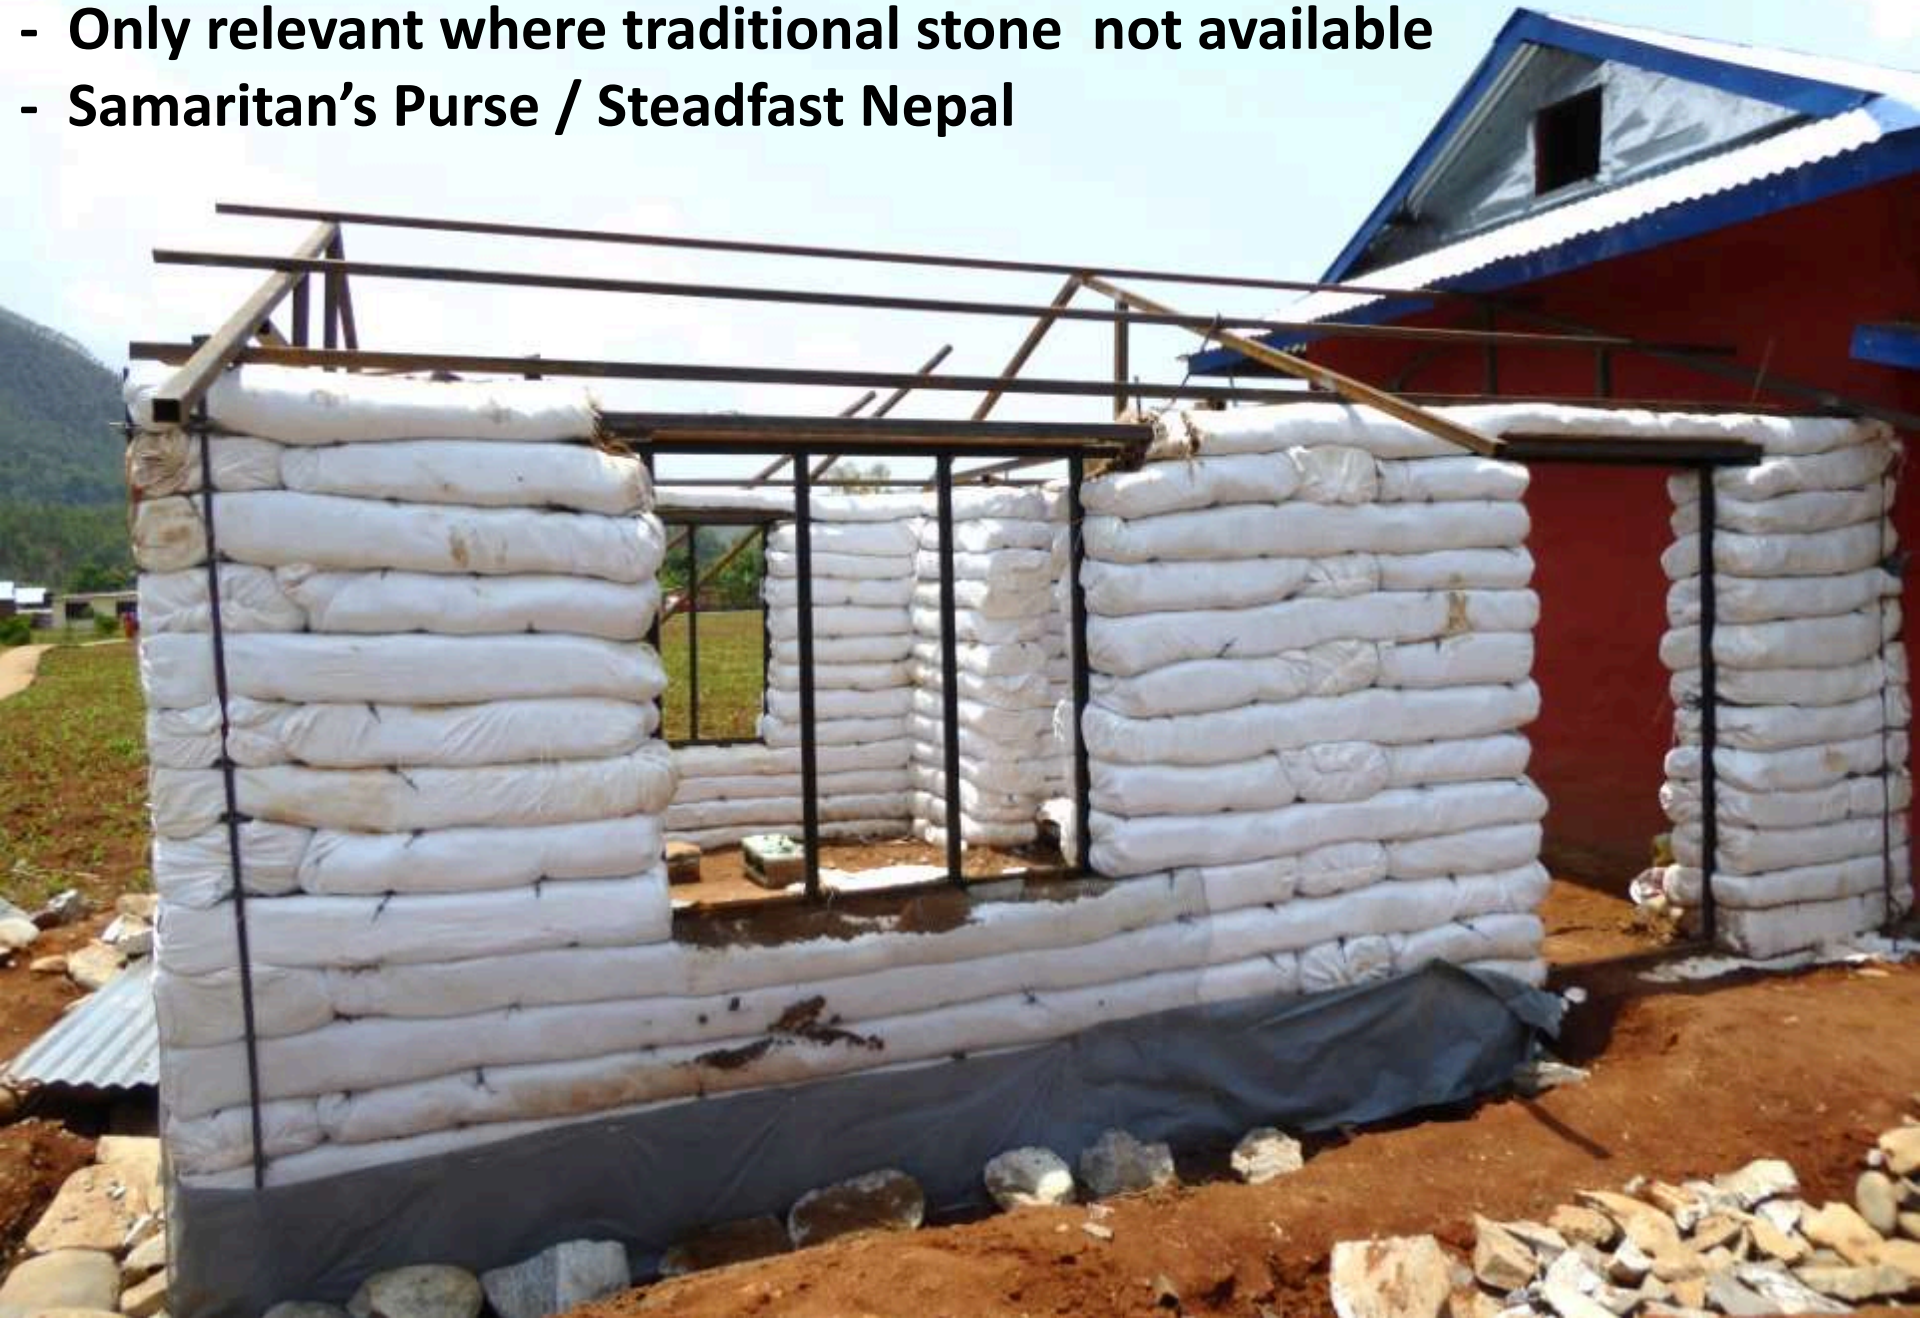
**Mixed masonry with mud: local materials**

**= vulnerable housing**

**Buttress walls and well-tied walls – roof –  
corners = EQ compliance**

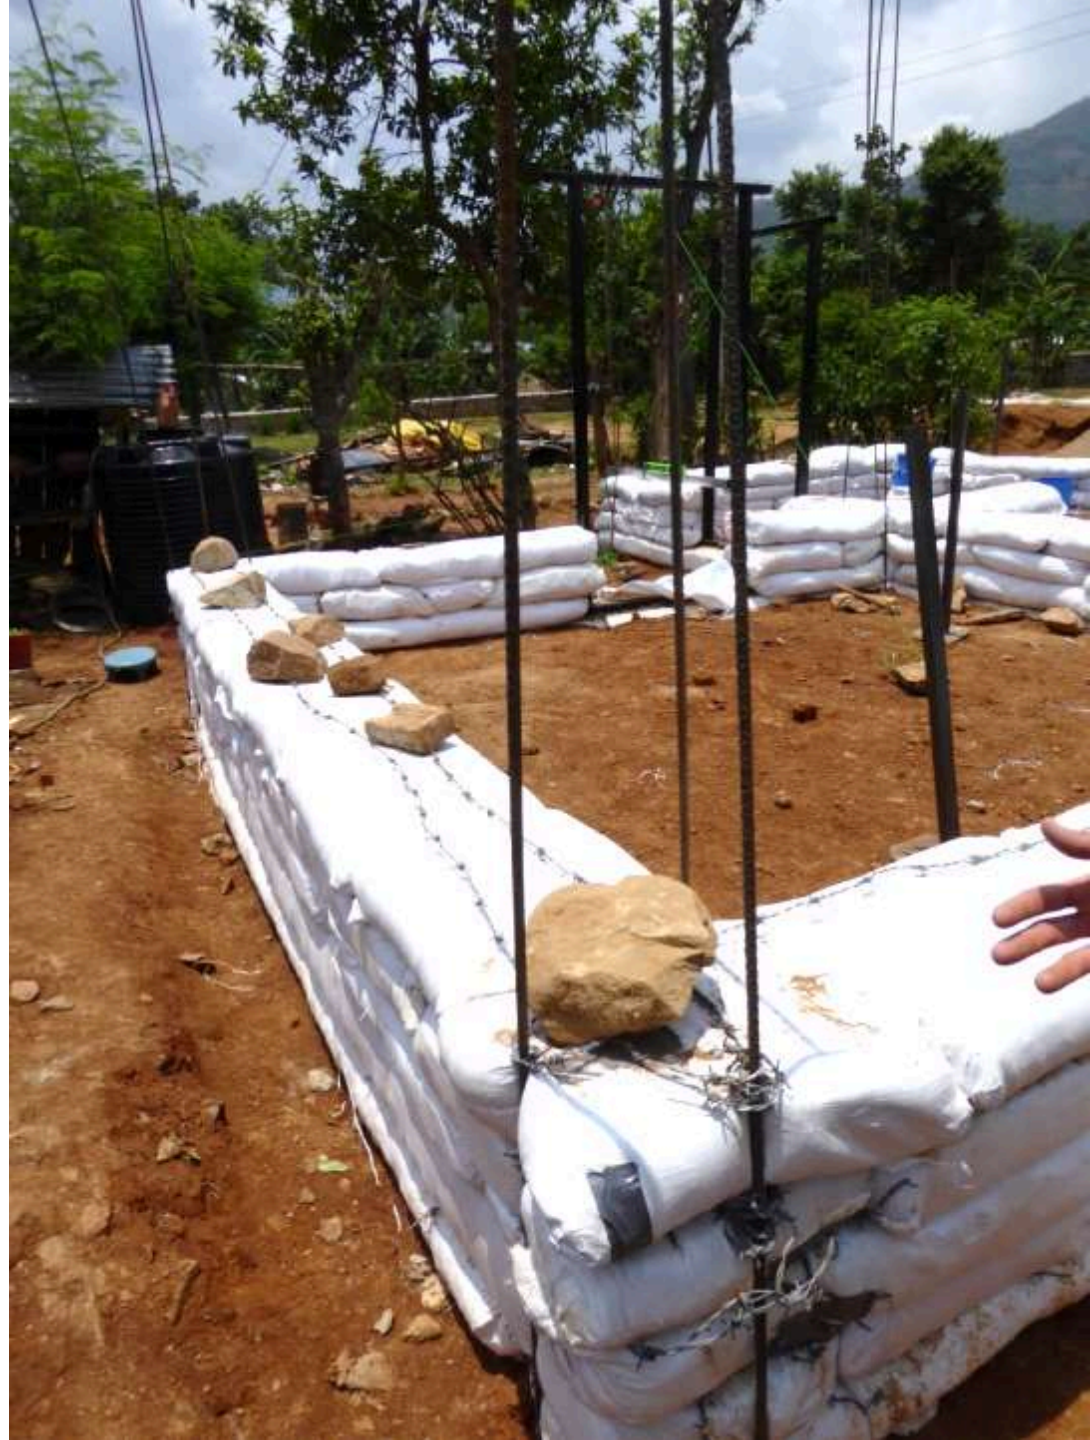
**Reinforced iron bars  
around each corner**

**Provides additional  
stability to prevent corner  
slippage in earthquakes**

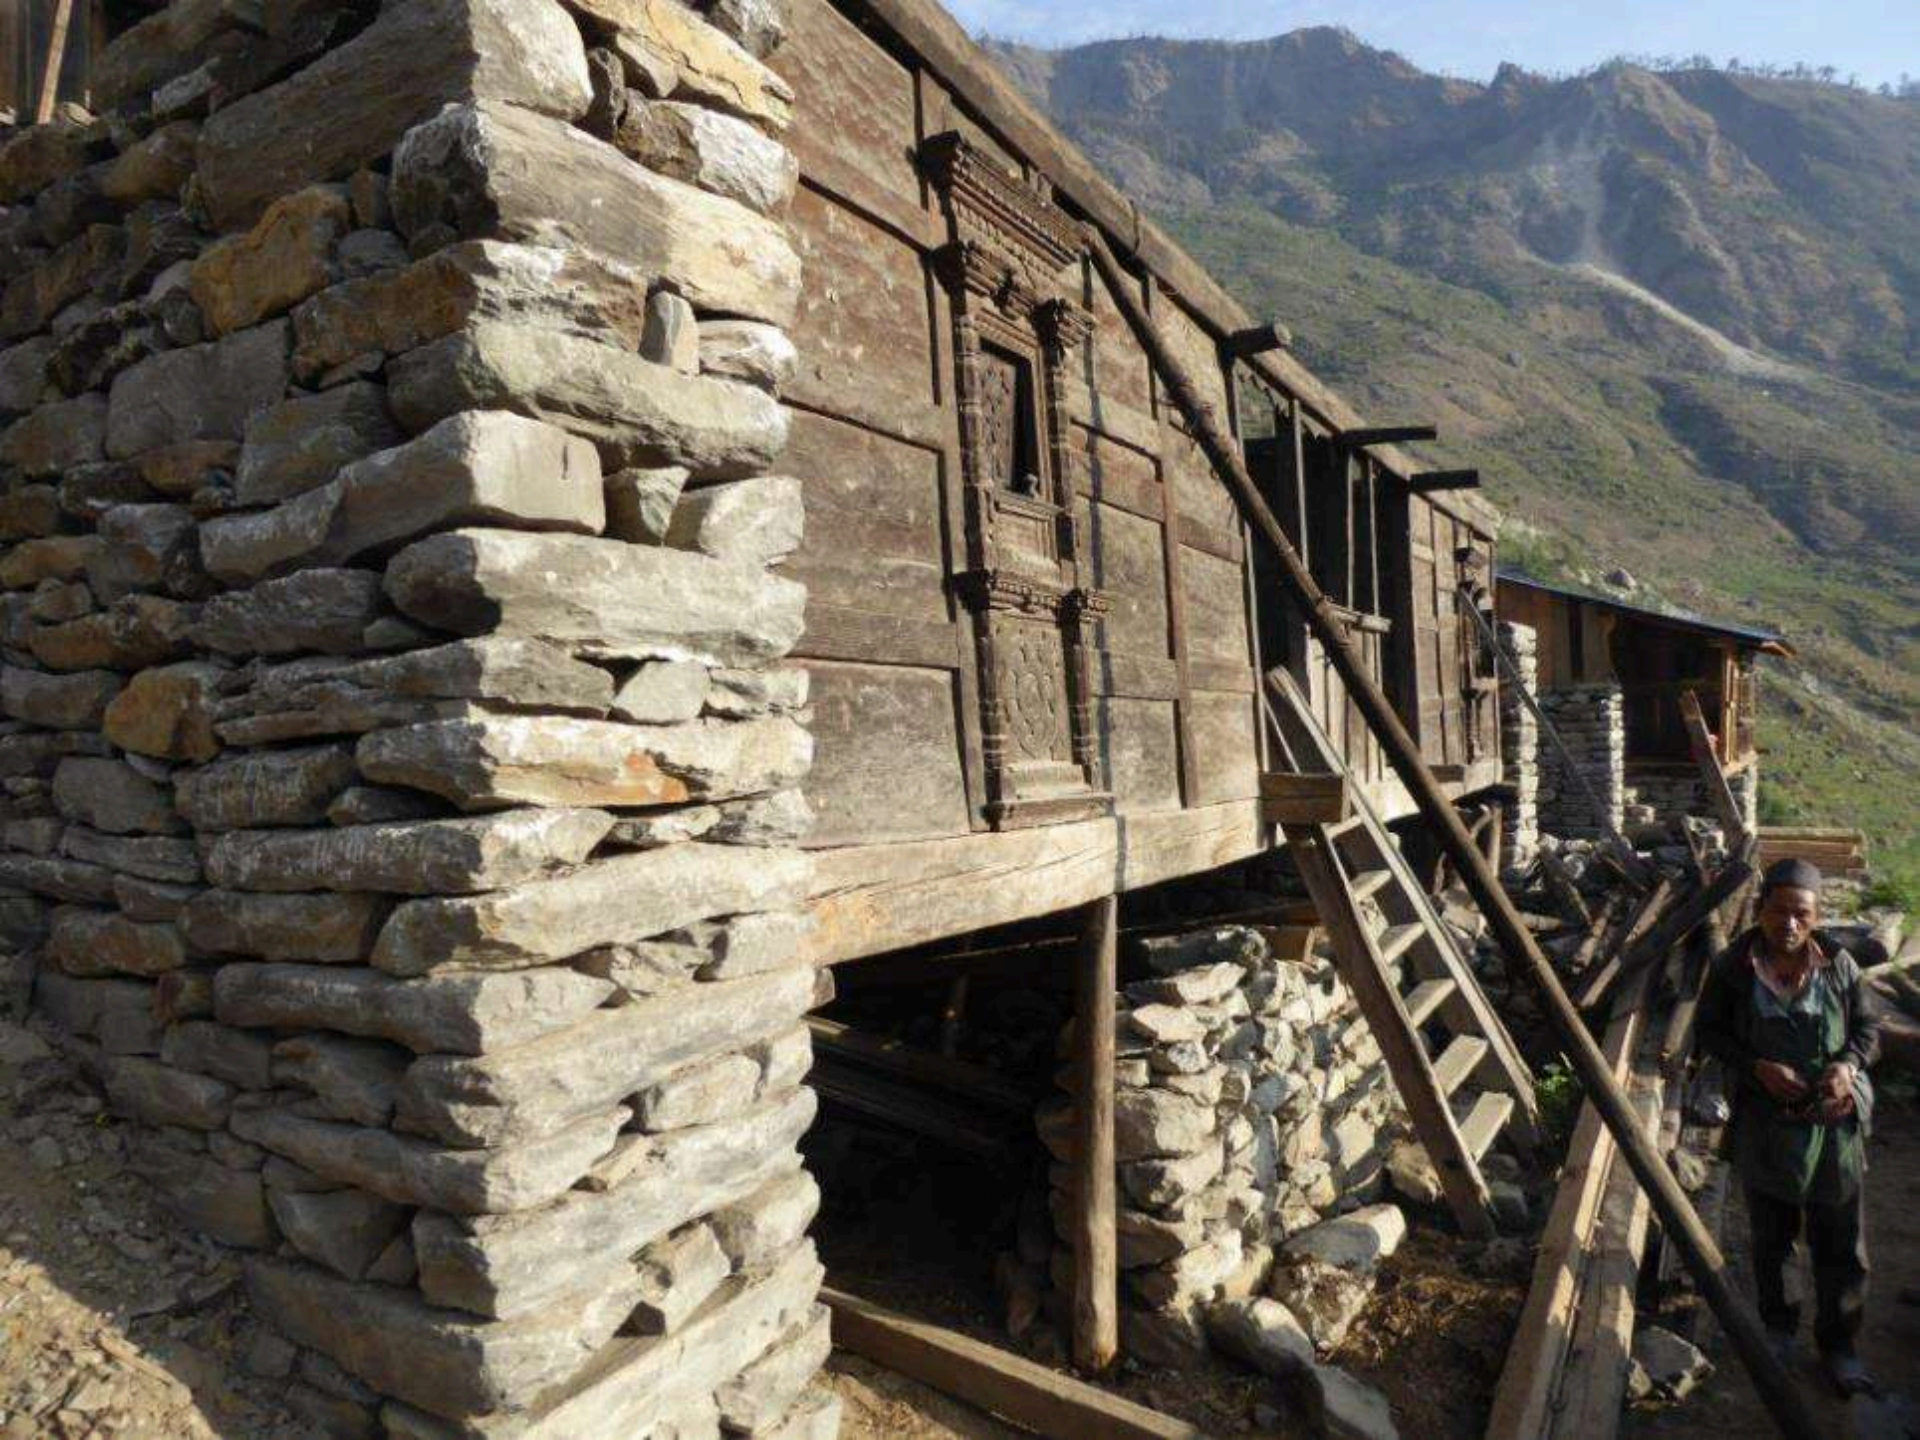
**Geological Surveys: need to communicate the plan of action with districts and communities. Which areas are no longer safe? What choices to people have?**

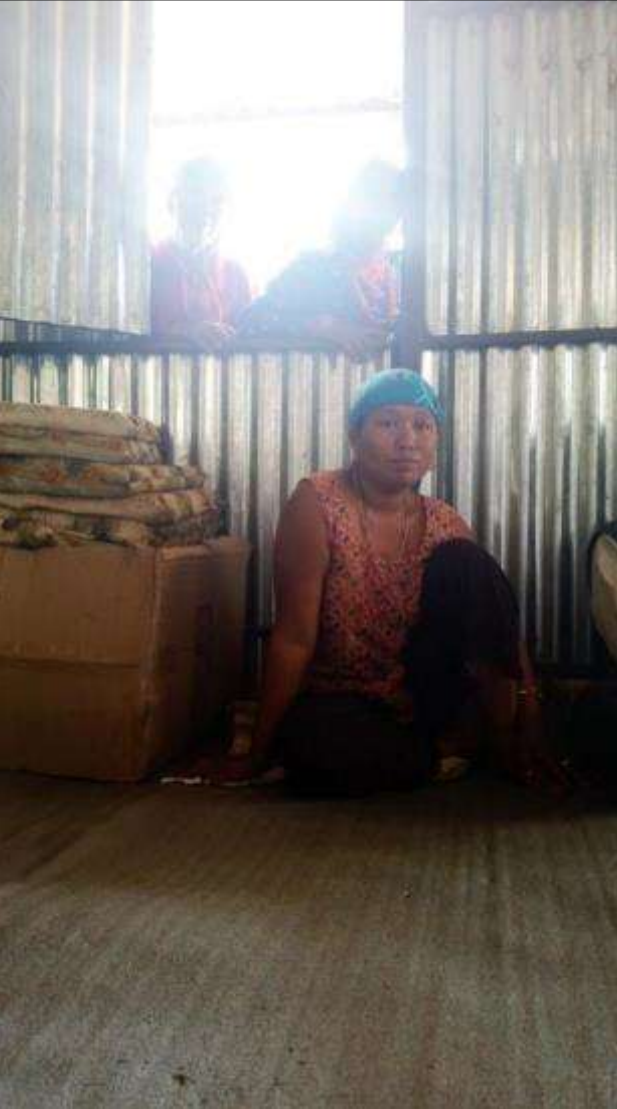
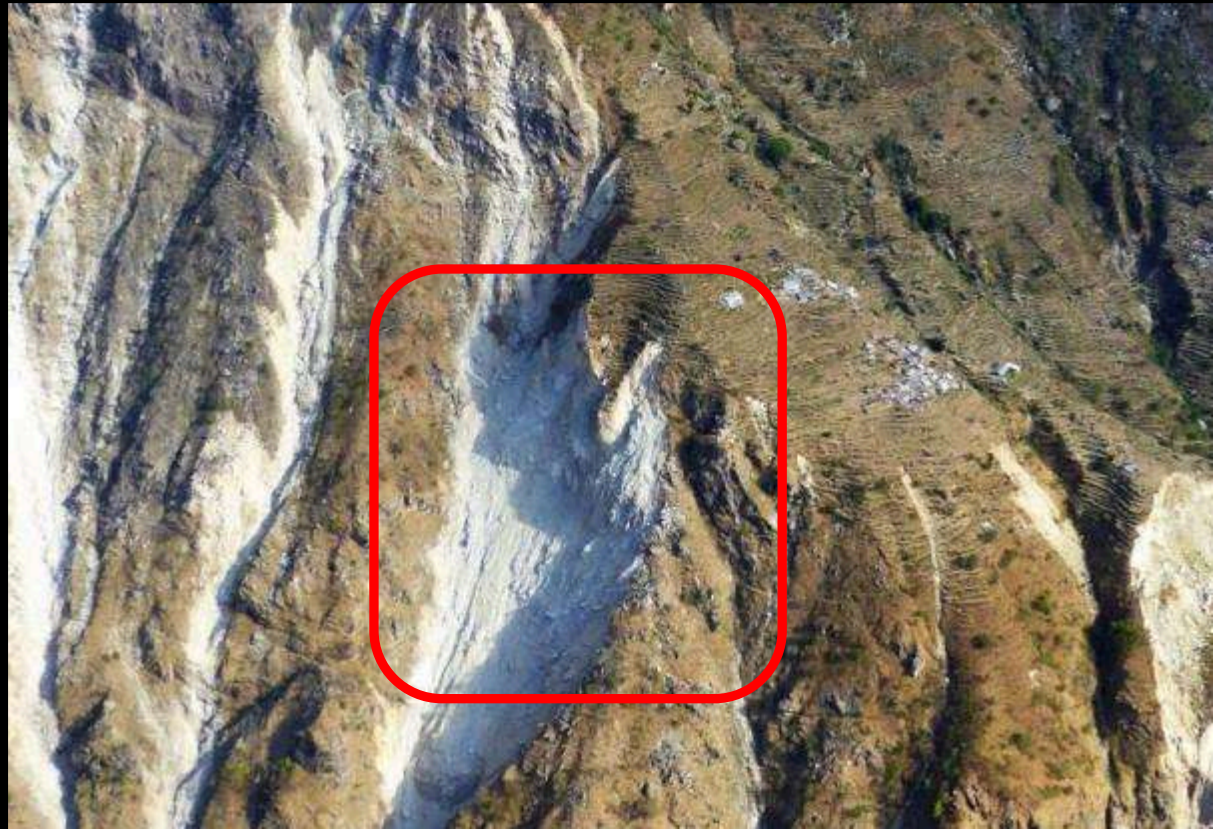
## Case study – Haku (Rasua district)

### The people who survived, but can't go home

- In IDP camps – Nuwarkhot
- Awaiting resettlement options
- NRA / PDRF has specific allocation
- Information and communication!

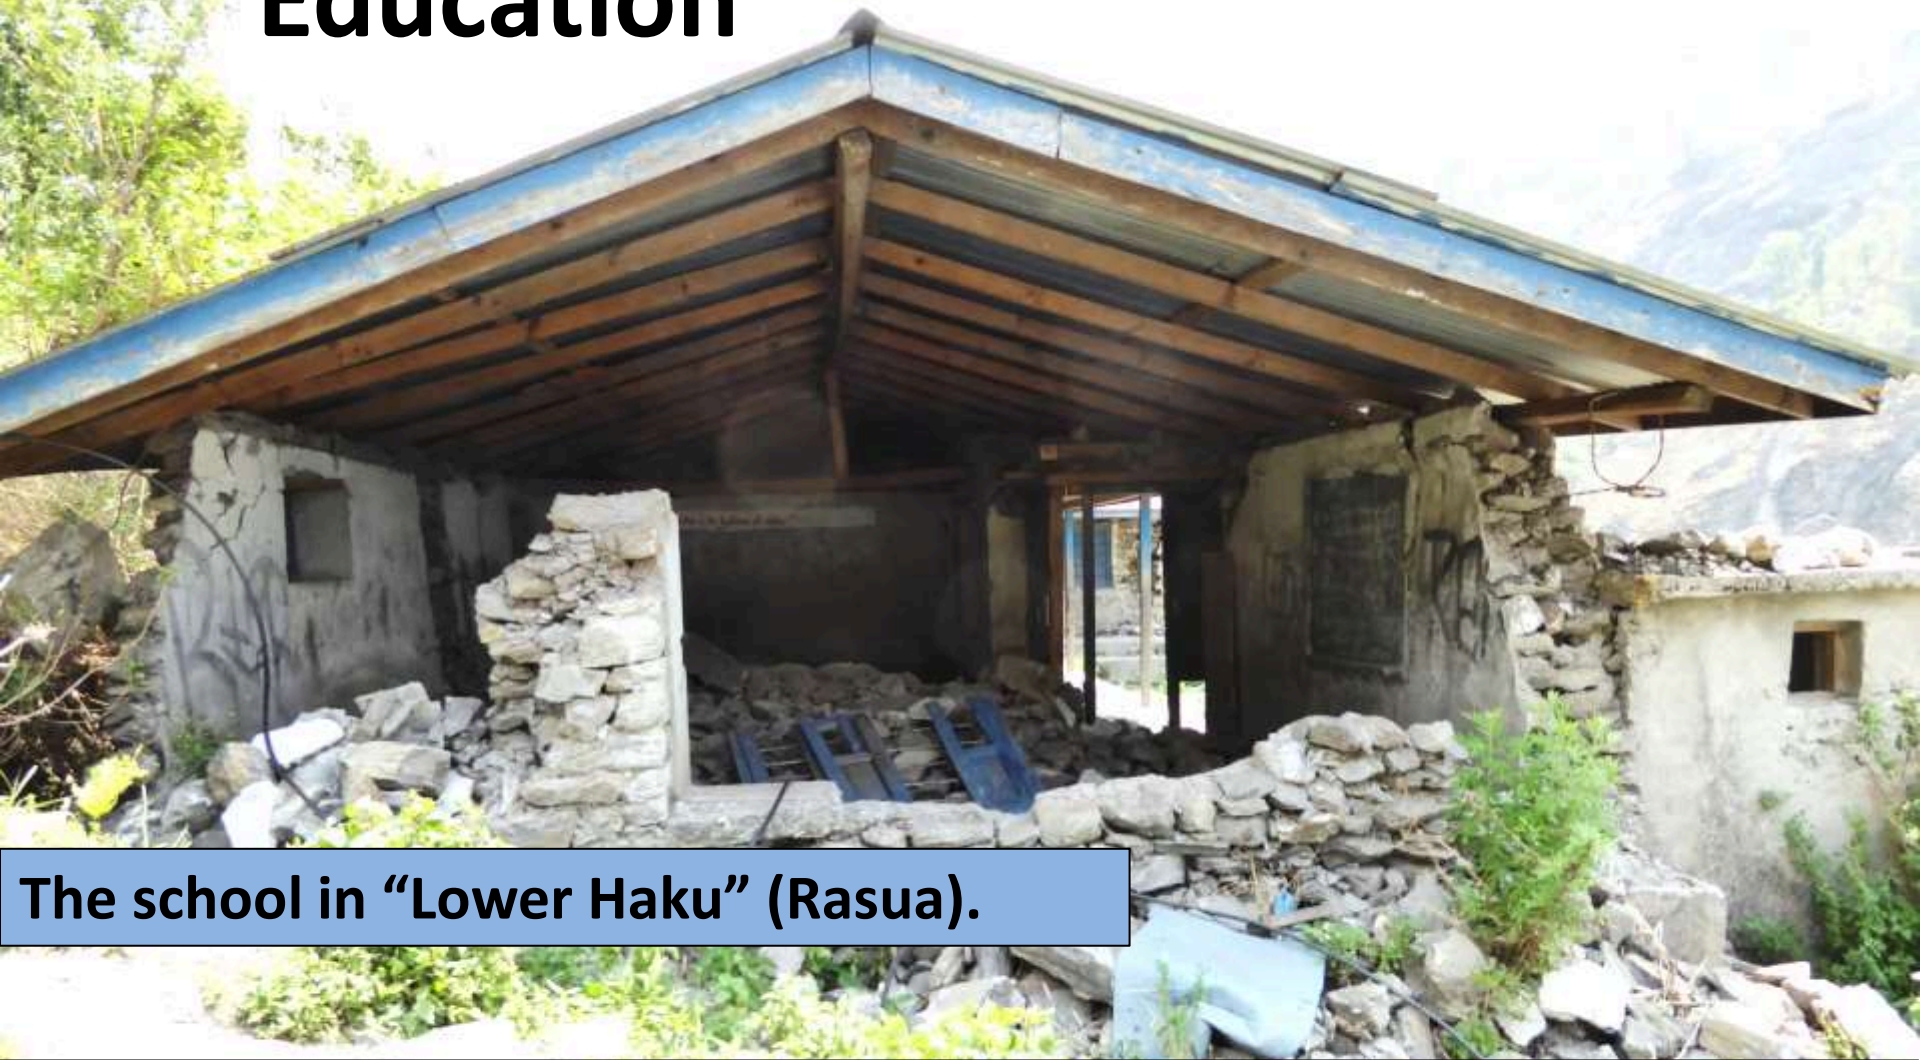
The school in “Lower Haku” (Rasua).

- Kids sent to urban IDP camp in Dunche to “not fall behind”.
- School reconstruction? “Delayed... we don’t know when”
- Interim transitional school would help.

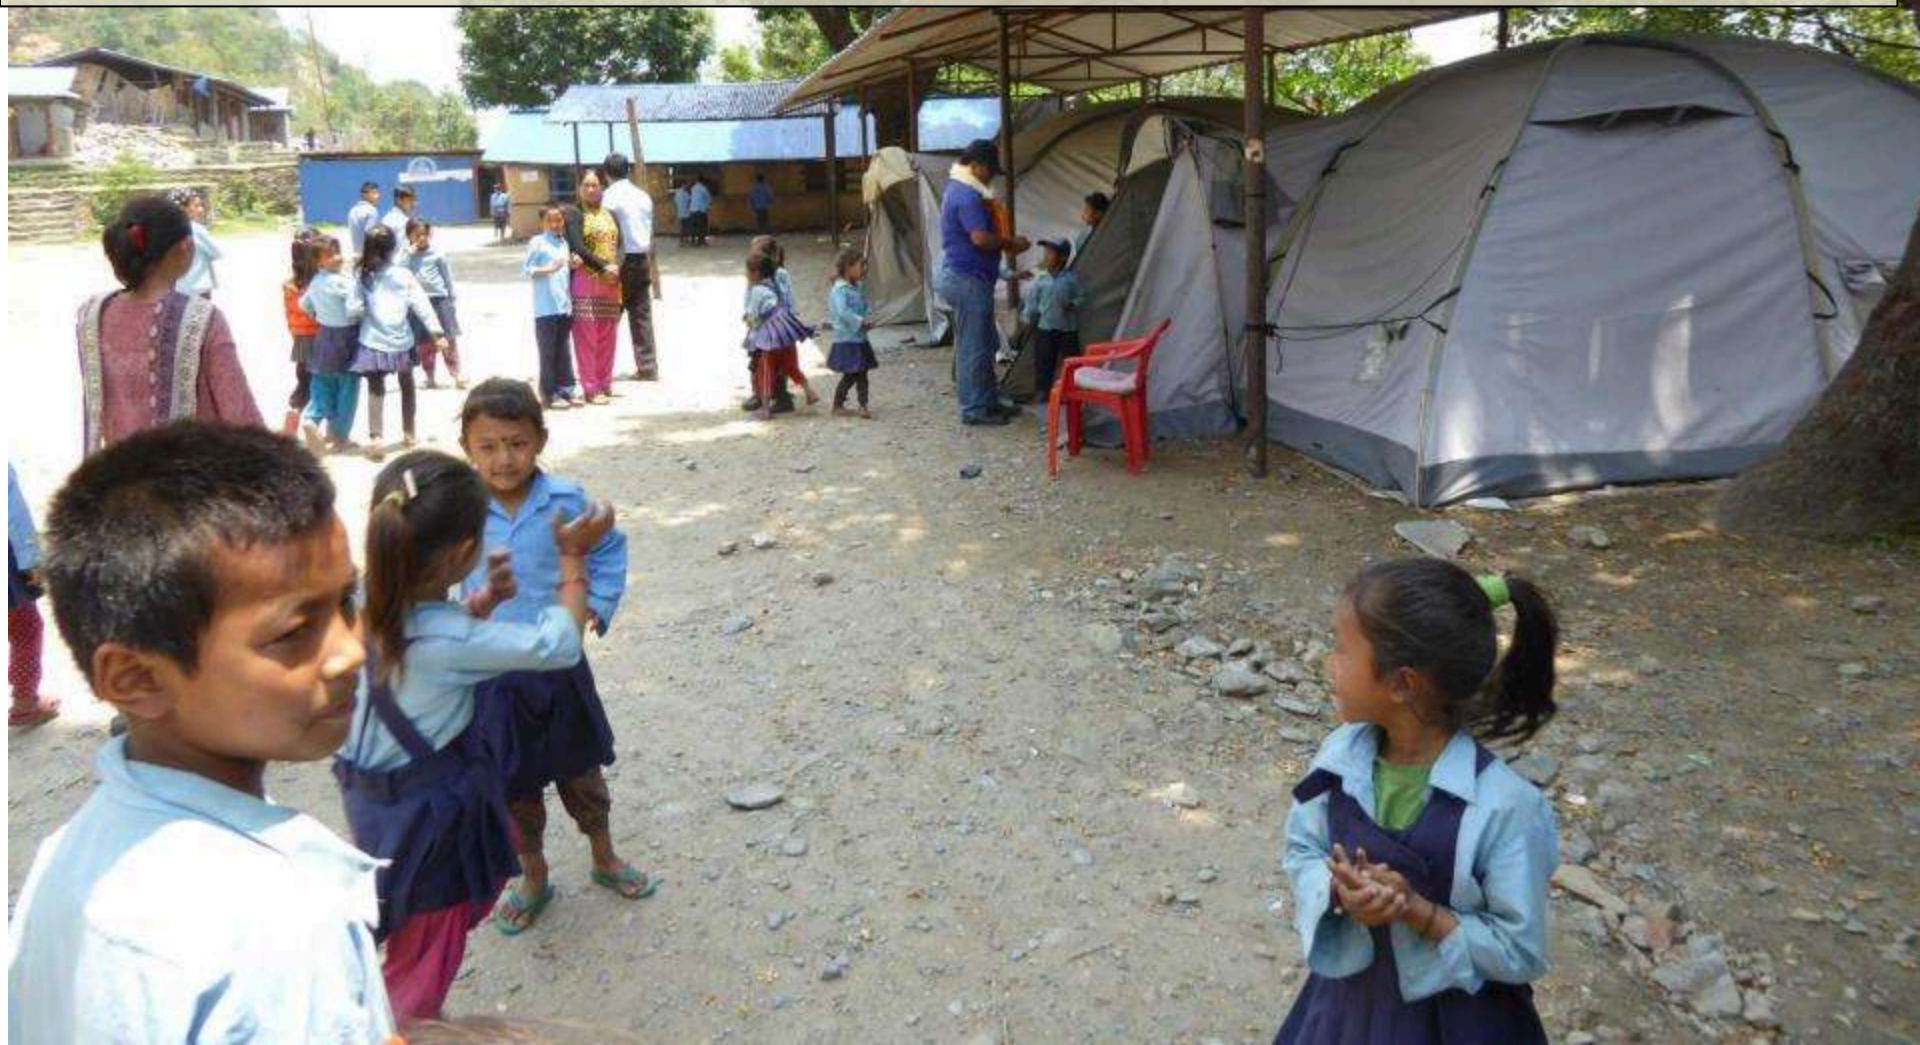
**Temporary school in tents, Rataon, N. Dhading. Many communities still have no temporary learning spaces – And this prevents return of IDPs in some areas.**

**Need to map out exactly which communities have and don't have temporary schools across each district, VDC and ward.**
