# District Report

## Kavrepalanchok

9 – 16 November 2017

### Field Visit Report

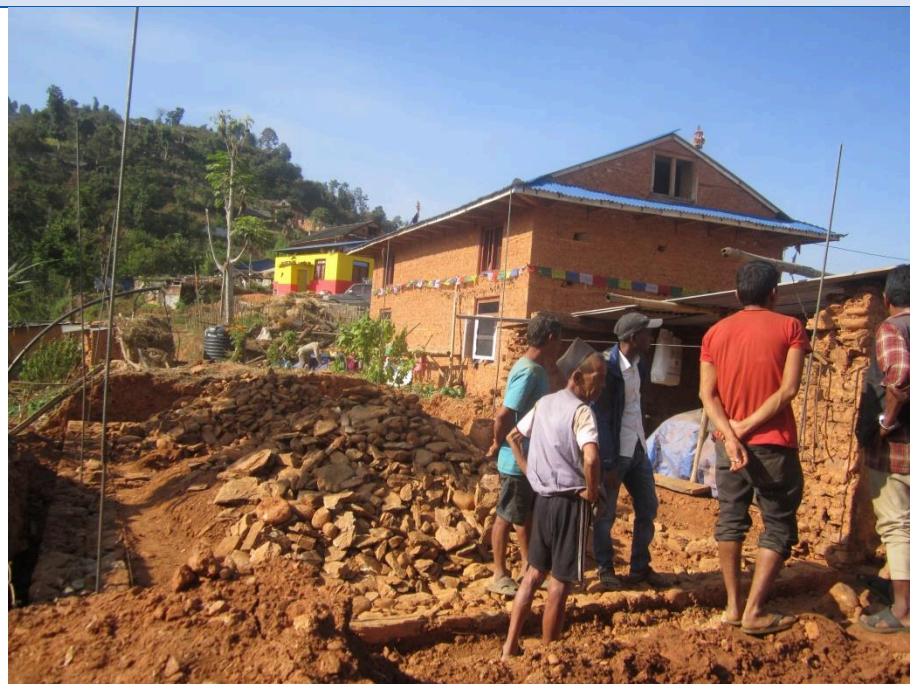
This ongoing construction of Stone in Mud Masonry at Koshidekha initially was preparing for Plinth Level RCC Band casting with no provisions of Vertical Reinforcements. The timely visit of DLPIU engineers provided the required assistance and timely correction for the construction.

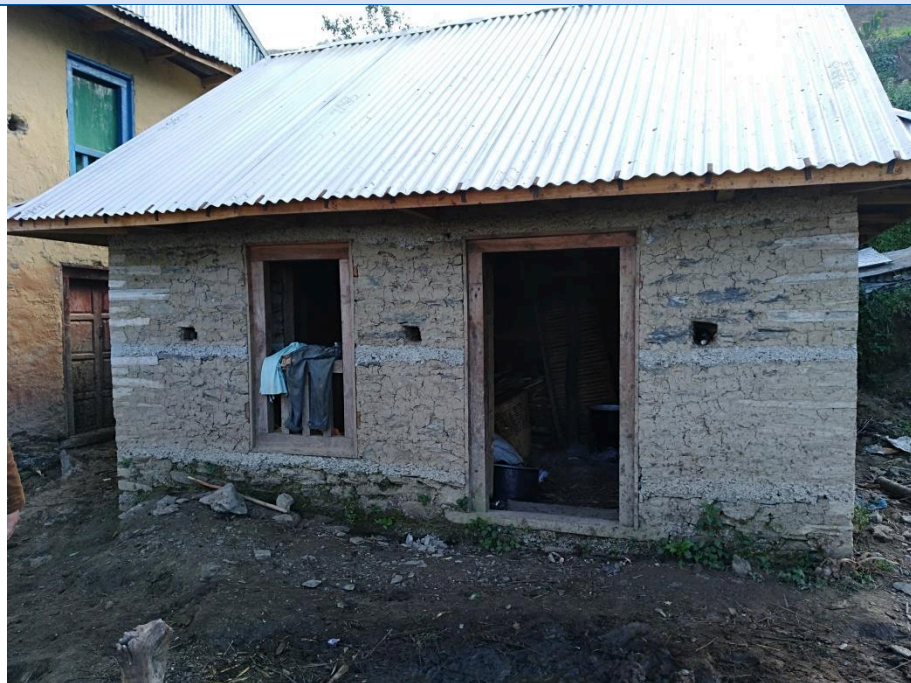
A one roomed Brick in Mud Masonry with RCC Band at SipaliChilaune. The house owner Pramod Regmi has received First Tranche and awaits the inspection for the further tranches.

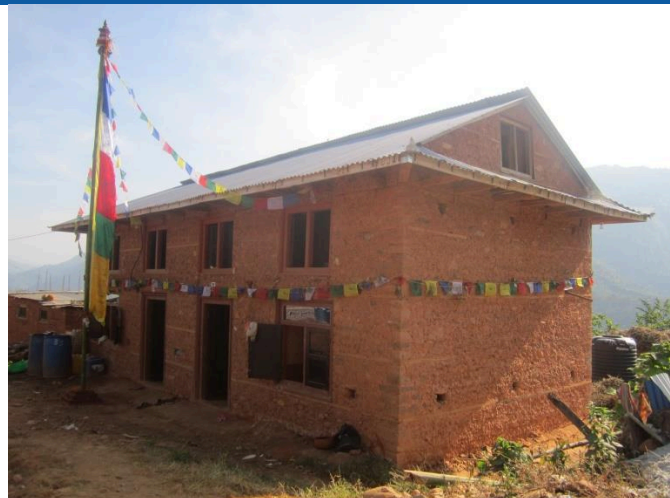
**Location:** Koshidekha VDC (Now Panchkhal Municipality)

**Building Typology:** Stone in Mud with Wooden Bands

This house has received Second Tranche. Due to a couple of months gap in technical assistance, none of the houses have been verified for the third tranche in the VDC.

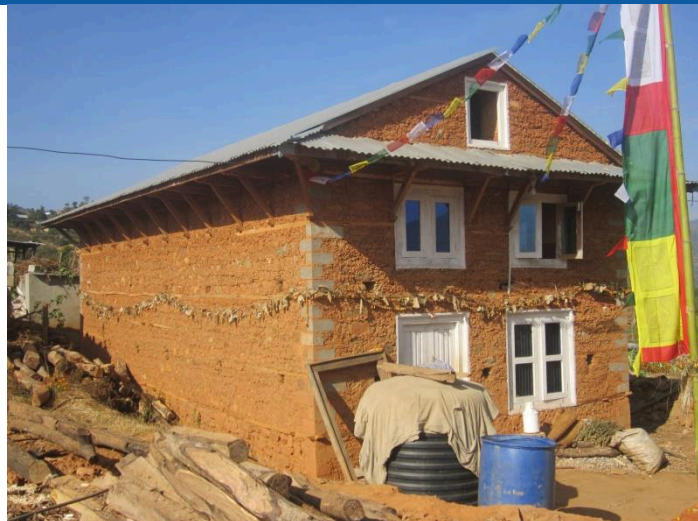
**Location:** Koshidekha VDC (Now Panchkhal Municipality)

**Building Typology:** Stone in Mud with Wooden Bands

This house has received Second Tranche whereas the inspection for the third tranche is yet to be done. Hollow Concrete Blocks have been used at the corners due to difficult access to proper large stones.

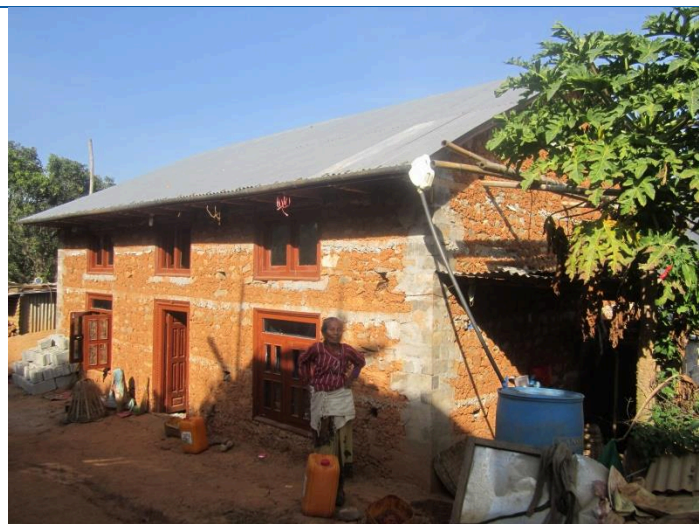
**Location:** Koshidekha VDC (Now Panchkhal Municipality)

**Building Typology:** Stone in Mud with RCC Bands

This house has received Second Tranche and still awaits the inspection for the Third Tranche.

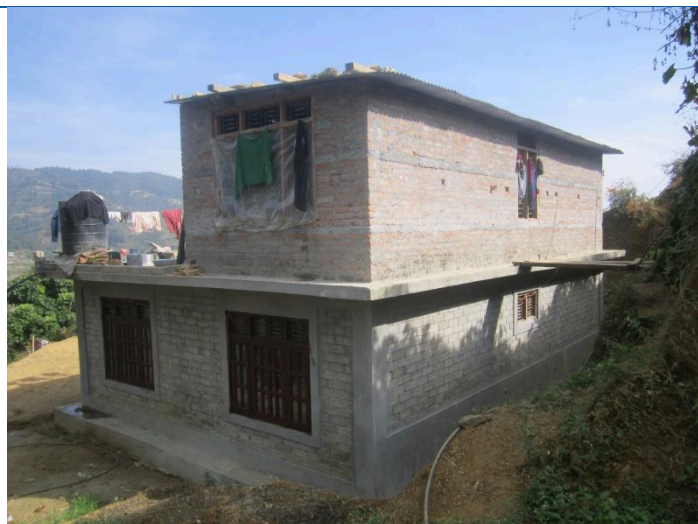
**Location:** Mahendrajyoti VDC (Now Banepa Municipality)

**Building Typology:** Interlocking Blocks with Brick in Cement Masonry at the First Floor

This house has received First Tranche and inspection for the second has been done. As the design does not comply with the designs in design catalogue and standards do not exist for such structures, there are confusions for the process of verifying such structures for the further tranches.

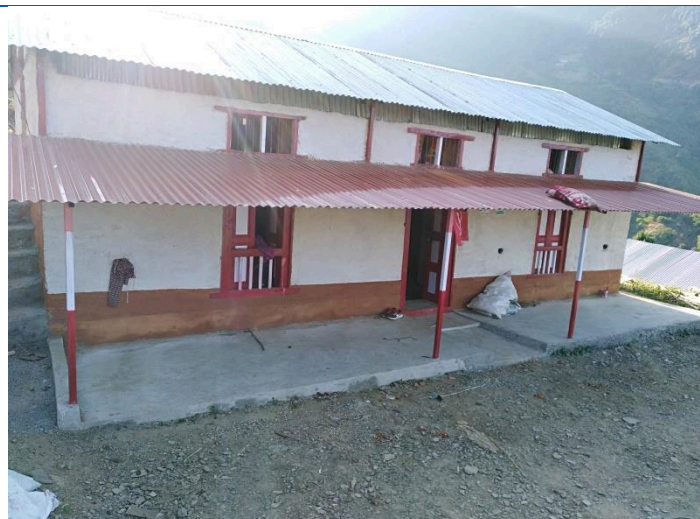
**House Owner:** Ambika Mainalee  
**Location:** SipaliChilaune (Now Roshi Gaupaika)  
**Building Typology:** Stone in Mud with RCC Bands  
This house has received First Tranche and still awaits the inspection for the Second Tranche.

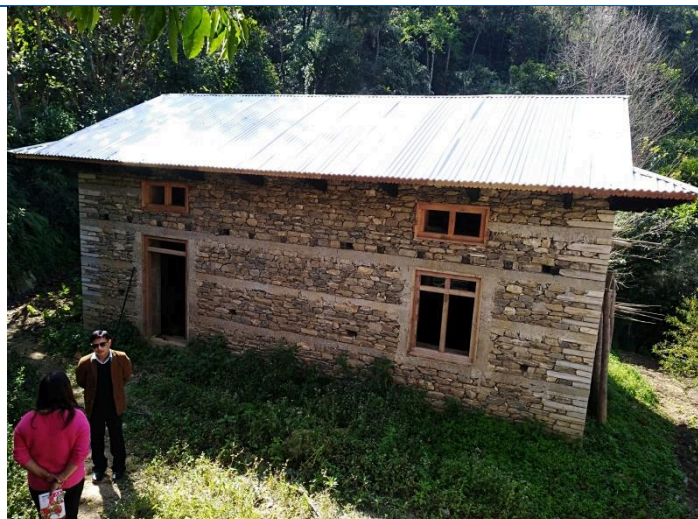
**House Owner:** Man Bahadur Ghalan  
**Location:** SipaliChilaune (Now Roshi Gaupaika)  
**Building Typology:** Stone in Cement with RCC Bands  
This house has received First Tranche and still awaits the inspection for the Second Tranche.
