Design Change  
Request No. 25\_128

Customer project Name/ 客户项目名称: JIM-4JJ MCR No. / MCR号:

# PDEC R25-128 (4JJ1-D 样件)

## Test Report Vehicle endurance test parts investigation

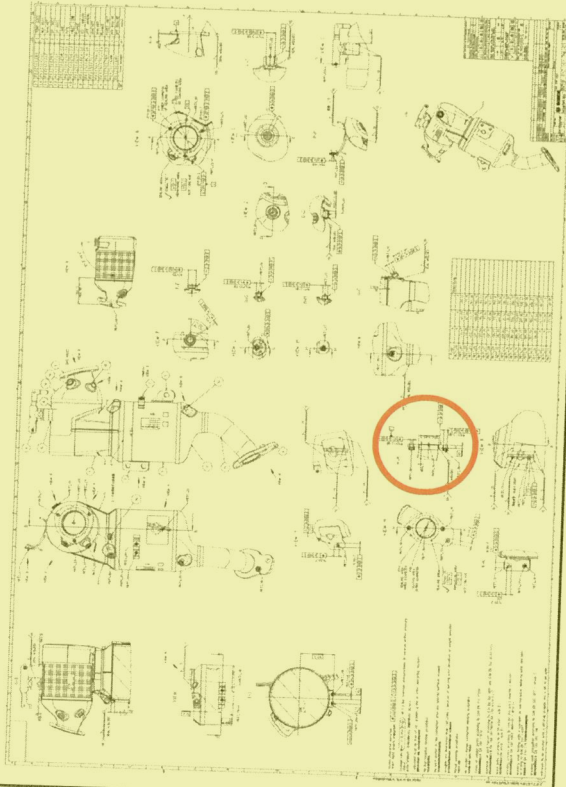
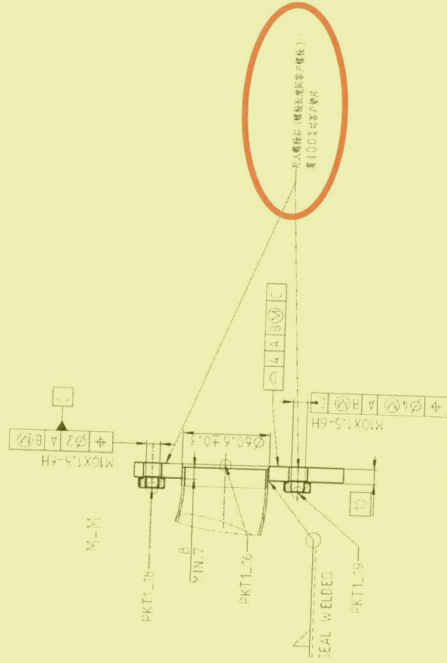
| 零件号 | | 零件名称 | | Project | 样件阶段 | 变更来源 |
|---|--|---|--|---|---|---|
| 变更描述 | | <div><p>增加新的检测方法:<br/>拧入螺栓后 (螺栓长度同客户螺栓),<br/>需100%过客户垫片</p></div> | | | | |
| 变更原因 | | 增加新的检测方法; | | | | |

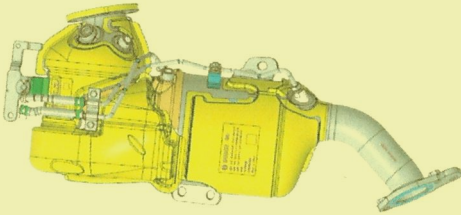
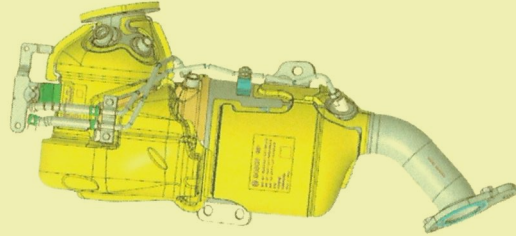
| | 零件号 | | 零件名称 | Project | 样件阶段 | 变更来源 |
|---|---|--|---|---|---|---|
| 变更描述 | | | <div>料号更改, 模型无变更<br/>由F01ZH003EA-03改为F01ZH003EA-00</div> | | | |
| 变更原因 | | | 料号更改 | | | |

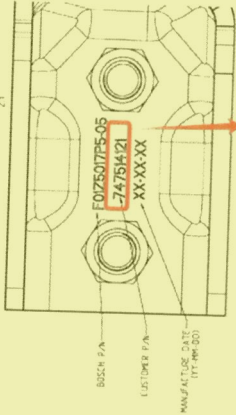
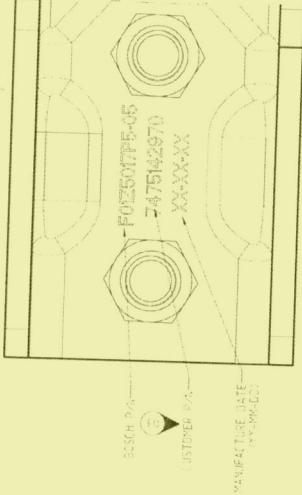
| 零件号 | | 零件名称 | Project | 样件阶段 | 变更来源 |
|---|--|---|---|---|---|
| | | 客户料号更新为<br>7475142970 | | | |
| 变更原因 | | 客户要求 | | | |

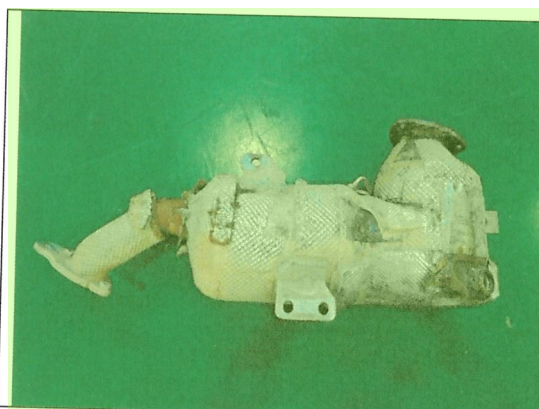
Fig.1 DOC+DPF overview

All components visual check are in acceptable condition.

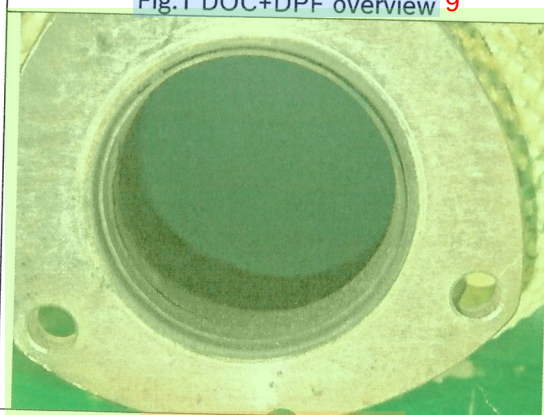
Fig.3 DOC inlet flange

| Part No. | components | No failure | Failure | Figure |
|---|---|---|---|---|
| 1 | DOC inlet flange | × | | Fig.3 |

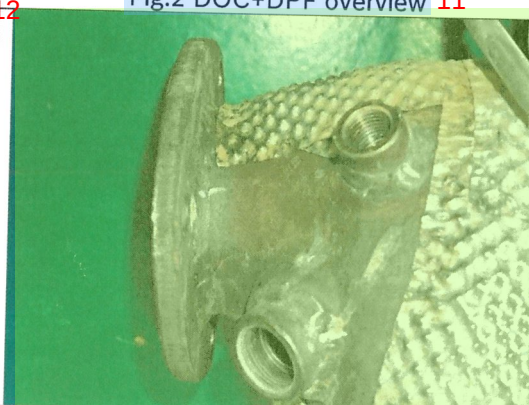
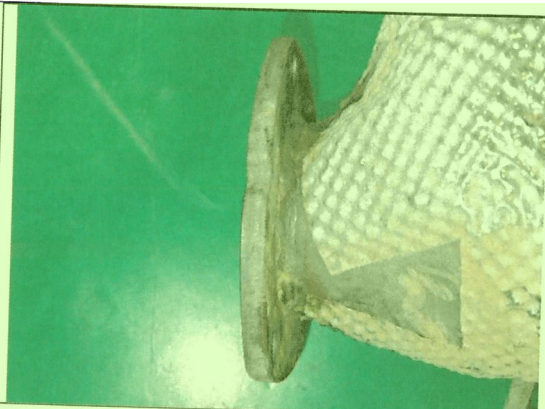
Fig.4 DOC inlet flange welding seam

| Part No. | components | No failure | Failure | Figure |
|---|---|---|---|---|
| 2 | DOC inlet flange welding seam | × | | Fig.4-5 |

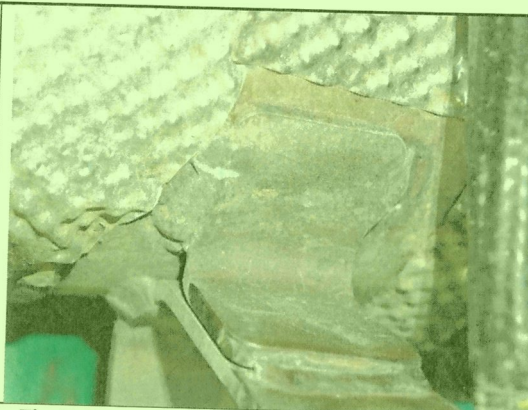
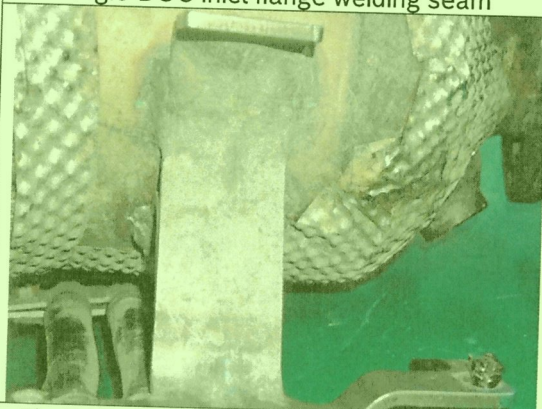
Fig.6 ΔP sensor bracket and welding seams

| Part No. | components | No failure | Failure | Figure |
|---|---|---|---|---|
| 3 | ΔP sensor bracket and welding seams | × | | Fig.6-7 |

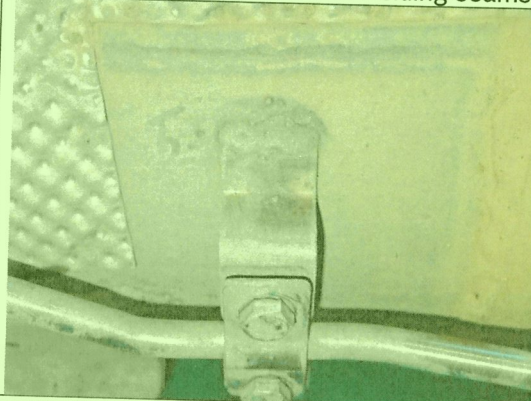
Fig.8 ΔP pipe bracket and welding seams

| 7 | $\Delta$ P pipe bracket and welding seams | x | Fig.8 |

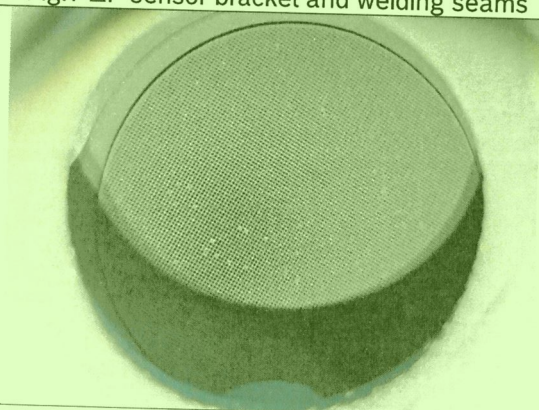
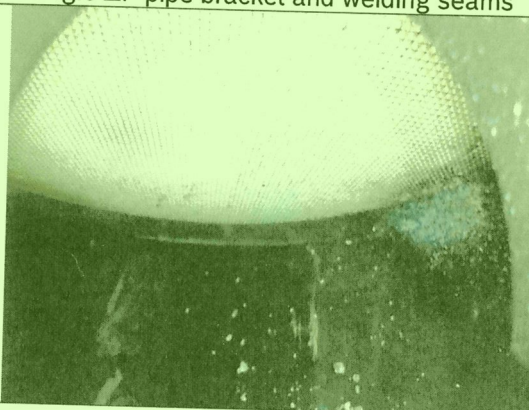
Fig.9 DOC catalyst

| Part No. | components | No failure | Failure | Figure |
|---|---|---|---|---|
| 4 | DOC catalyst | × | | Fig.9-10 |

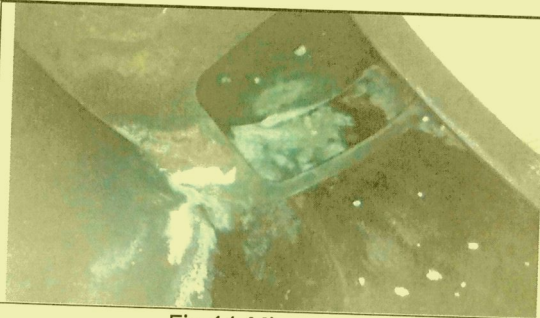
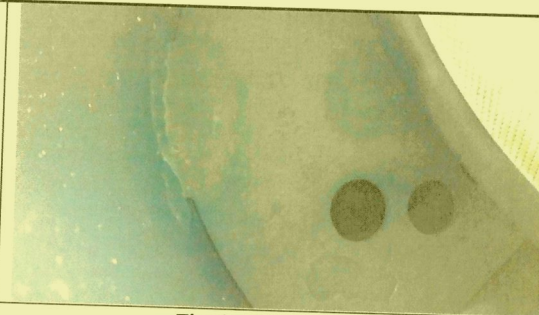
Fig.11 Mixer plate

| 6 | Mixer plate | x | Fig.11-12 |

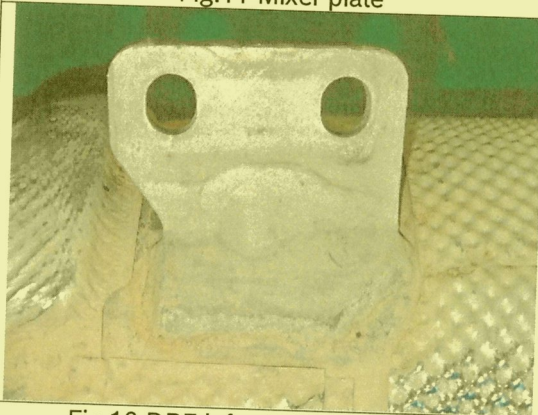
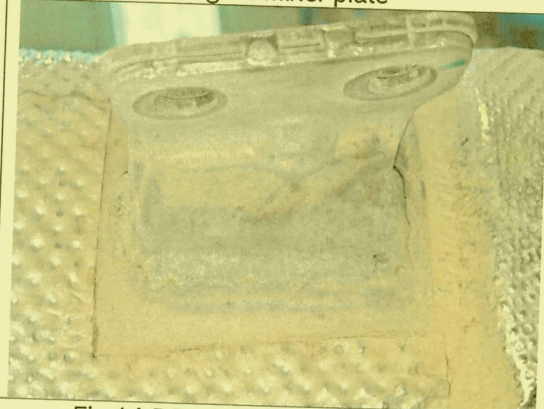
Fig.13 DPF left mounting bracket 1

| 8 | DPF left mounting bracket 1 | x | Fig.13-14 |

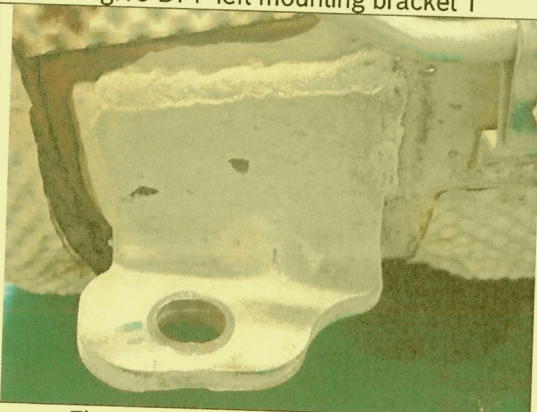
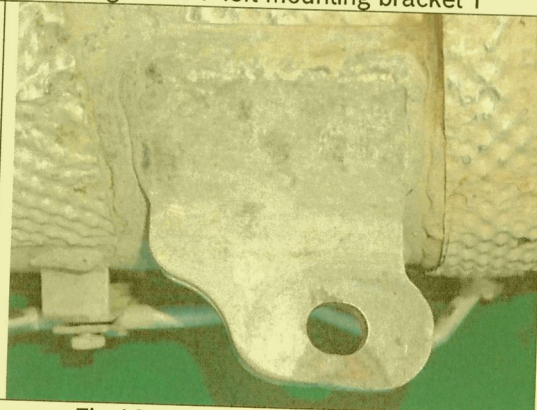
Fig.15 DPF right mounting bracket

| 10 | DPF right mounting bracket | x | Fig.15-16 |

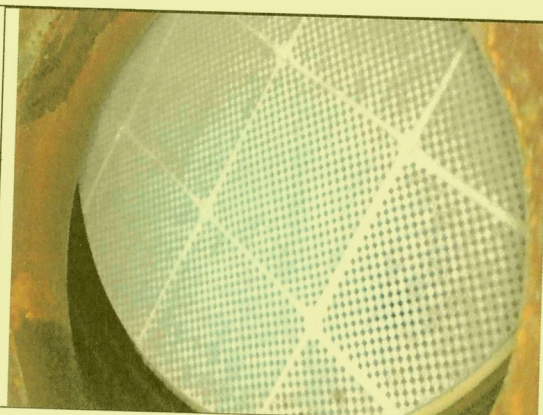
Fig.17 DPF catalyst

| 11 | DPF catalyst | x | Fig.17 |

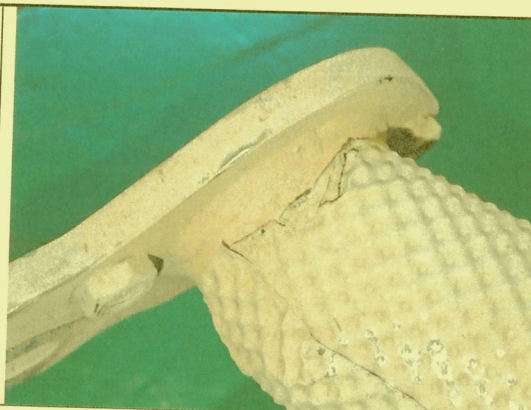
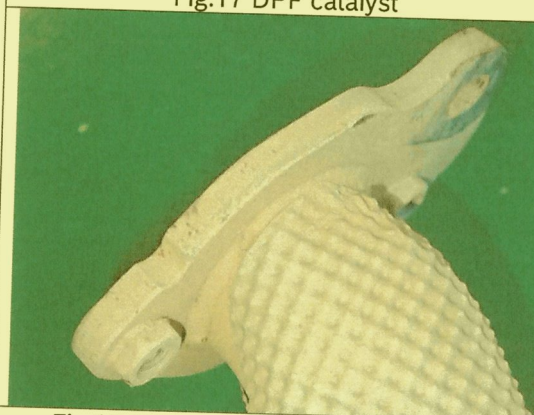
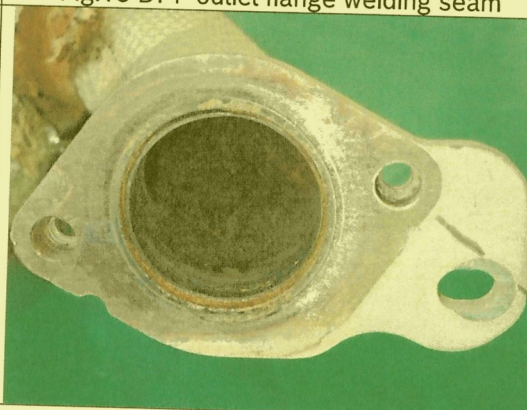
Fig.18 DPF outlet flange welding seam

| 12 | DOC outlet flange welding seam | x | Fig.18-19 |

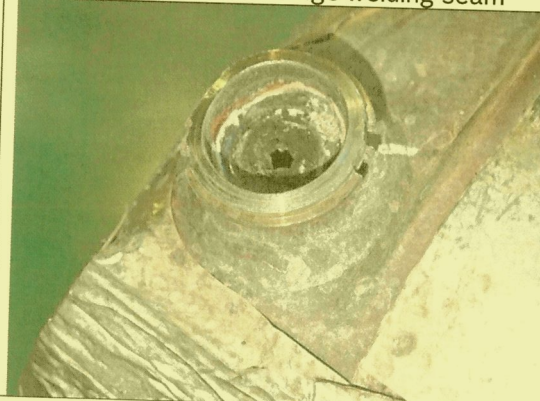
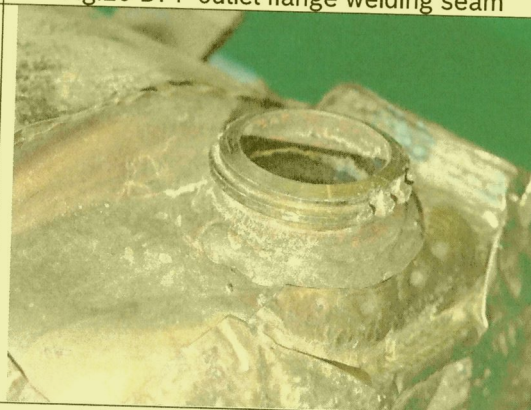
Fig.21 DM flange and welding seam

| 5 | DM flange | x | Fig.21-22 |

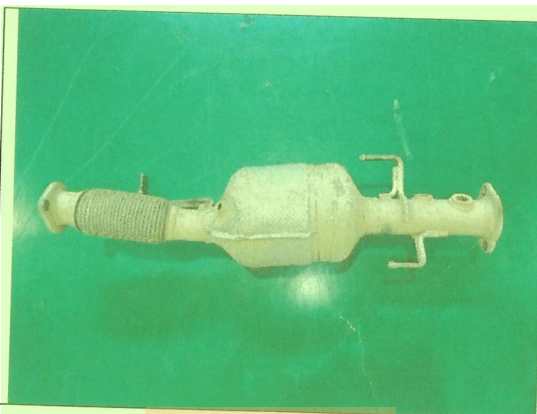
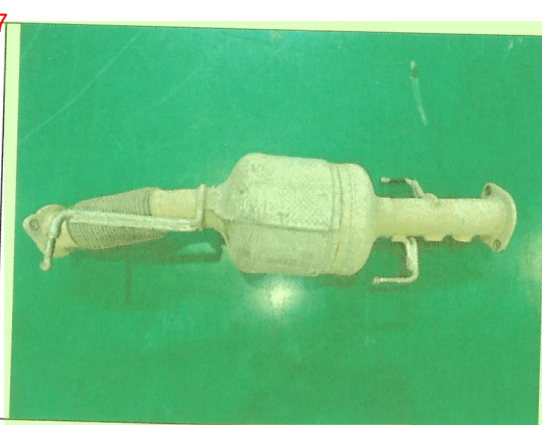
| Part No. | components | No failure | Failure | Figure |
|---|---|---|---|---|
| 7 | SCR sleeve welding seam | × | | Fig.23-24 |

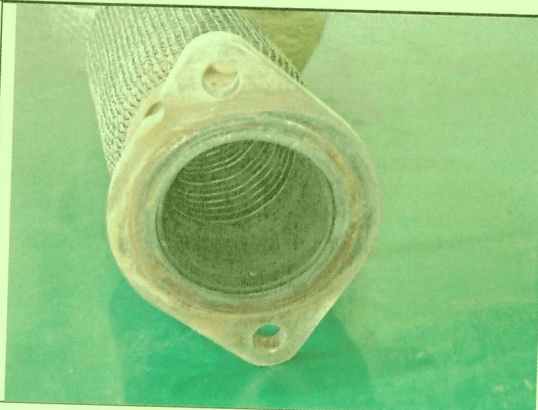
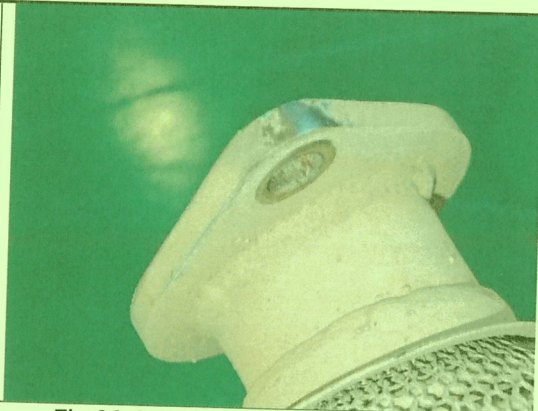
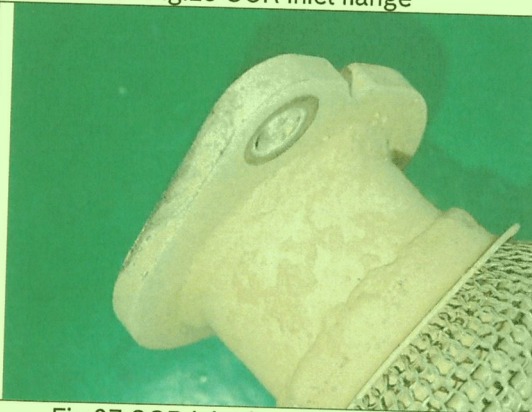
Fig.25 SCR inlet flange

| Part No. | components | No failure | Failure | Figure |
|---|---|---|---|---|
| 1 | SCR inlet flange and welding seams | × | | Fig.25-27 |

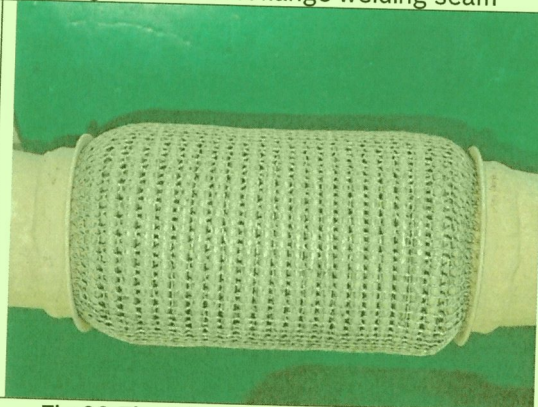
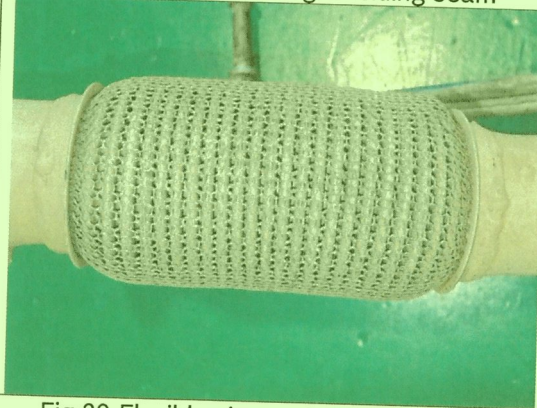
Fig.28 Flexible pipe outlet welding seam

| Part No. | components | No failure | Failure | Figure |
|---|---|---|---|---|
| 2 | Flexible inlet welding seam | × | | Fig.28-29 |
| 3 | Flexible pipe | × | | Fig.28-29 |
| 4 | Flexible pipe outlet welding seam | × | | Fig.28-29 |

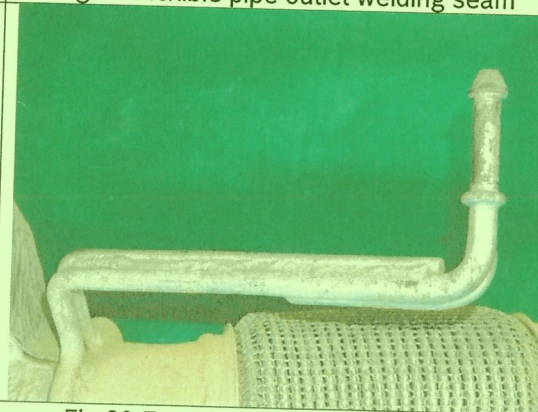
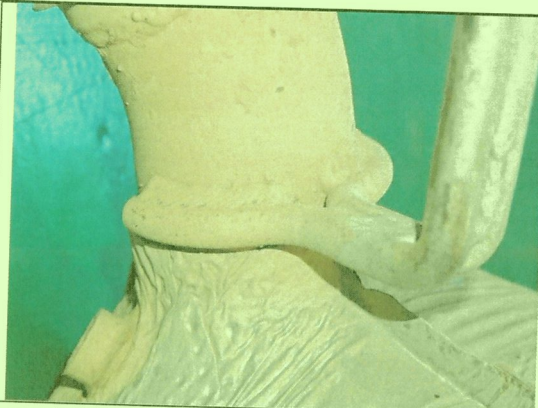
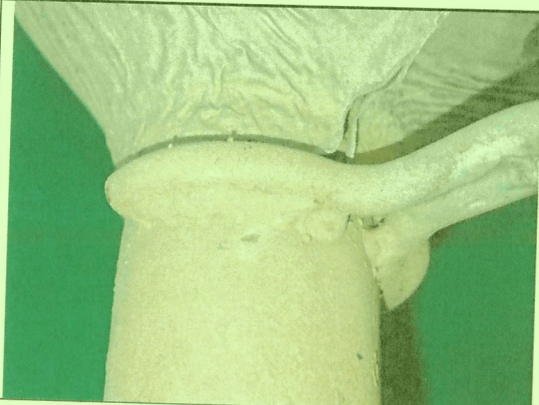
Fig.30 Front hook and welding seam

| Part No. | components | No failure | Failure | Figure |
|---|---|---|---|---|
| 5 | Front hook and welding seam | × | | Fig.30-32 |

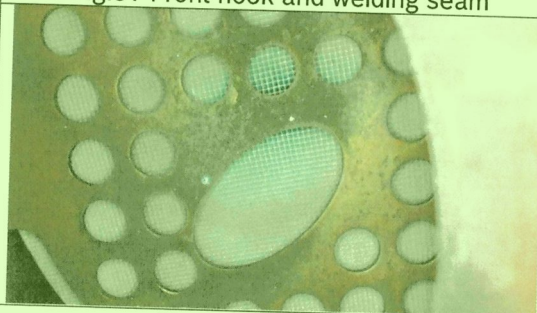
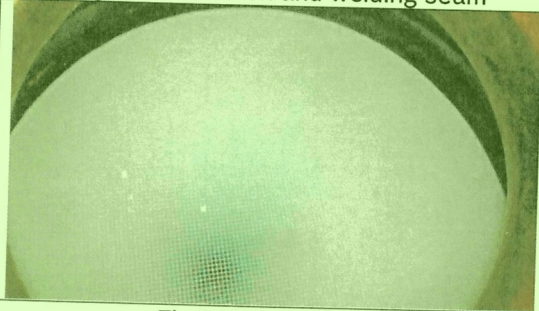
Fig.33 SCR catalyst

| Part No. | components | No failure | Failure | Figure |
|---|---|---|---|---|
| 6 | SCR catalyst | × | | Fig.33-34 |

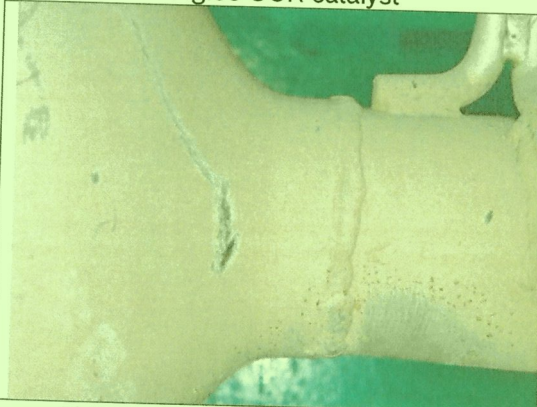
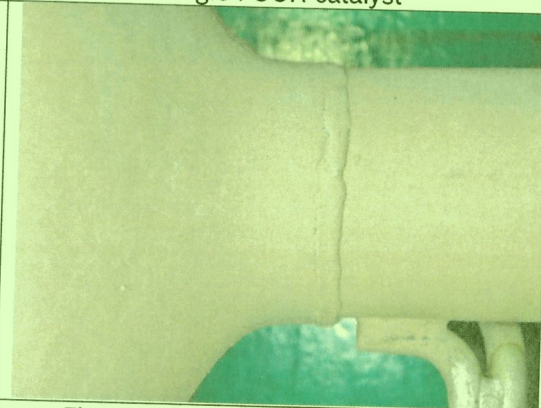
Fig.35 SCR outlet pipe welding seam

| Part No. | components | No failure | Failure | Figure |
|---|---|---|---|---|
| 8 | SCR outlet pipe welding seam | × | | Fig.35-36 |

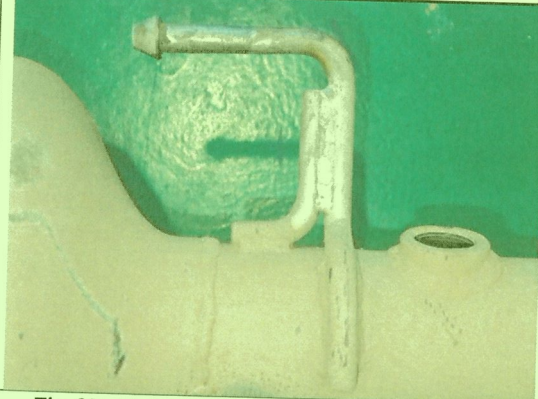
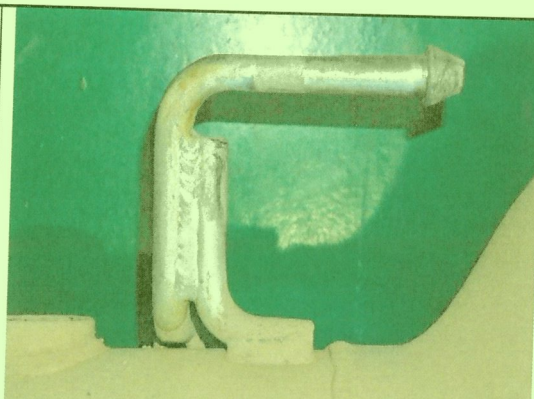
Fig.37 Right rear hook and welding seam

| Part No. | components | No failure | Failure | Figure |
|---|---|---|---|---|
| 9 | Right rear hook and welding seam | × | | Fig.37-38 |

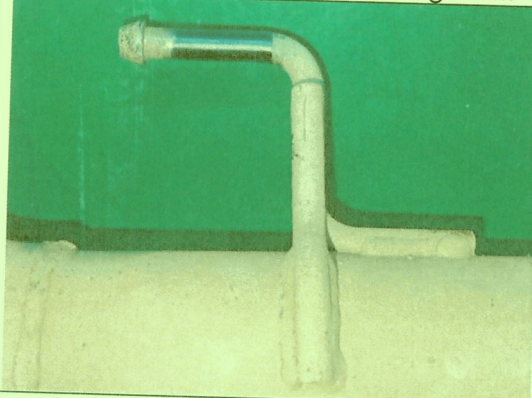
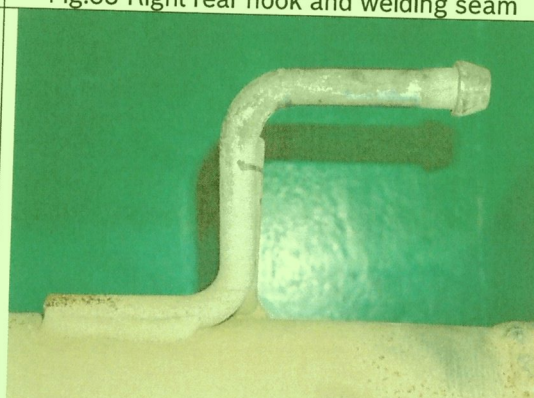
Fig.39 Left rear hook and welding seam

| Part No. | components | No failure | Failure | Figure |
|---|---|---|---|---|
| 10 | Left rear hook and welding seam | × | | Fig.39-40 |

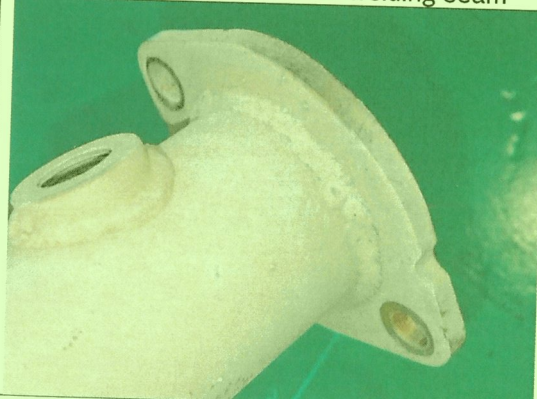
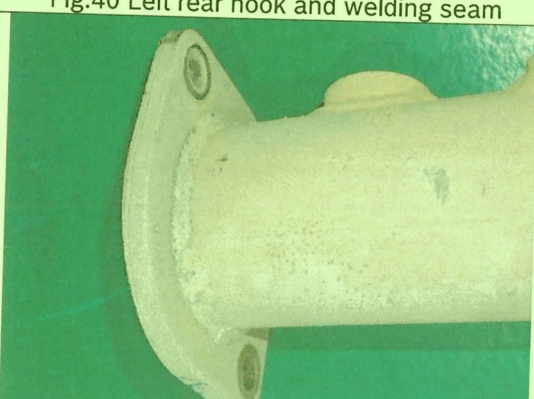
Fig.41 SCR outlet flange welding seam

| Part No. | components | No failure | Failure | Figure |
|---|---|---|---|---|
| 11 | SCR outlet flange welding seam | × | | Fig.41-42 |
